# FOUR SCHOOLS RENOVATION PROJECT MANSFIELD, CT

January 9, 2008

### EXISTING CONDITIONS ANALYSIS

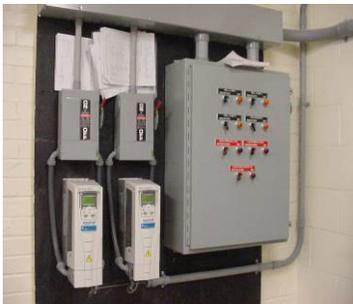
## WATER PUMPS VFD'S:

There is one domestic water pump and two circulating pumps for the hydronic system. The pumps are 5 years. They are of adequate size, in good condition, raise no energy efficiency issues and are suitable for continued existing use.

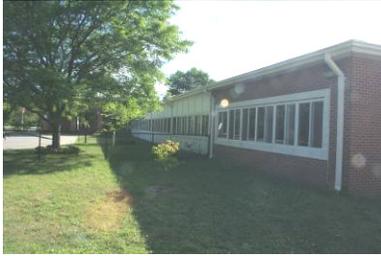
The exterior walls of the 1990 additions were constructed using concrete masonry unit (CMU) backup and brick exterior. Wall sections from the construction documents used to build these additions indicate 2" of rigid polystyrene insulation between the two wythes of masonry.

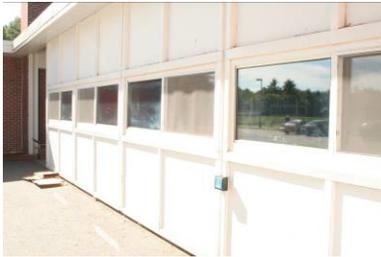
**Windows** - New aluminum windows with insulating glass were installed in both the original building and in the new additions when these were constructed in 1990. It was noted in some spaces that the insulating glass seals have failed evidenced by condensation and fogging between the two glass panes. The size of operable units appears to meet current codes for rescue and ventilation requirements. Shading devices consist of Venetian blinds.

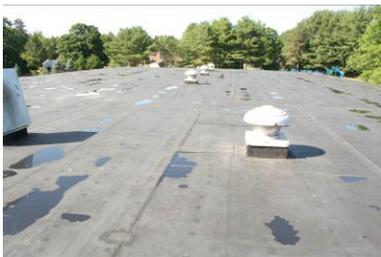
**Roof** - The entire building received a new roof when the 1990 additions were constructed. The roof is a single-ply EPDM (rubber) fully adhered .060" membrane manufactured by Firestone. The membrane has markings indicating it was manufactured in "11-89" and portions in "06-90". There is evidence of insulation fasteners projecting up in several areas, thus creating potential stress and tear points. Internal roof drains were located throughout the non-pitched roof areas. The roof pitches to exterior gutters connected to downspouts and an underground storm drainage system. Drawings indicate the presence of 2½" of rigid polystyrene insulation beneath the EPDM membrane and on some portions of the roof, tapered insulation adds to this thickness. Some ponding was noted by standing water and evidence of residue left where previous moisture had evaporated. A standing seam metal roof occurs over the new entranceway to the school.

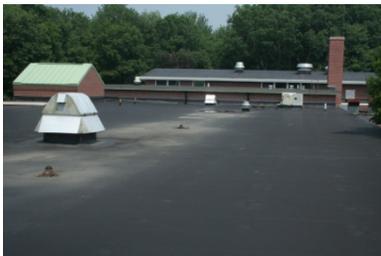
**Roof** - The entire building received a new roof when the 1990 additions were constructed. The roof is a single-ply EPDM (rubber) fully adhered .060" membrane manufactured by Firestone. The membrane has markings indicating it was manufactured in "10-89". Internal roof drains were located throughout the non-pitched roof areas. The roof pitches to exterior gutters connected to downspouts and an underground storm drainage system. Drawings indicate the presence of 2½" of rigid insulation beneath the EPDM membrane and on some portions of the roof, tapered insulation adds to this thickness. Some ponding was noted by standing water and evidence of residue left where previous moisture had evaporated. A standing seam metal roof occurs over the new entranceway to the school.

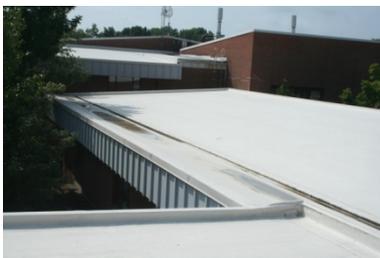
**Roof** - The roof of the original building consists of a white reinforced Stevens Hi-Tuff EP PVC membrane over rigid insulation. There are built-in gutters with drains at regular intervals but no slope in the gutter trough between the drains. This creates pockets of standing water where leaves and debris collect. In some locations, standing water was noted on both the high and lower side of the gutter trough.

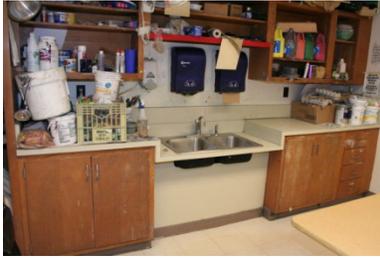
**Classroom Casework** - Throughout the building, most of the casework has been constructed with stained wood base and wall cabinets and plastic laminate countertops and backsplashes. Similar construction was used in the Science Laboratories except for the use of solid, black resinous laboratory countertops and backsplashes. In some locations the wear and deterioration was showing on the vertical surfaces of the wood cabinetry and the plastic laminate countertops and the edgings. Some of the science rooms appear to have newer casework and are in better condition.

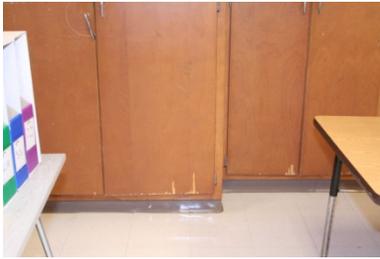
**Doors and Frames** - Throughout the entire building doors are solid core wood mounted in hollow metal frames with wire glass vision panels and lites in the doors. Some doors, especially around stairways, show evidence of considerable traffic and wear and tear. Doors between corridors and some stairways were noted as not having positive latching devices and only push/pull plates.

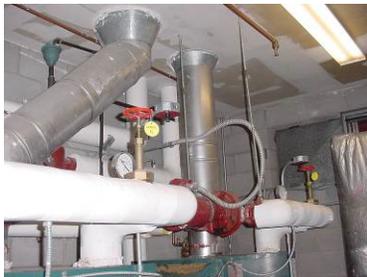
### BREECHING:

**Boiler Room and Fuels** - The boiler room added with the 1999 addition contains two identical Burnham cast iron boilers of 580 MBH each. Boiler controls are by Honeywell and the hydronic piping system uses a glycol solution. The boilers provide heating to the 1999 addition packaged roof top unit, fin tube radiation, cabinet unit heaters and heat pump unit ventilators. The boilers are not large enough nor can they be expanded to heat the entire school after the removal of the electric baseboard radiation heaters and the electric heat pumps.

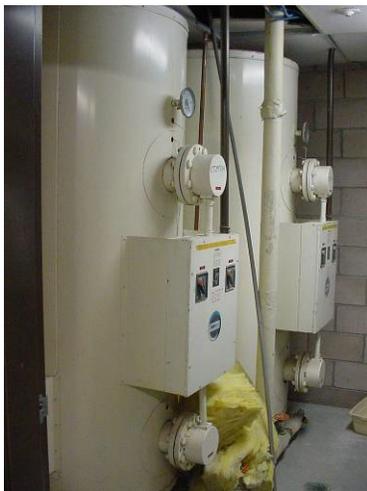
**Hot and Cold Water Distribution Piping** - The hot and cold water distribution piping is copper and varies in age, the oldest being 45 years old and the most recent 1-year old. There is no need to replace the copper piping or service valves based on age unless they show signs of oxidation by green discoloration, it leaks or is damaged. Shower mixing valves are recommended for replacement due to age and malfunctioning conditions. There is no evidence of polybutylene piping for the domestic water distribution system. However, if found, it should be replaced with copper piping.

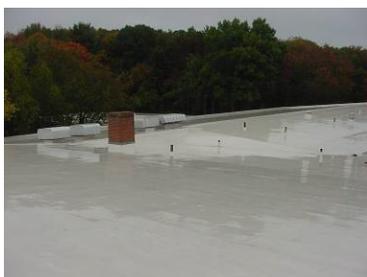
**Sanitary Waste and Vent System Piping** - The cast iron and PVC sanitary waste piping system and the galvanized steel and PVC vent piping systems are original to the building. There are no complaints about their condition or reliability. Galvanized piping showing signs of rust and damaged piping of any adjacent material should be replaced.
