# FOUR SCHOOLS RENOVATION PROJECT MANSFIELD, CT

January 9, 2008

### EXISTING CONDITIONS ANALYSIS

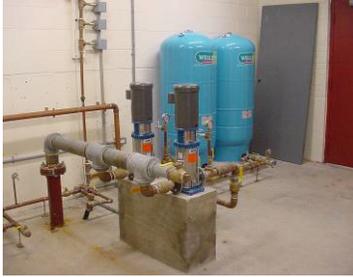
## WATER PUMPS & PRESSURE TANKS:

**Domestic Water** - Domestic and water for the hydronic systems is provided by two new wells drilled in 2007 to replace the original wells. Two new 5000 gallon in ground water storage tanks were also installed. The water system is of adequate size, in good condition, raises no energy efficiency issues and is suitable for continued existing use.

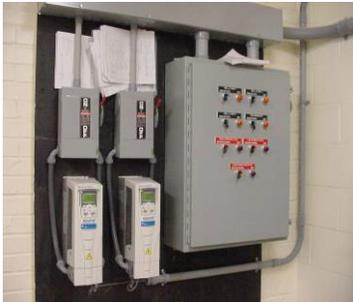
## WATER PUMPS VFD'S:

There is one domestic water pump and two circulating pumps for the hydronic system. The pumps are 5 years. They are of adequate size, in good condition, raise no energy efficiency issues and are suitable for continued existing use.

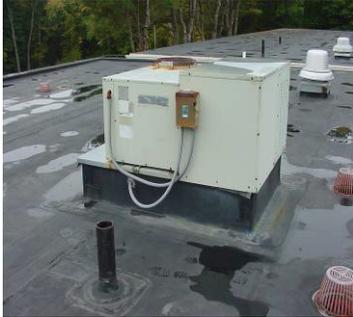
### 6 TON RTU:

**Ventilation and Air Conditioning** - A 12 year old 6 ton roof top unit provides cooling for the offices through a ducted air distribution system. It is recommended to replace the RTU based on its age and condition.

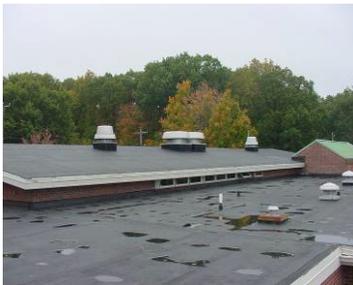
### UNIT VENTILATORS:

One roof top unit ventilator provides exhaust for two classrooms through ducts and grills. Make up air is provided through operable sash windows. It is recommended to replace these systems with a dedicated outside air system (DOAS) and heat recovering unit ventilators.

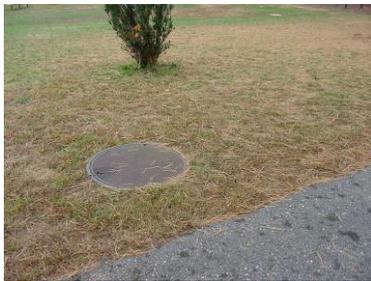
**SEPTIC:**

The cast iron and PVC sanitary waste piping system and the galvanized steel and PVC vent piping systems are original to the building or installed in the 1989 renovation. There are no complaints about their condition or reliability. Galvanized piping showing signs of rust and damaged piping of any adjacent material should be replaced.

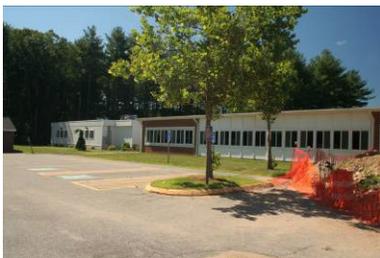
**Exterior Walls** - The exterior walls of the 1955 original building consist of a wood-framed curtain wall type system with non-insulated transite panels over 1/2" plywood and replacement aluminum windows. Where visual access was available, it did not appear that there was insulation of any significant thickness backing the transite panels over 1/2" plywood. Some of the end walls at the classrooms wings and the higher walls surrounding the Gymnasium / Cafeteria were constructed using concrete masonry units as a backup and brick veneer on the exterior surface. Based on the building's original age, it does not appear likely that there is insulation between the two wythes of masonry.

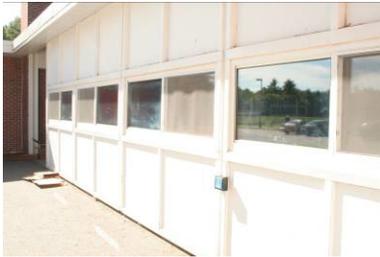
**Windows** - New aluminum windows with insulating glass were installed in both the original building and in the new additions when these were constructed in 1990. It was noted in some spaces that the insulating glass seals have failed evidenced by condensation and fogging between the two glass panes. The size of operable units appears to meet current codes for rescue and ventilation requirements. Shading devices consist of Venetian blinds.

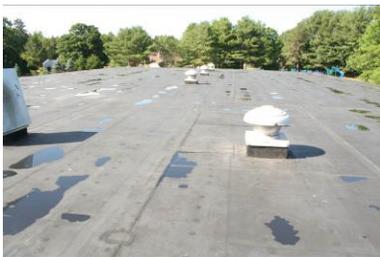
**Roof** - The entire building received a new roof when the 1990 additions were constructed. The roof is a single-ply EPDM (rubber) fully adhered .060" membrane manufactured by Firestone. The membrane has markings indicating it was manufactured in "11-89" and portions in "06-90". There is evidence of insulation fasteners projecting up in several areas, thus creating potential stress and tear points. Internal roof drains were located throughout the non-pitched roof areas. The roof pitches to exterior gutters connected to downspouts and an underground storm drainage system. Drawings indicate the presence of 2½" of rigid polystyrene insulation beneath the EPDM membrane and on some portions of the roof, tapered insulation adds to this thickness. Some ponding was noted by standing water and evidence of residue left where previous moisture had evaporated. A standing seam metal roof occurs over the new entranceway to the school.

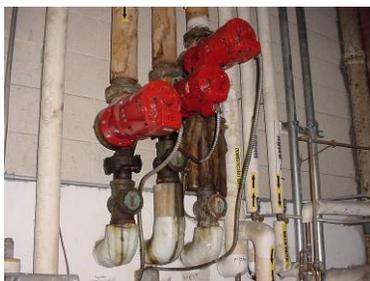
### HOT WATER PUMPS:

**Pumps:** The existing inline pumps appear to be in fair condition; however, they are approaching the end of their useful life.

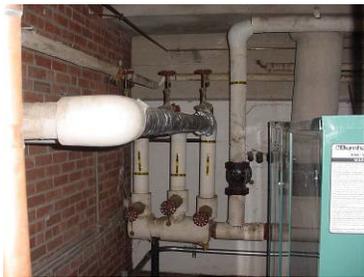
### HOT WATER VALVES:

**Condition & Recommendations:** In general, the hot water distribution system is old and at the end of its useful life. Terminal heating equipment appears to be original construction vintage and is not easily modified/ altered to meet current building needs. Changes in the classroom space(s), needs and ventilation system will have a direct impact on this equipment also. Our current recommendation is to provide new heating distribution equipment including pumps and piping. The new equipment would be coordinated with any and all classroom modifications. Piping layout would be revised to include individual zone control.

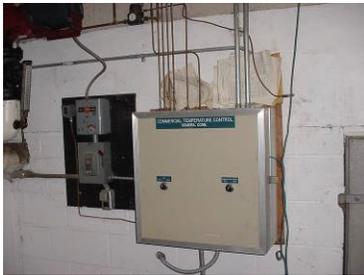
### HVAC CONTROL SYSTEM:

**HVAC** - The existing HVAC control system consists of combination of pneumatic, electro-mechanical and direct digital controls. The boilers are controlled by an existing digital controller (Allerton Technologies) while the distribution system uses pneumatics and electro-mechanical devices.

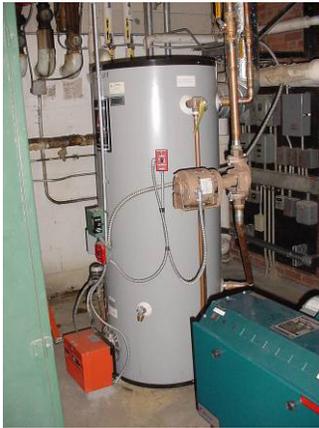
### DOMESTIC HOT WATER:

The existing domestic hot water system consists of an oil fired hot water heater (backup & summer operation) and storage tank with tank-less hot water heaters located within the boilers (winter operation).

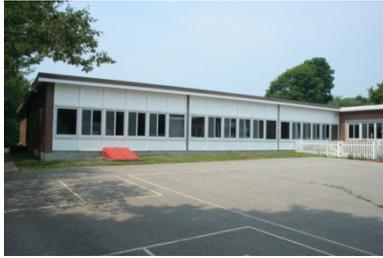
**Windows** - New aluminum windows with insulating glass were installed in both the original building and in the new additions when these were constructed in 1990. It was noted in some spaces that the insulating glass seals have failed evidenced by condensation and fogging between the two glass panes. The size of operable units appears to meet current codes for rescue and ventilation requirements. Shading devices consist of Venetian blinds.

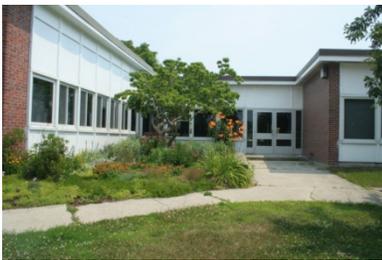
### SIDEWALK CONDITION:

The sidewalks throughout the school site are generally concrete and in fair condition, though there are some walks in poor condition particularly along the front of the school on the south end and on the south side of the school. These walks should be repaired as required. The sidewalks along the bus drop off area are too narrow to meet present design standards, and should be widened. There is a ramp on the southeast corner of the building that appears to exceed handicapped accessibility standards for slope.

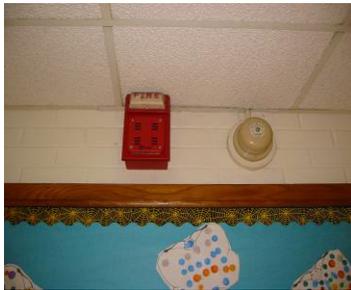
**FIRE ALARM SYSTEM:**

The fire alarm system is a combination of old and new. The new being a new Silent Knight model SK-5208 FACP installed last year. It is an 8 zone non-addressable system. Not replaced are most of the pull stations, flashing lights and horns. The system has no voice evacuation, no interface to kitchen hood, and no exterior notification. Notification devices are not ADA compliant. It is recommended to install a new addressable fire alarm system to bring fire systems up to current ADA and NFPA requirements.

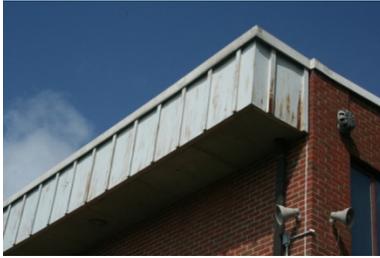
An overhang extends around the exterior walls in many locations. This is constructed using a painted metal vertical ribbed fascia, which was noted as requiring painting and showing rust penetration, most particularly on the south wide. The underside of this overhang contains a transite (cement asbestos board) panel secure to the underside of the roof overhang structural system.

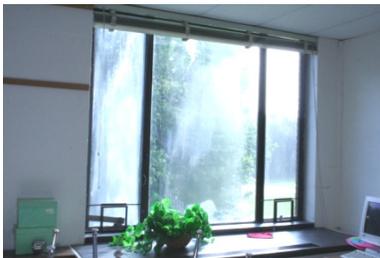
**Windows** - Windows in the original building are fabricated from aluminum materials with insulated glass, appearing to be 3/8" total thickness. It was observed that the seals in many locations have failed by the formation of condensation and streaking of moisture between the panes. A date stamp of /85 was noted in some units. The configuration of most of the original building's windows do not conform to current building and fire safety code requirements for Rescue and Ventilation units in each classroom.

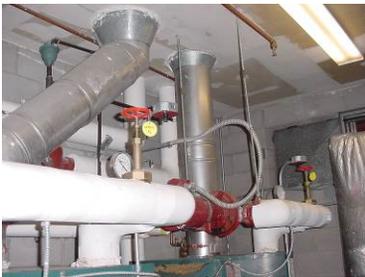
### BREECHING:

**Boiler Room and Fuels** - The boiler room added with the 1999 addition contains two identical Burnham cast iron boilers of 580 MBH each. Boiler controls are by Honeywell and the hydronic piping system uses a glycol solution. The boilers provide heating to the 1999 addition packaged roof top unit, fin tube radiation, cabinet unit heaters and heat pump unit ventilators. The boilers are not large enough nor can they be expanded to heat the entire school after the removal of the electric baseboard radiation heaters and the electric heat pumps.

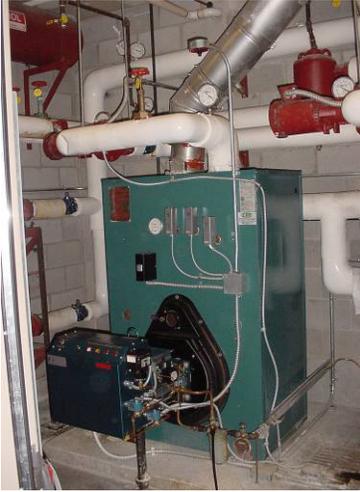
**BOILER:**

Fuel for the boilers is #2 oil stored in a 2000-gallon in ground tank as part of the 1999 addition. The tanks are equipped with gauging and leak detection. It is of adequate size for its present use. Recommended is additional fuel oil capacity to accommodate new boilers required with the elimination of electric baseboard heat and electric water heaters. Natural gas is available in the neighborhood and extending a line to the school will offer dual fuel availability (#2 oil/natural gas) for boilers and roof top units, which will increase the efficacy of renovations and offer an economical hedge for fuel price fluctuation.

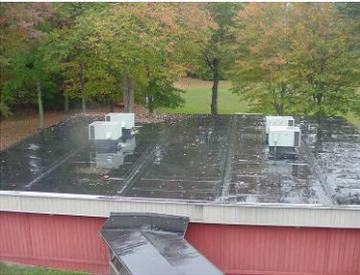
**CLASSROOM ANNEX:**

The Classroom annex comprised of four classrooms and connected to the main school building by an enclosed corridor is heated and cooled by 4 packaged roof top units. These units are due for replacement in 7 years. It is recommended to replace them with packaged roof top units with either a gas burner or a hot water coil for heating.

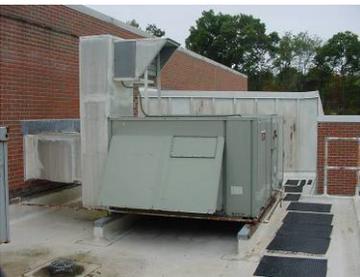
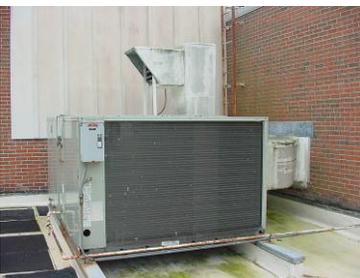
**AUDITORIUM ROOF TOP UNITS:**

**Auditorium** - The auditorium is heated, ventilated and air-conditioned from two identical Trane packaged roof top units with 350,000 BTU gas fired heaters, 18-ton DX cooling units, 7200 CFM supply fans with exhaust back through the unit. Ducted into the auditorium is supply air and returned through exhaust grills. These units installed in 1996 need replacement. Propane provided from a town owned underground propane tank to gas burners in the roof top units provide heat for the auditorium. It is recommended to supply the replacement units with natural gas if available and remove the propane tank.

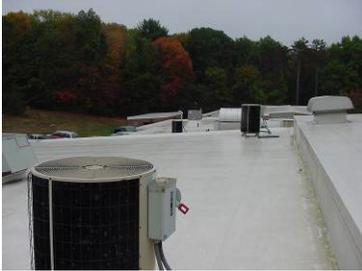
### CAFETERIA HEAT PUMPS:

*Cafeteria* - Roof mounted split system electric heat pumps heat the cafeteria. Roof-mounted fans provide ventilation. The heat pumps are 16 years old and not as energy efficient as heating with oil or gas. It is recommended to replace the cafeteria heating and ventilation system with an indirect glycol package roof top unit with DX cooling.

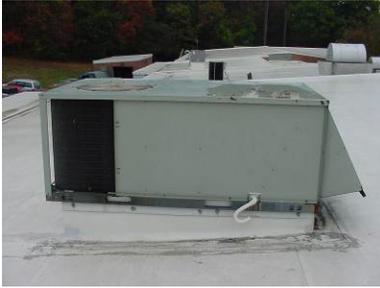
### MUSIC ROOM ROOF TOP UNIT:

**Instrument Music Room** - The instrumental music room is heated, ventilated and air conditioned by two Trane packaged roof top units with electric heat, 6 ton DX cooling units and supply fans with exhaust back through the unit. Supply air ducted into the music room returns through exhaust grills in the auditorium. The unit installed in 1992 needs replacement. It is recommended to replace the music room packaged roof top unit with a packaged roof top unit using hot glycol heating with DX cooling and supply air fan.

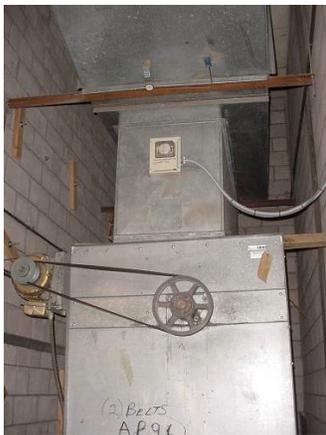
### PLENUM EXHAUST FAN:

**Gymnasium** - In a plenum adjacent to the gymnasium is a supply fan with electric an electric heating coil for ventilating and heating the gym, exercise room and locker rooms. Ceiling fans are mounted in the gym for circulating air. This ventilation equipment is over 30 years old. It is recommended to replace the motor with an energy efficient high power factor motor and install hydronic heating.

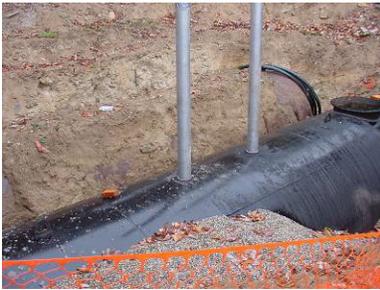
### ONE OF TWO WATER STORAGE TANKS:

**Water Supply** - The middle school water supply is from two recently drilled wells. A new pump building built in 2007 houses water pumps, pressure tanks and related electrical equipment including variable frequency drives for maintaining proper water pressure.

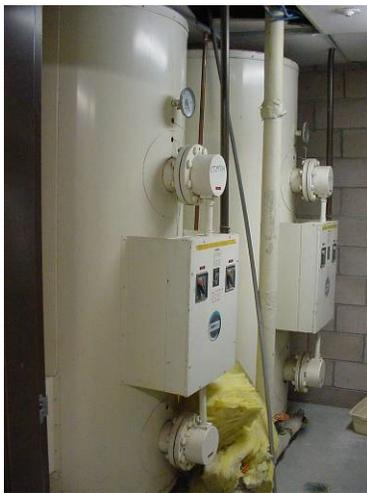
### HUBBELL 350 GALLON WATER HEATERS:

**Hot and Cold Water Distribution Piping** - The hot and cold water distribution piping is copper and varies in age, the oldest being 45 years old and the most recent 1-year old. There is no need to replace the copper piping or service valves based on age unless they show signs of oxidation by green discoloration, it leaks or is damaged. Shower mixing valves are recommended for replacement due to age and malfunctioning conditions. There is no evidence of polybutylene piping for the domestic water distribution system. However, if found, it should be replaced with copper piping.

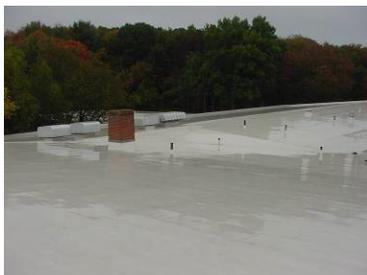
### VENT PIPING:

**Sanitary Waste and Vent System Piping** - The cast iron and PVC sanitary waste piping system and the galvanized steel and PVC vent piping systems are original to the building. There are no complaints about their condition or reliability. Galvanized piping showing signs of rust and damaged piping of any adjacent material should be replaced.
