Memorandum

Regarding: Storrs Lodge, LLC, Town of Mansfield Inland Wetland Application Review (PN: 1605880)

Date: May 12, 2016

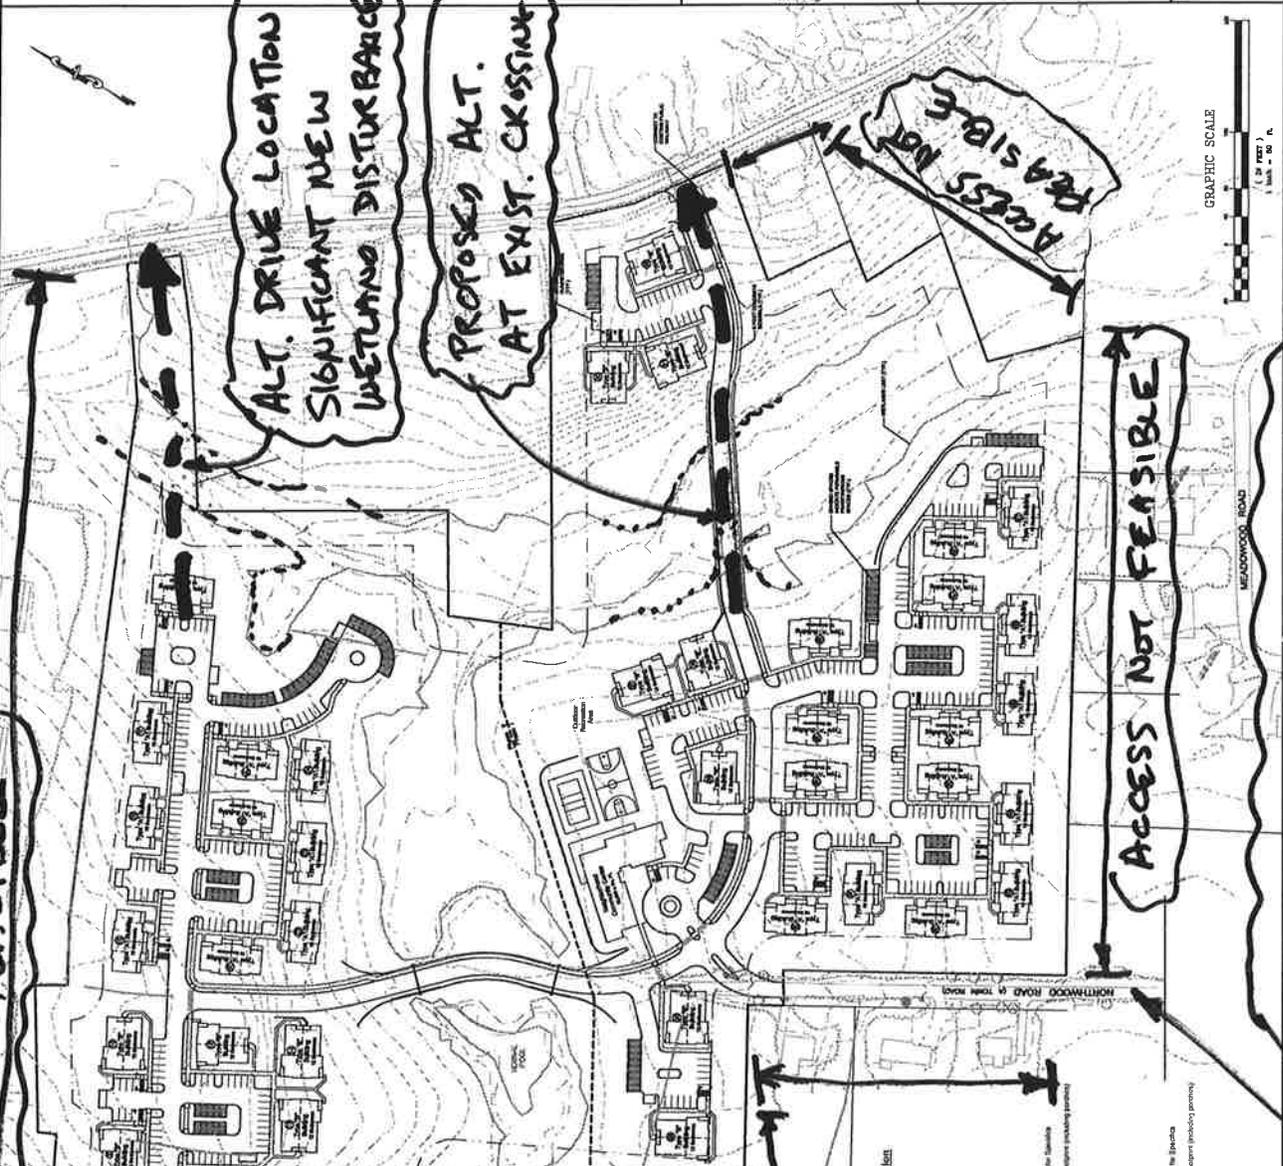
SKETCH #1
 5/24/16

ACCESS NOT FEASIBLE

ALT. DRIVE LOCATION
 SIGNIFICANT NEW
 WETLAND DISTURBANCE

PROPOSED ACT.
 AT EXIST. CROSSING

SINGLE PAVICIT
 ACCESS
 TO NORTHWOOD NOT PRUDENT

ACCESS TO
 WEST NOT
 FEASIBLE

Given the topographical features of the property and practical access limitations to existing public roadways, any type of development on this property would include access roads and public utility connections basically following the layout included in the proposed project. It is the opinion of the applicant that there are no other feasible road locations on the property. See Sketch #1, attached.
