Re: WETLANDS ASSESSMENT-SUPPLEMENTAL: VERNAL POOL INVESTIGATION

Lodges at Storrs, Hunting Lodge Road, Mansfield, CT

REMA Job No.: 15-1860-MNS18

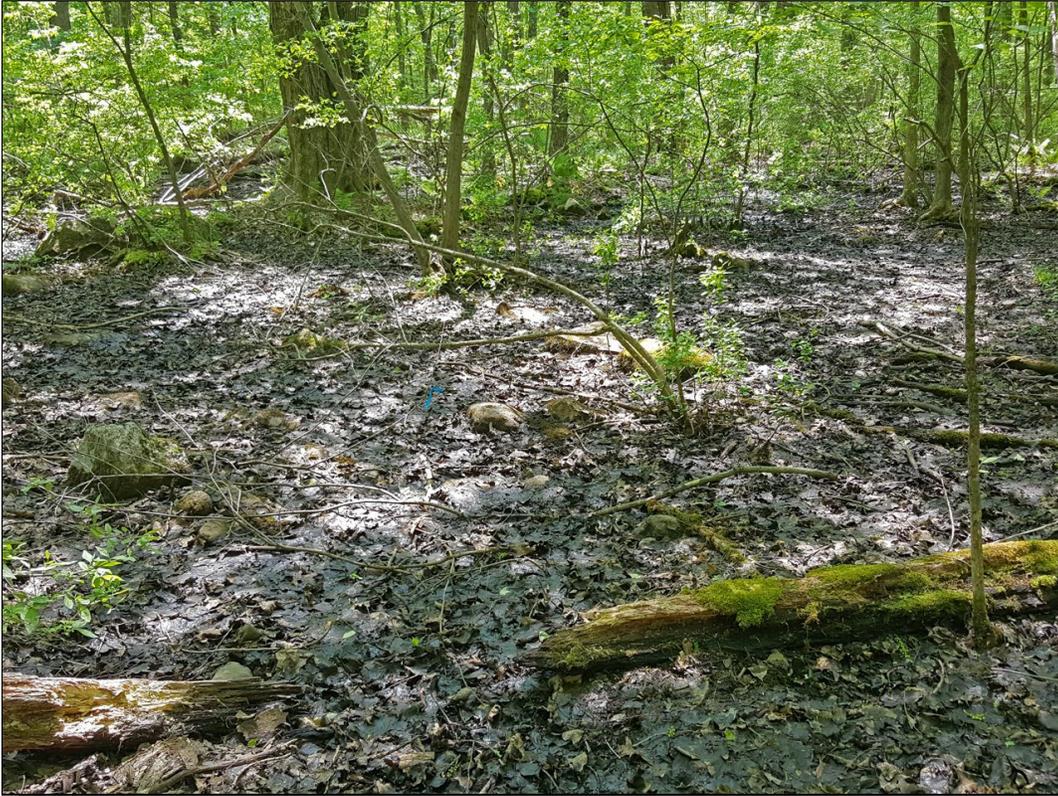
Photo 1: Wetland A (with embedded vernal pool habitat); on 5-25-16; southern section of VP where wood frog egg masses had been observed; facing southwesterly

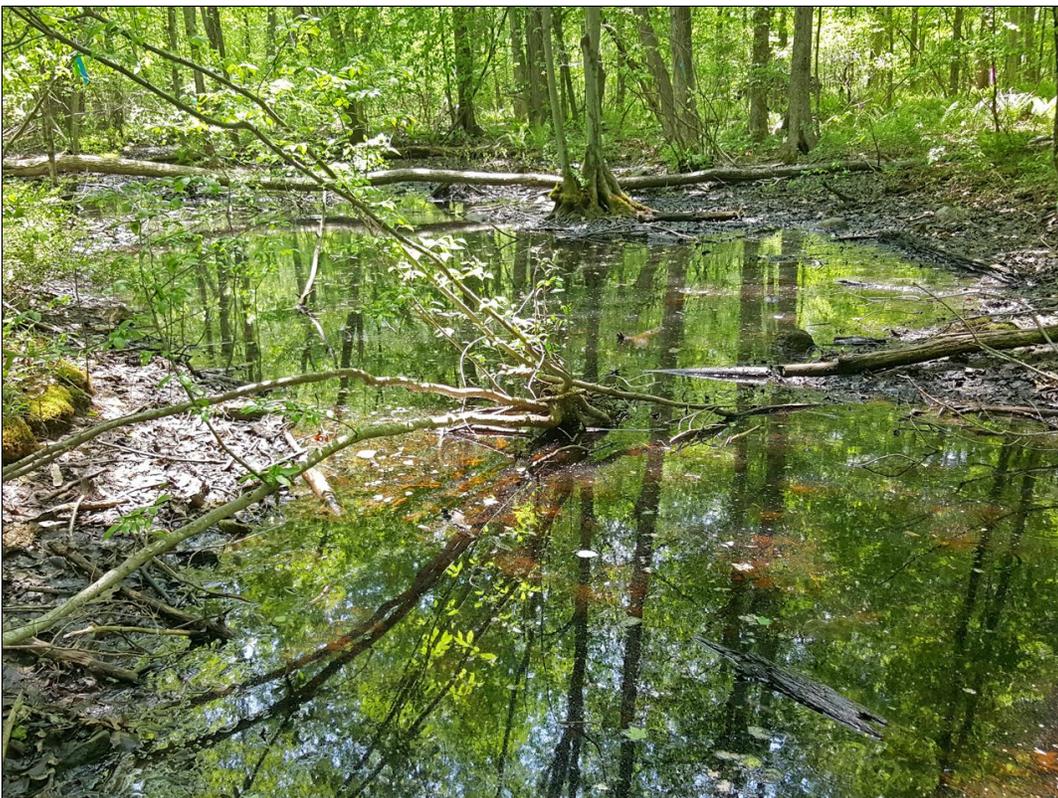
Photo 2: Wetland A; vernal pool, near location of wood frog egg mass raft; northern section; 5-25-16; facing southwesterly

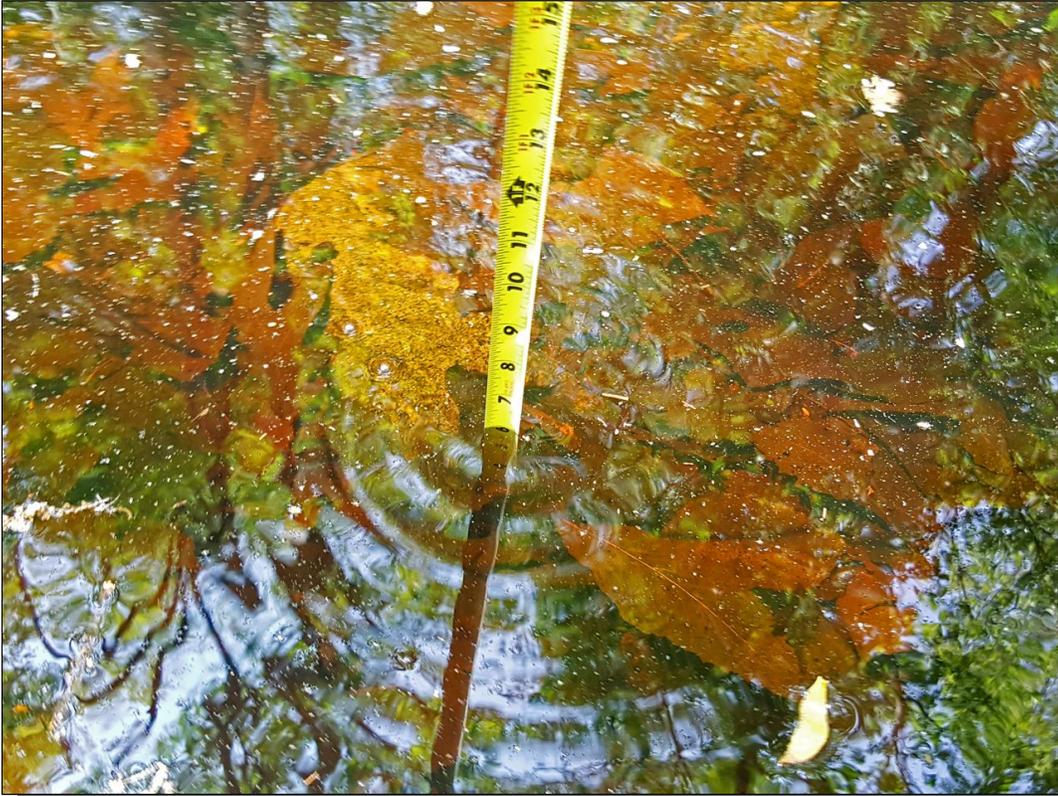
- **May 18th**: Water depths average 5-6 inches; only about 40% of original pool remains inundated; several adult green frogs noted at pool
- **May 25th**: Water depths average 6-7 inches; many wood frog tadpoles observed in the deepest portion of the pool, in sunlight; no limbs observed emerging on tadpoles.
- **May 27th**: Same observations as above.
- **June 13th**: Water depths average 4-5 inches; neomorphs may have emerged, but none are observed in the perimeter of pool during brief walk through; green frogs still present.

Photo 3: Wetland A (with embedded vernal pool habitat); on 5-25-16; average water depth is 6 to 7 inches; about 40% of original vernal pool holding water.

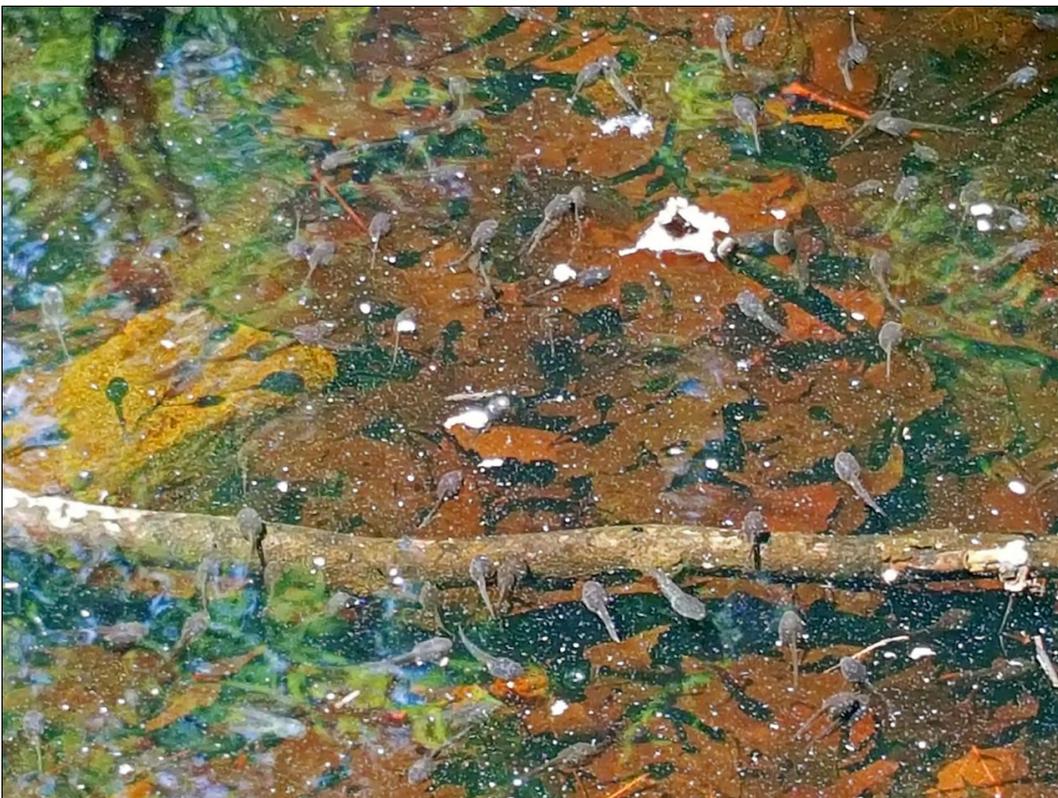
Photo 4: Wetland A; vernal pool, in a sunlight area with wood frog tadpoles; 5-25-16

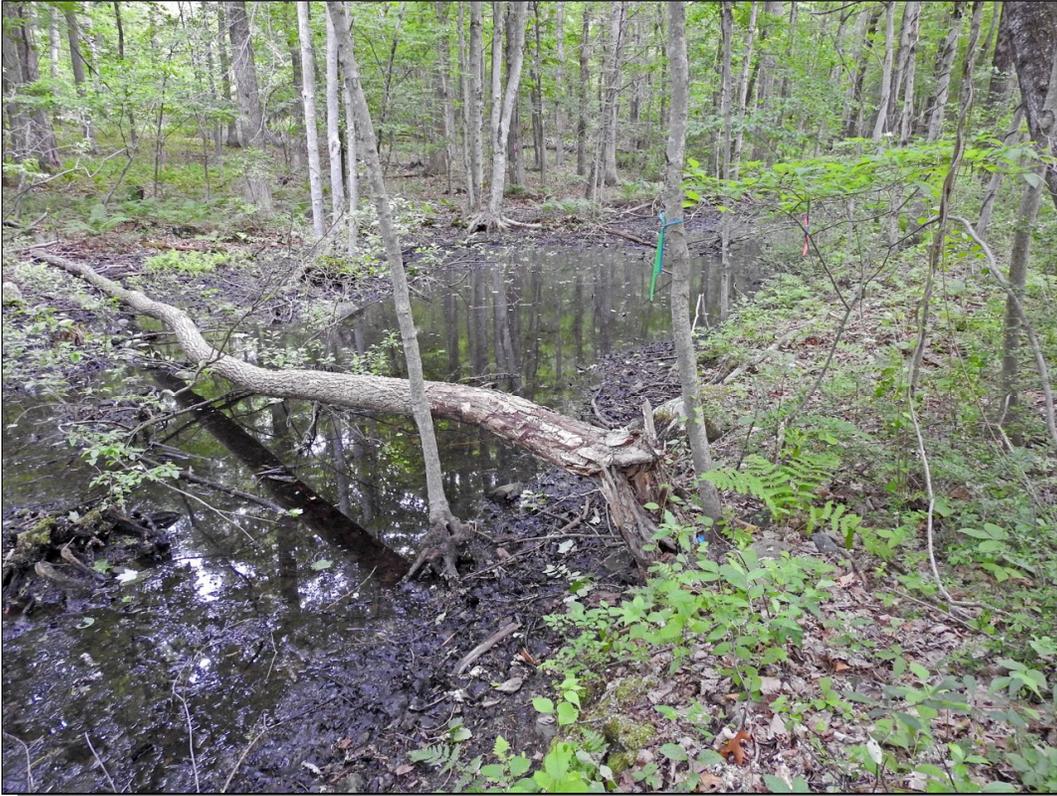
Photo 5: On 6-13-16 vernal pool area is further reduced and water depths average 4-5 inches; facing northwesterly
