June 14, 2016

Re: WETLANDS ASSESSMENT-SUPPLEMENTAL: WATER QUALITY INVESTIGATION
Lodges at Storrs, Hunting Lodge Road, Mansfield, CT

REMA Job No.: 15-1860-MNS18

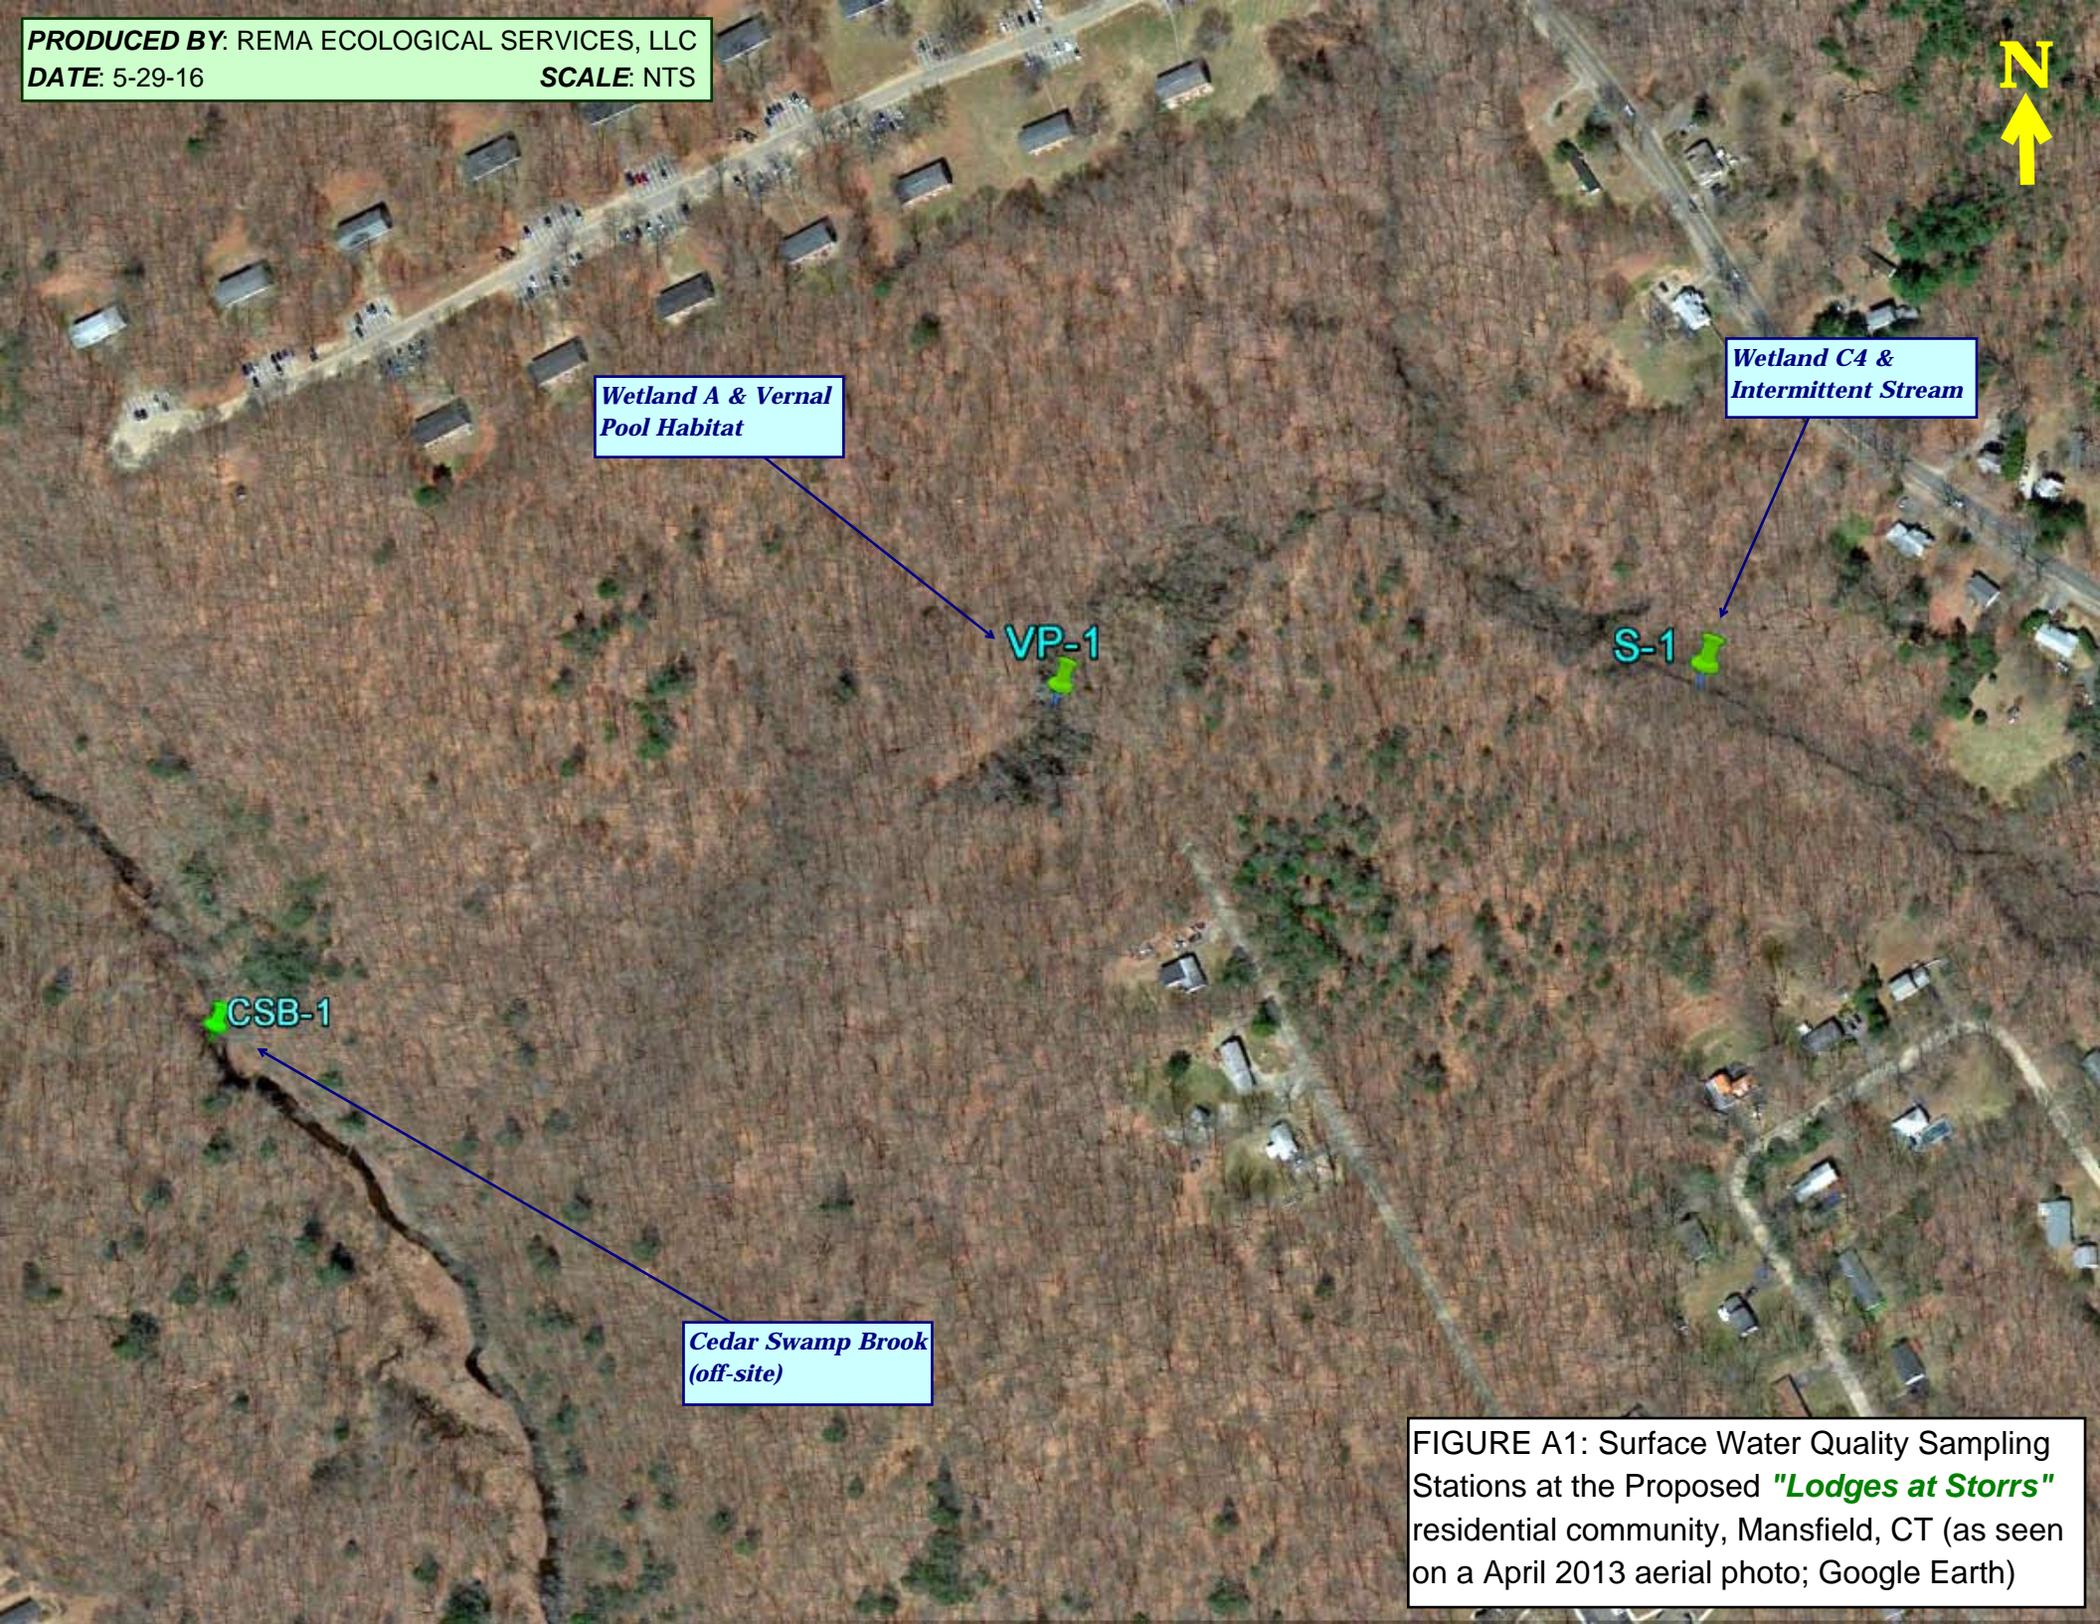
FIGURE A1: Surface Water Quality Sampling Stations at the Proposed "**Lodges at Storrs**" residential community, Mansfield, CT (as seen on a April 2013 aerial photo; Google Earth)

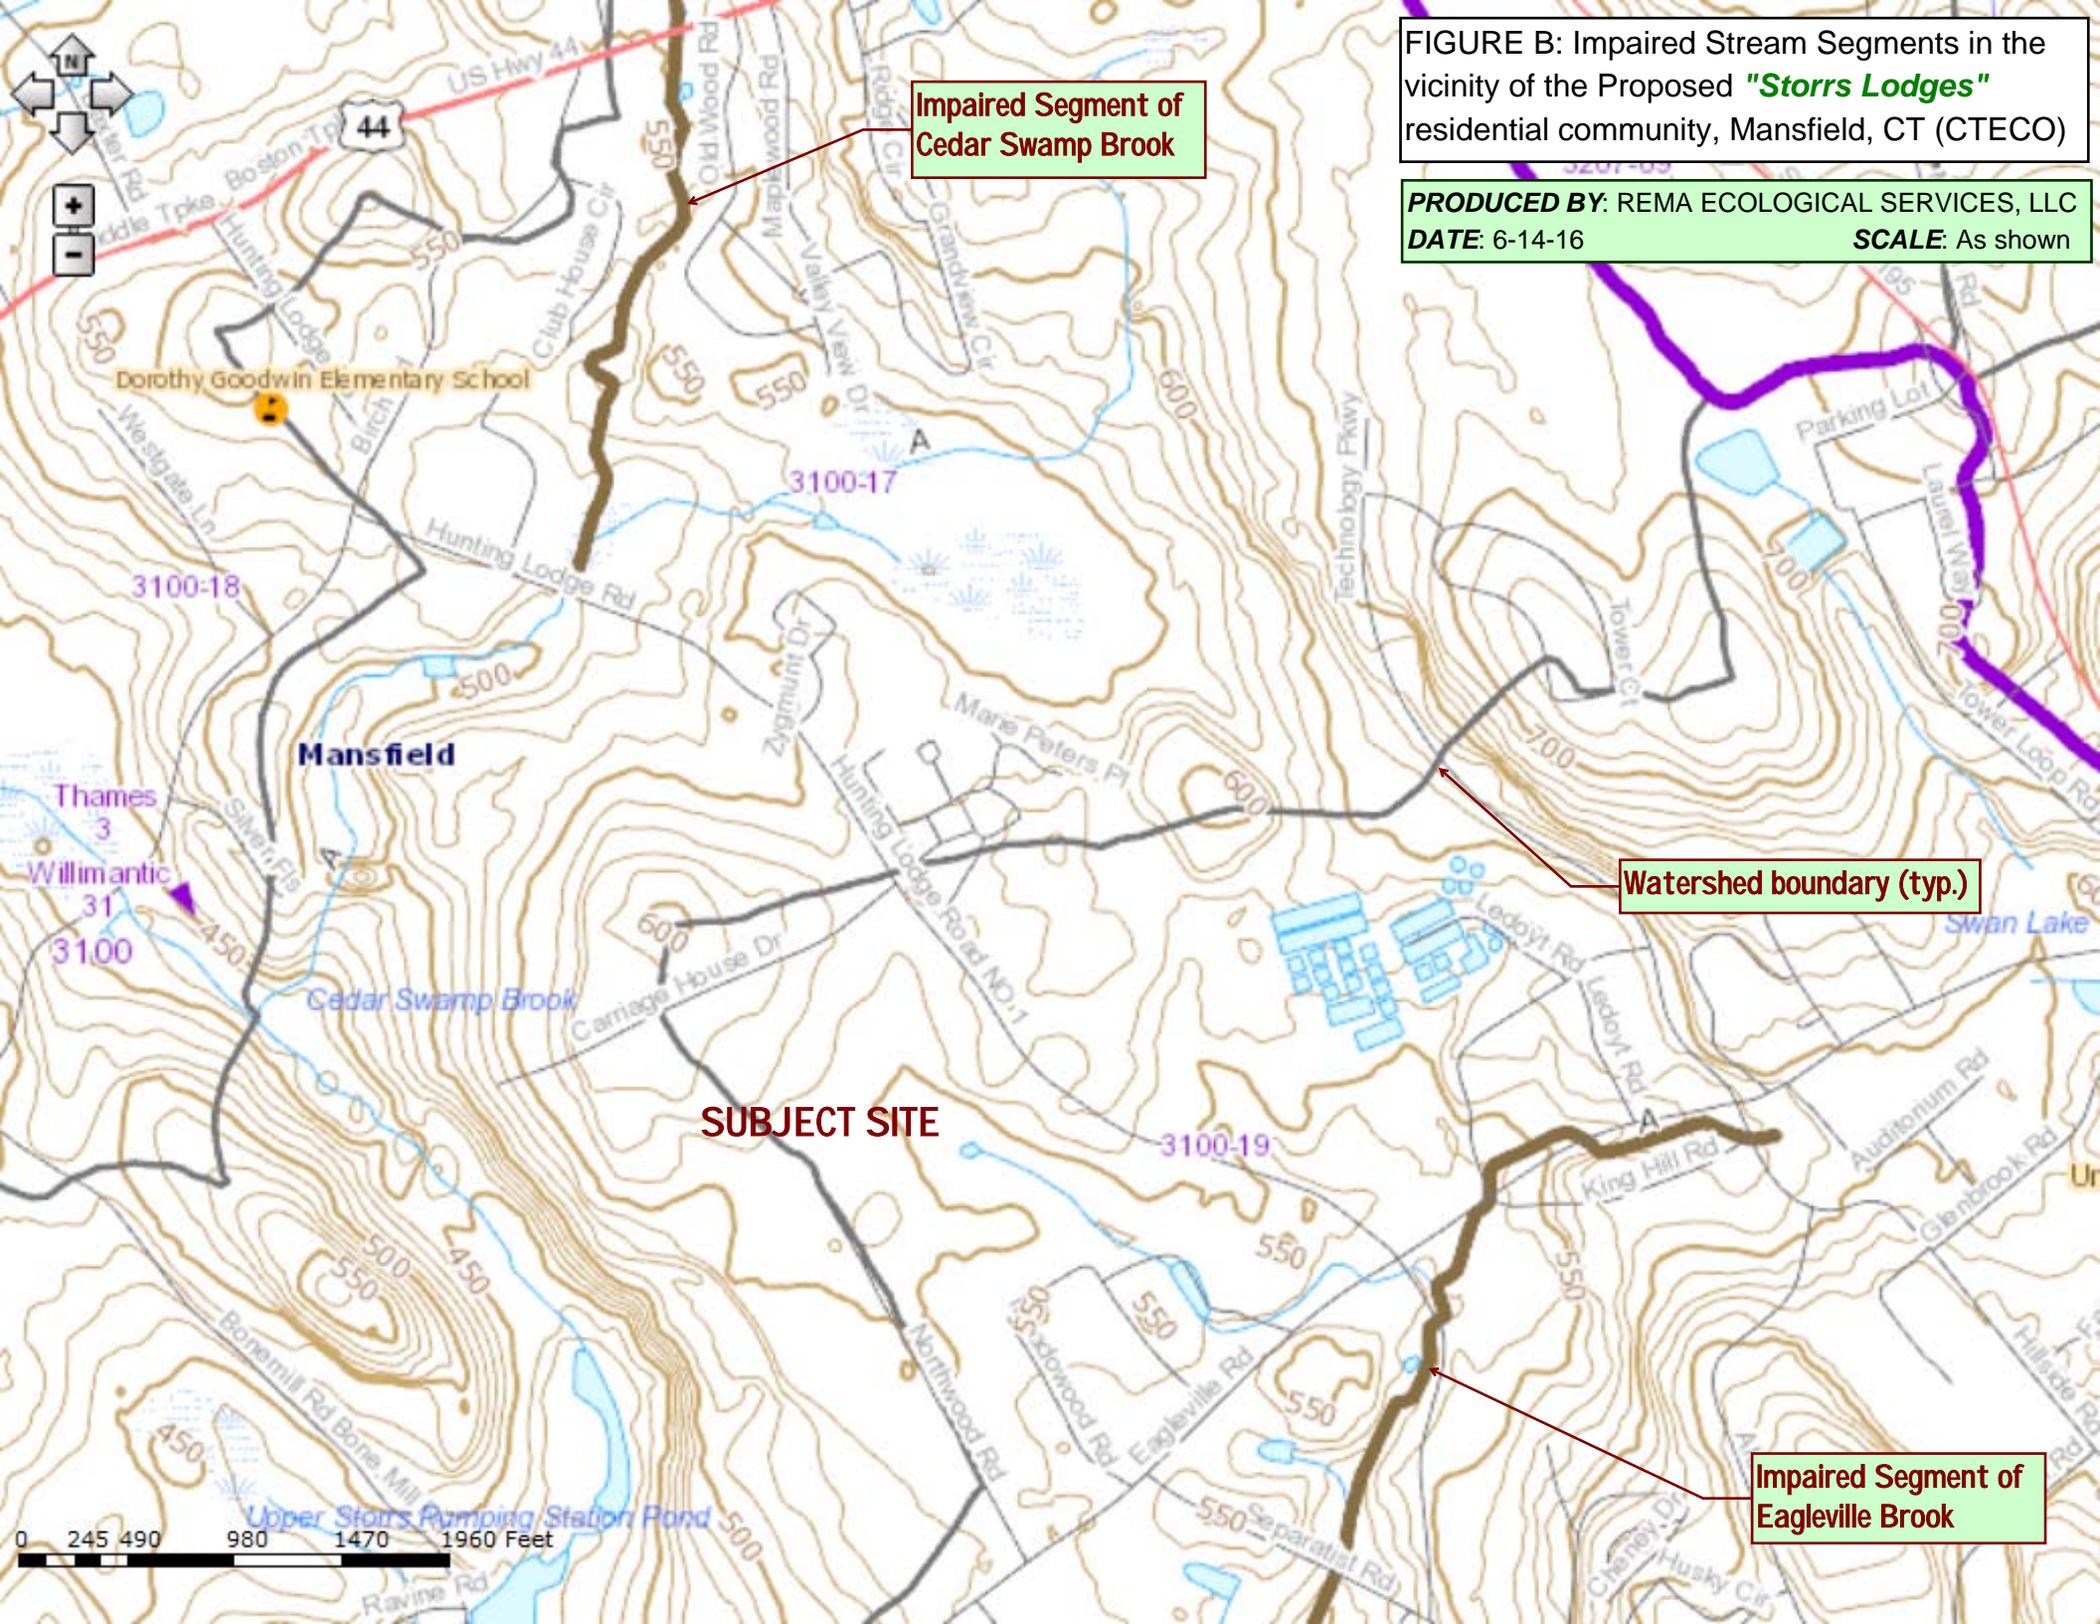
FIGURE B: Impaired Stream Segments in the vicinity of the Proposed "Storrs Lodges" residential community, Mansfield, CT (CTECO)

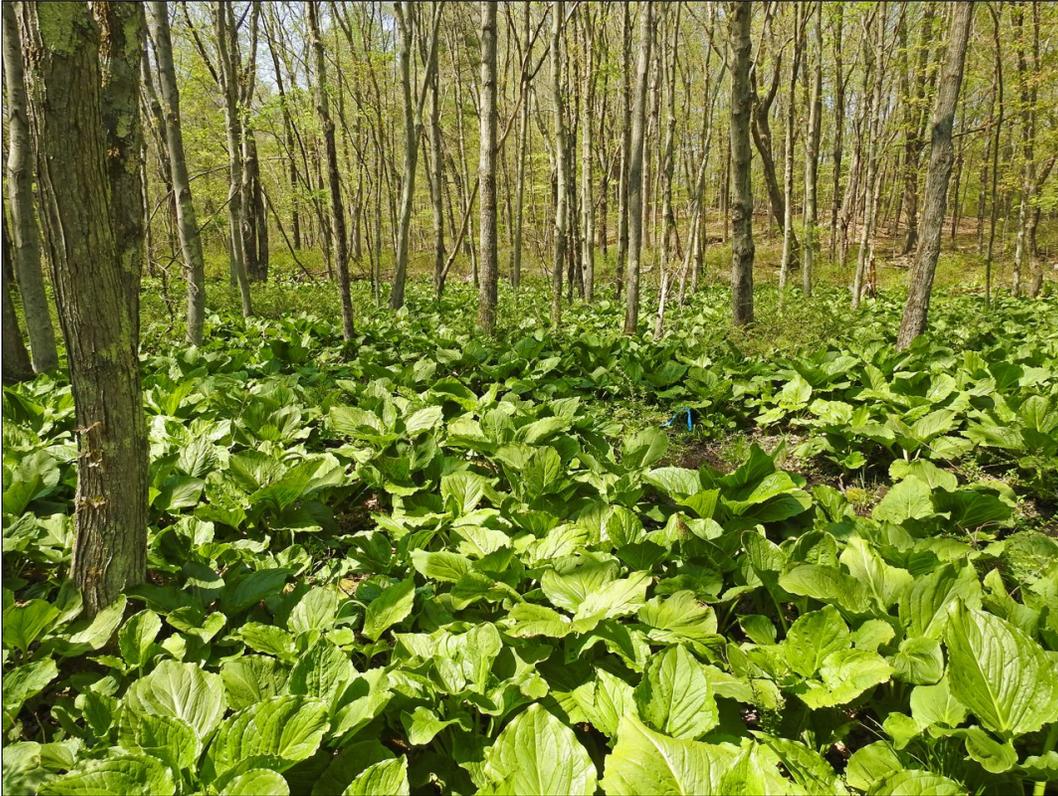
Photo 1: Station 1 (Stream-1) surface water quality sampling station (at blue flag) at unnamed stream within Wetland C4; facing northeasterly

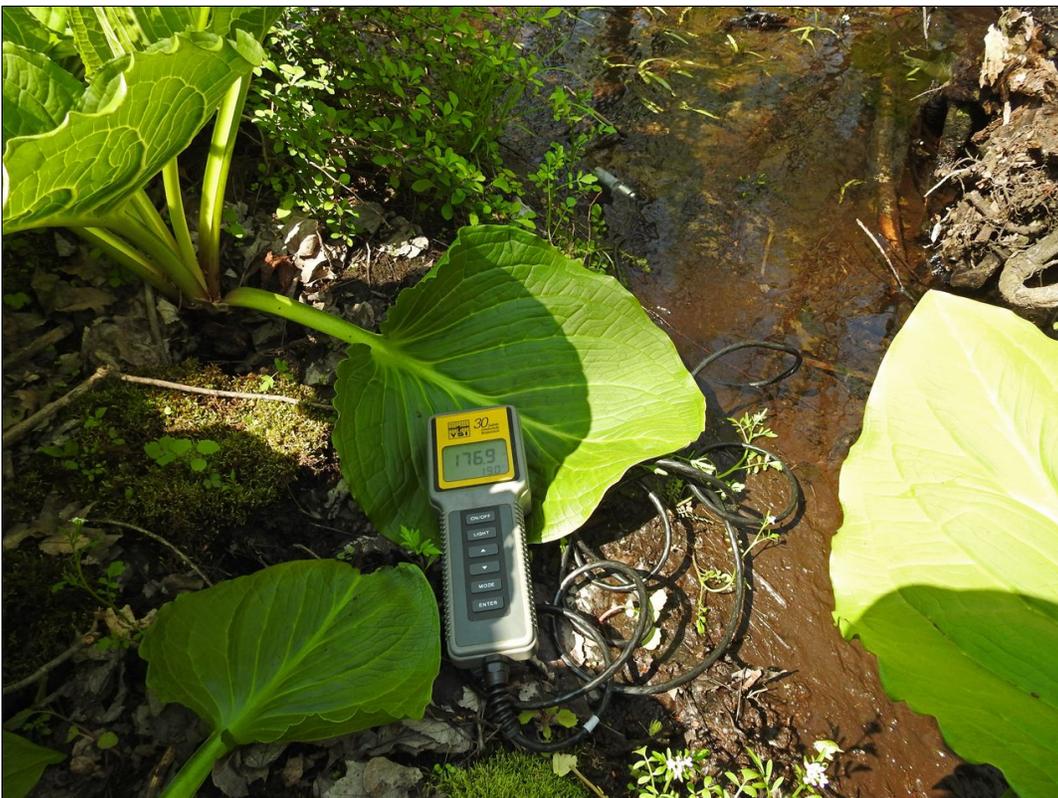
Photo 2: Station 1 (Stream-1) surface water quality sampling; conductivity (176.9 µS/cm) and temperature (19 Celsius) was measured with YSI meter.

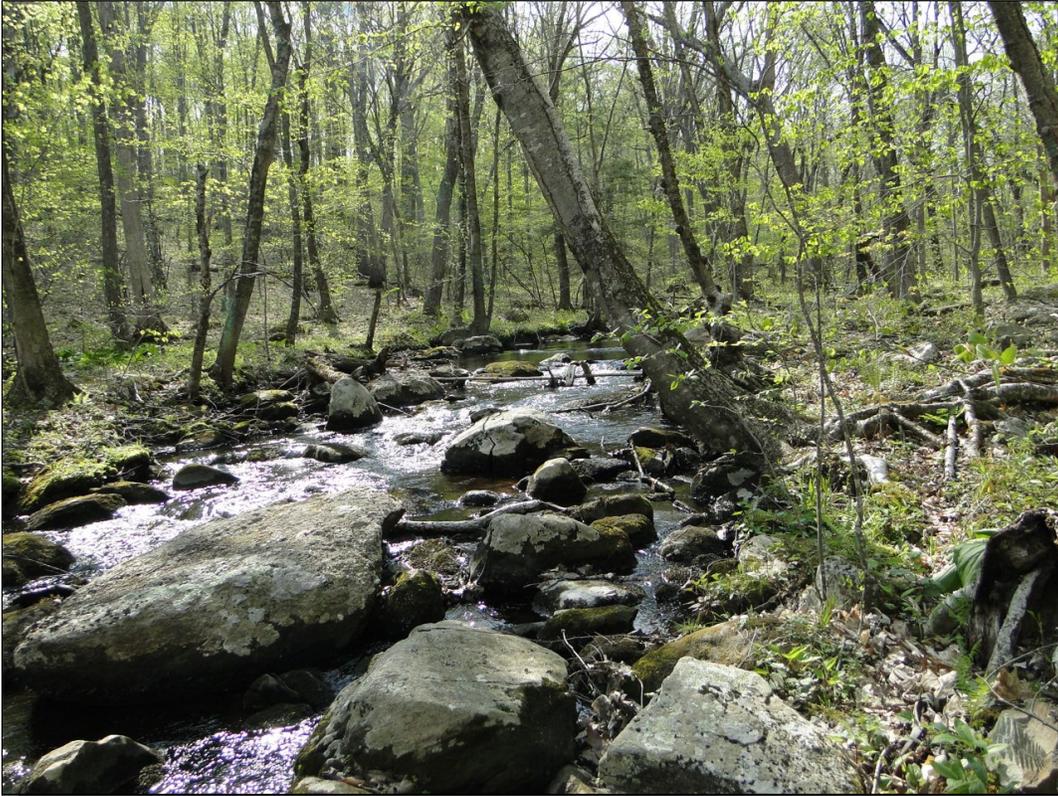
Photo 3: Station CSB-1 (Cedar Swamp Brk.), sampling for surface water (near bank, 4' upstream of start of photo). Macroinvertebrates also collected from this riffle. Facing northerly. Note high percent cover of boulders, full canopy cover, & stable banks.

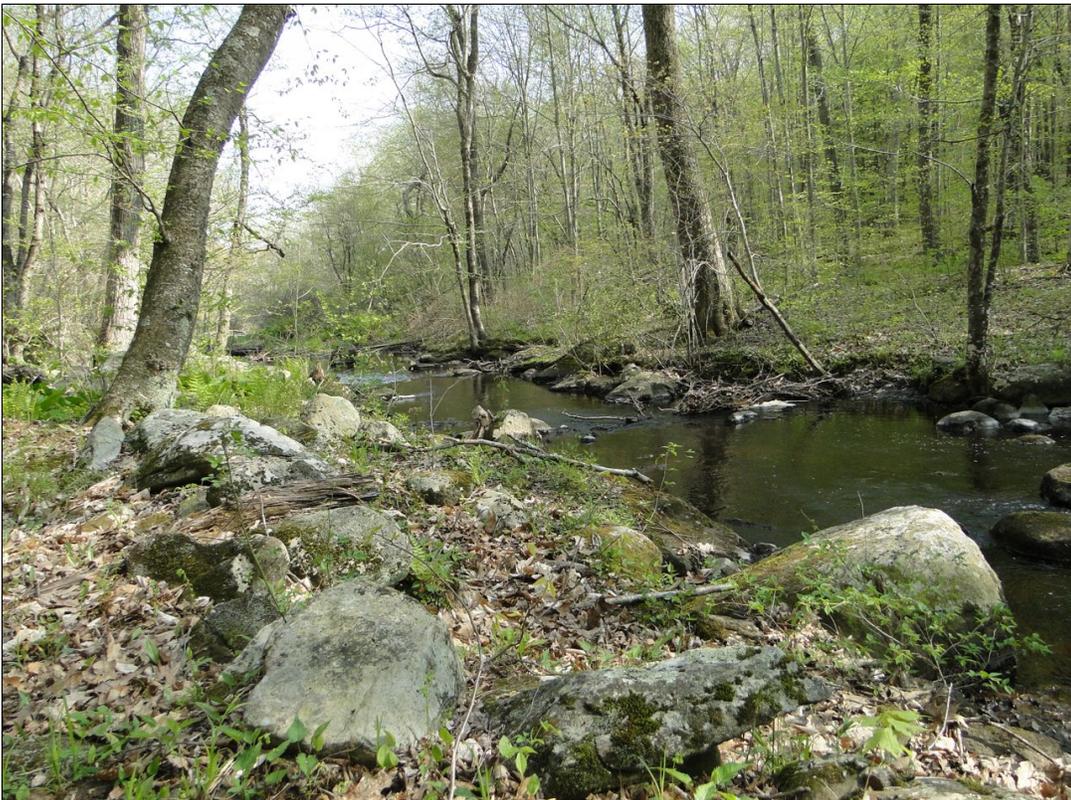
Photo 2: Downgradient of CSB-1 (Cedar Swamp Brook). This segment of stream is a run (habitat). Note lack of bank erosion & downward incision. Watershed has much forest cover.

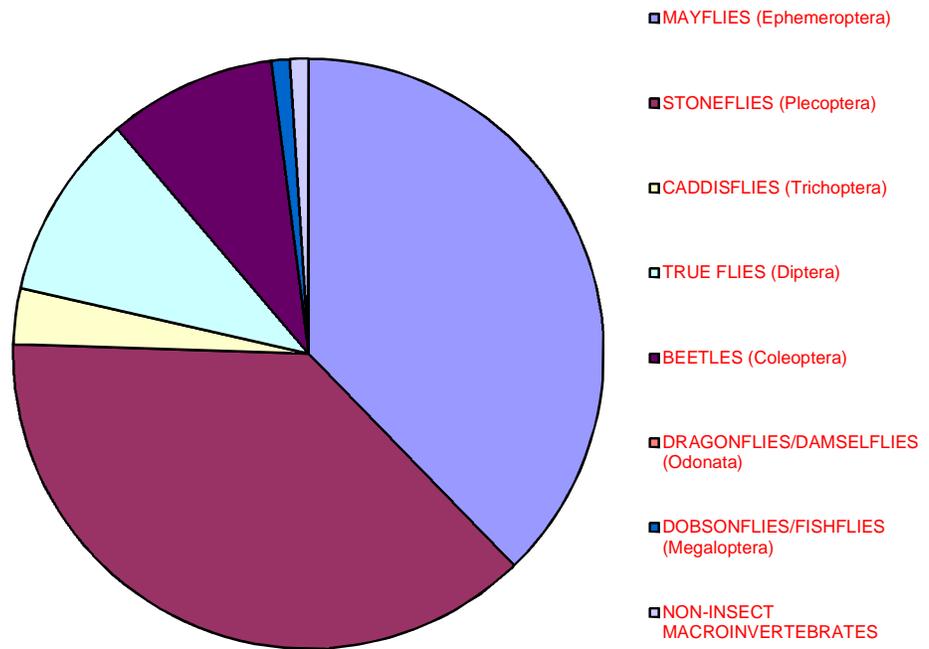
Sample Community Balance by Order

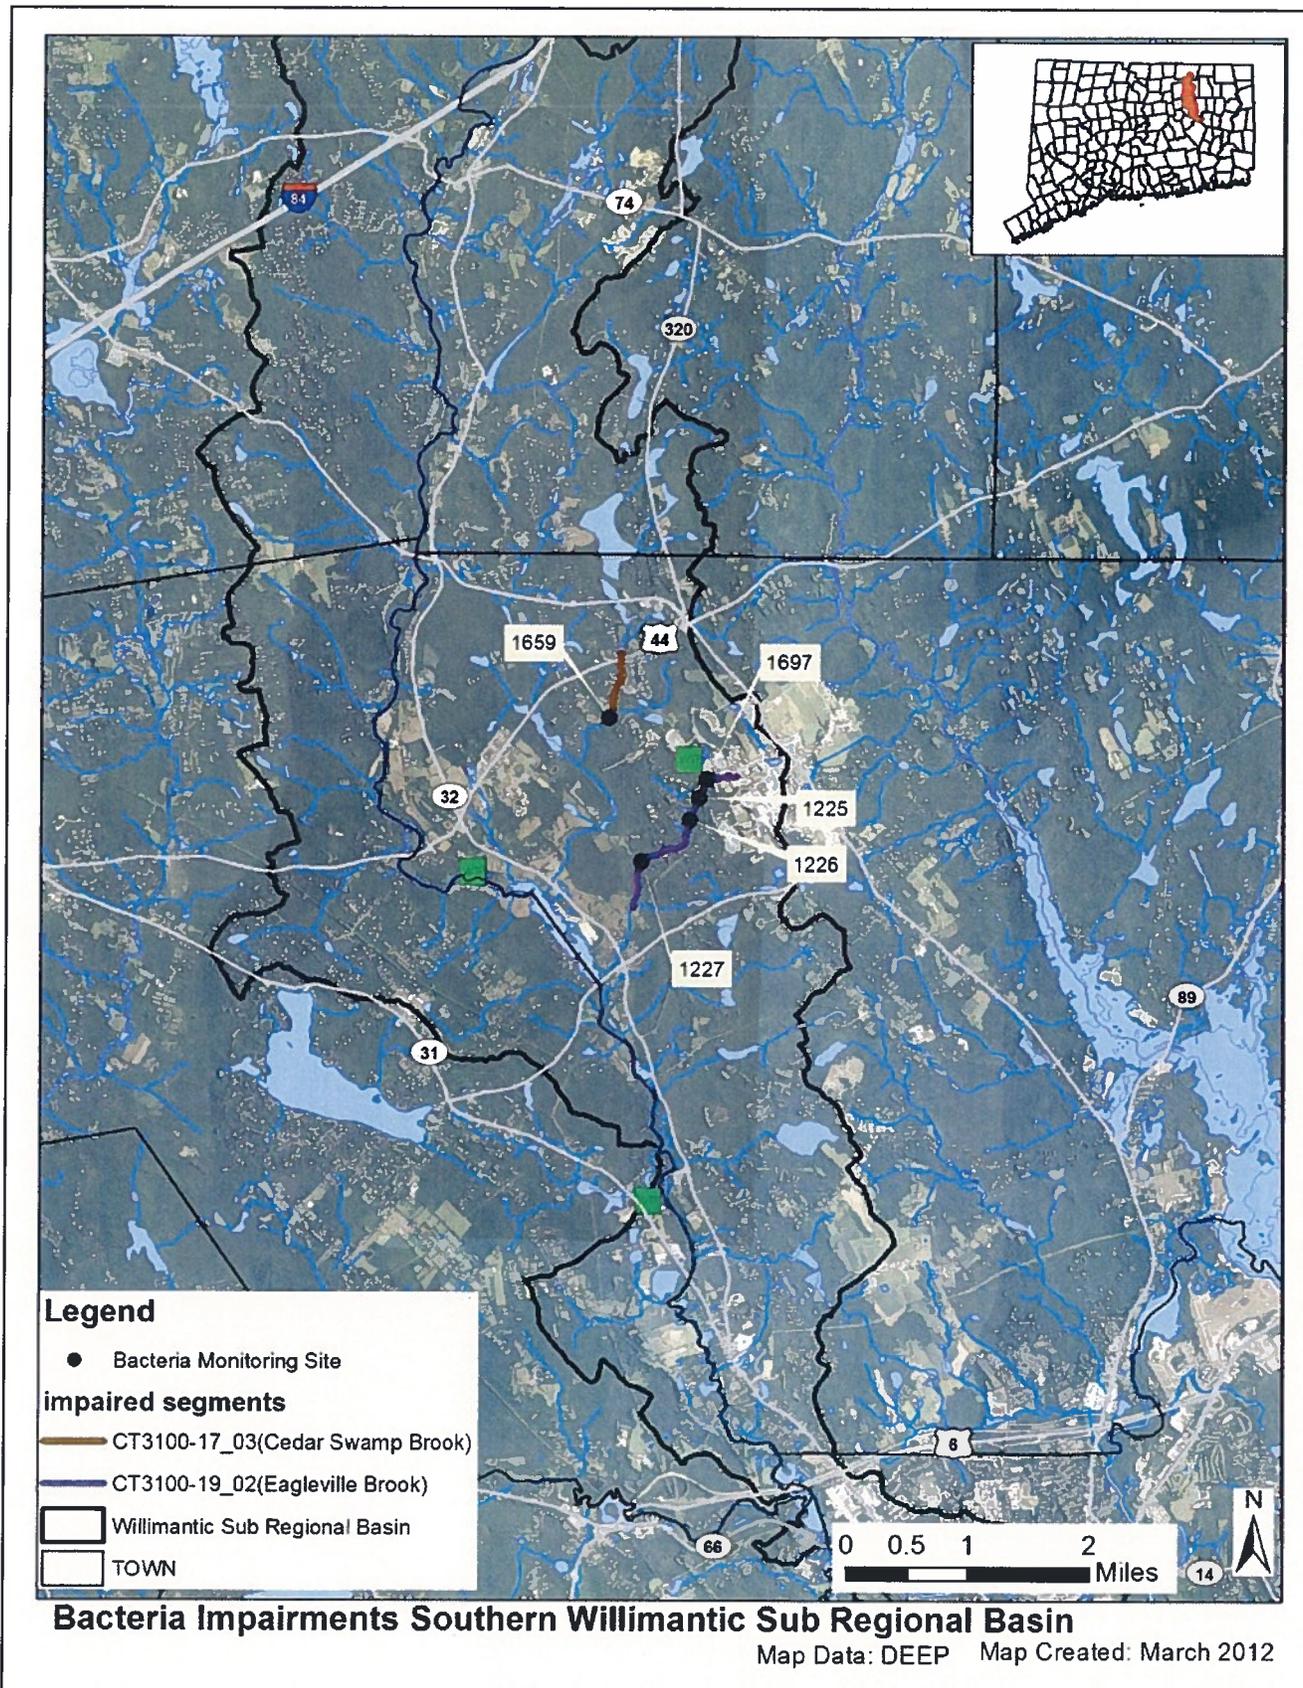
Figure 3: GIS map featuring general information of the Willimantic River watershed at the sub-regional level – Showing Eagleville Brook and Cedar Swamp Brook impaired segments
