**Re: WETLANDS ASSESSMENT & IMPACT ANALYSIS: SUMMARY OF FINDINGS**

***Storrs Lodges, Connecticut***

Hunting Lodge Road, Mansfield, CT

*REMA Job No.: 15-1860-MNS18*

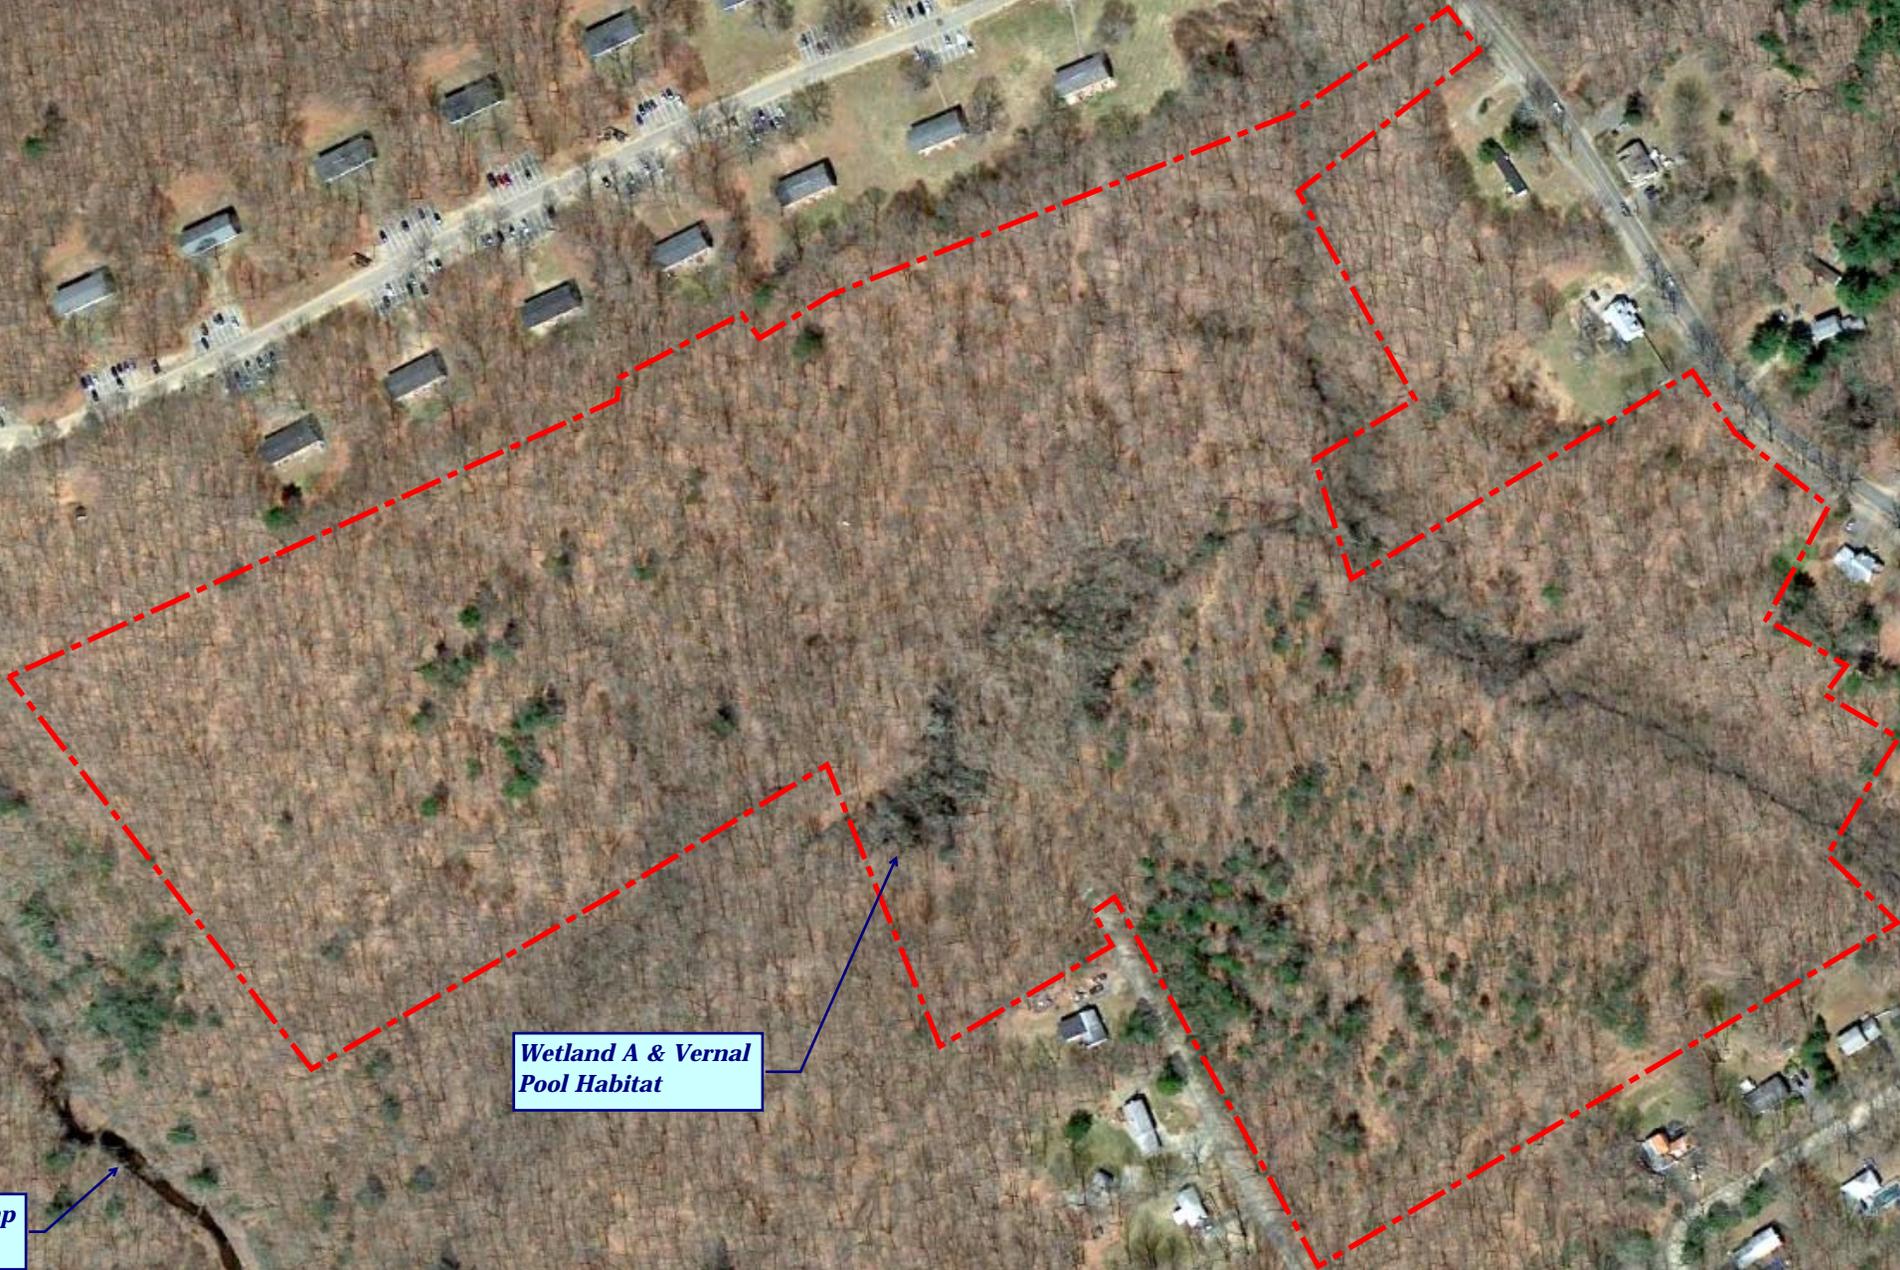
FIGURE 3: Proposed "*Storrs Lodges*" residential community, Mansfield, CT (as seen on a April 2013 aerial photo; Google Earth)

Cedar Swamp Brook

Wetland A & Vernal Pool Habitat

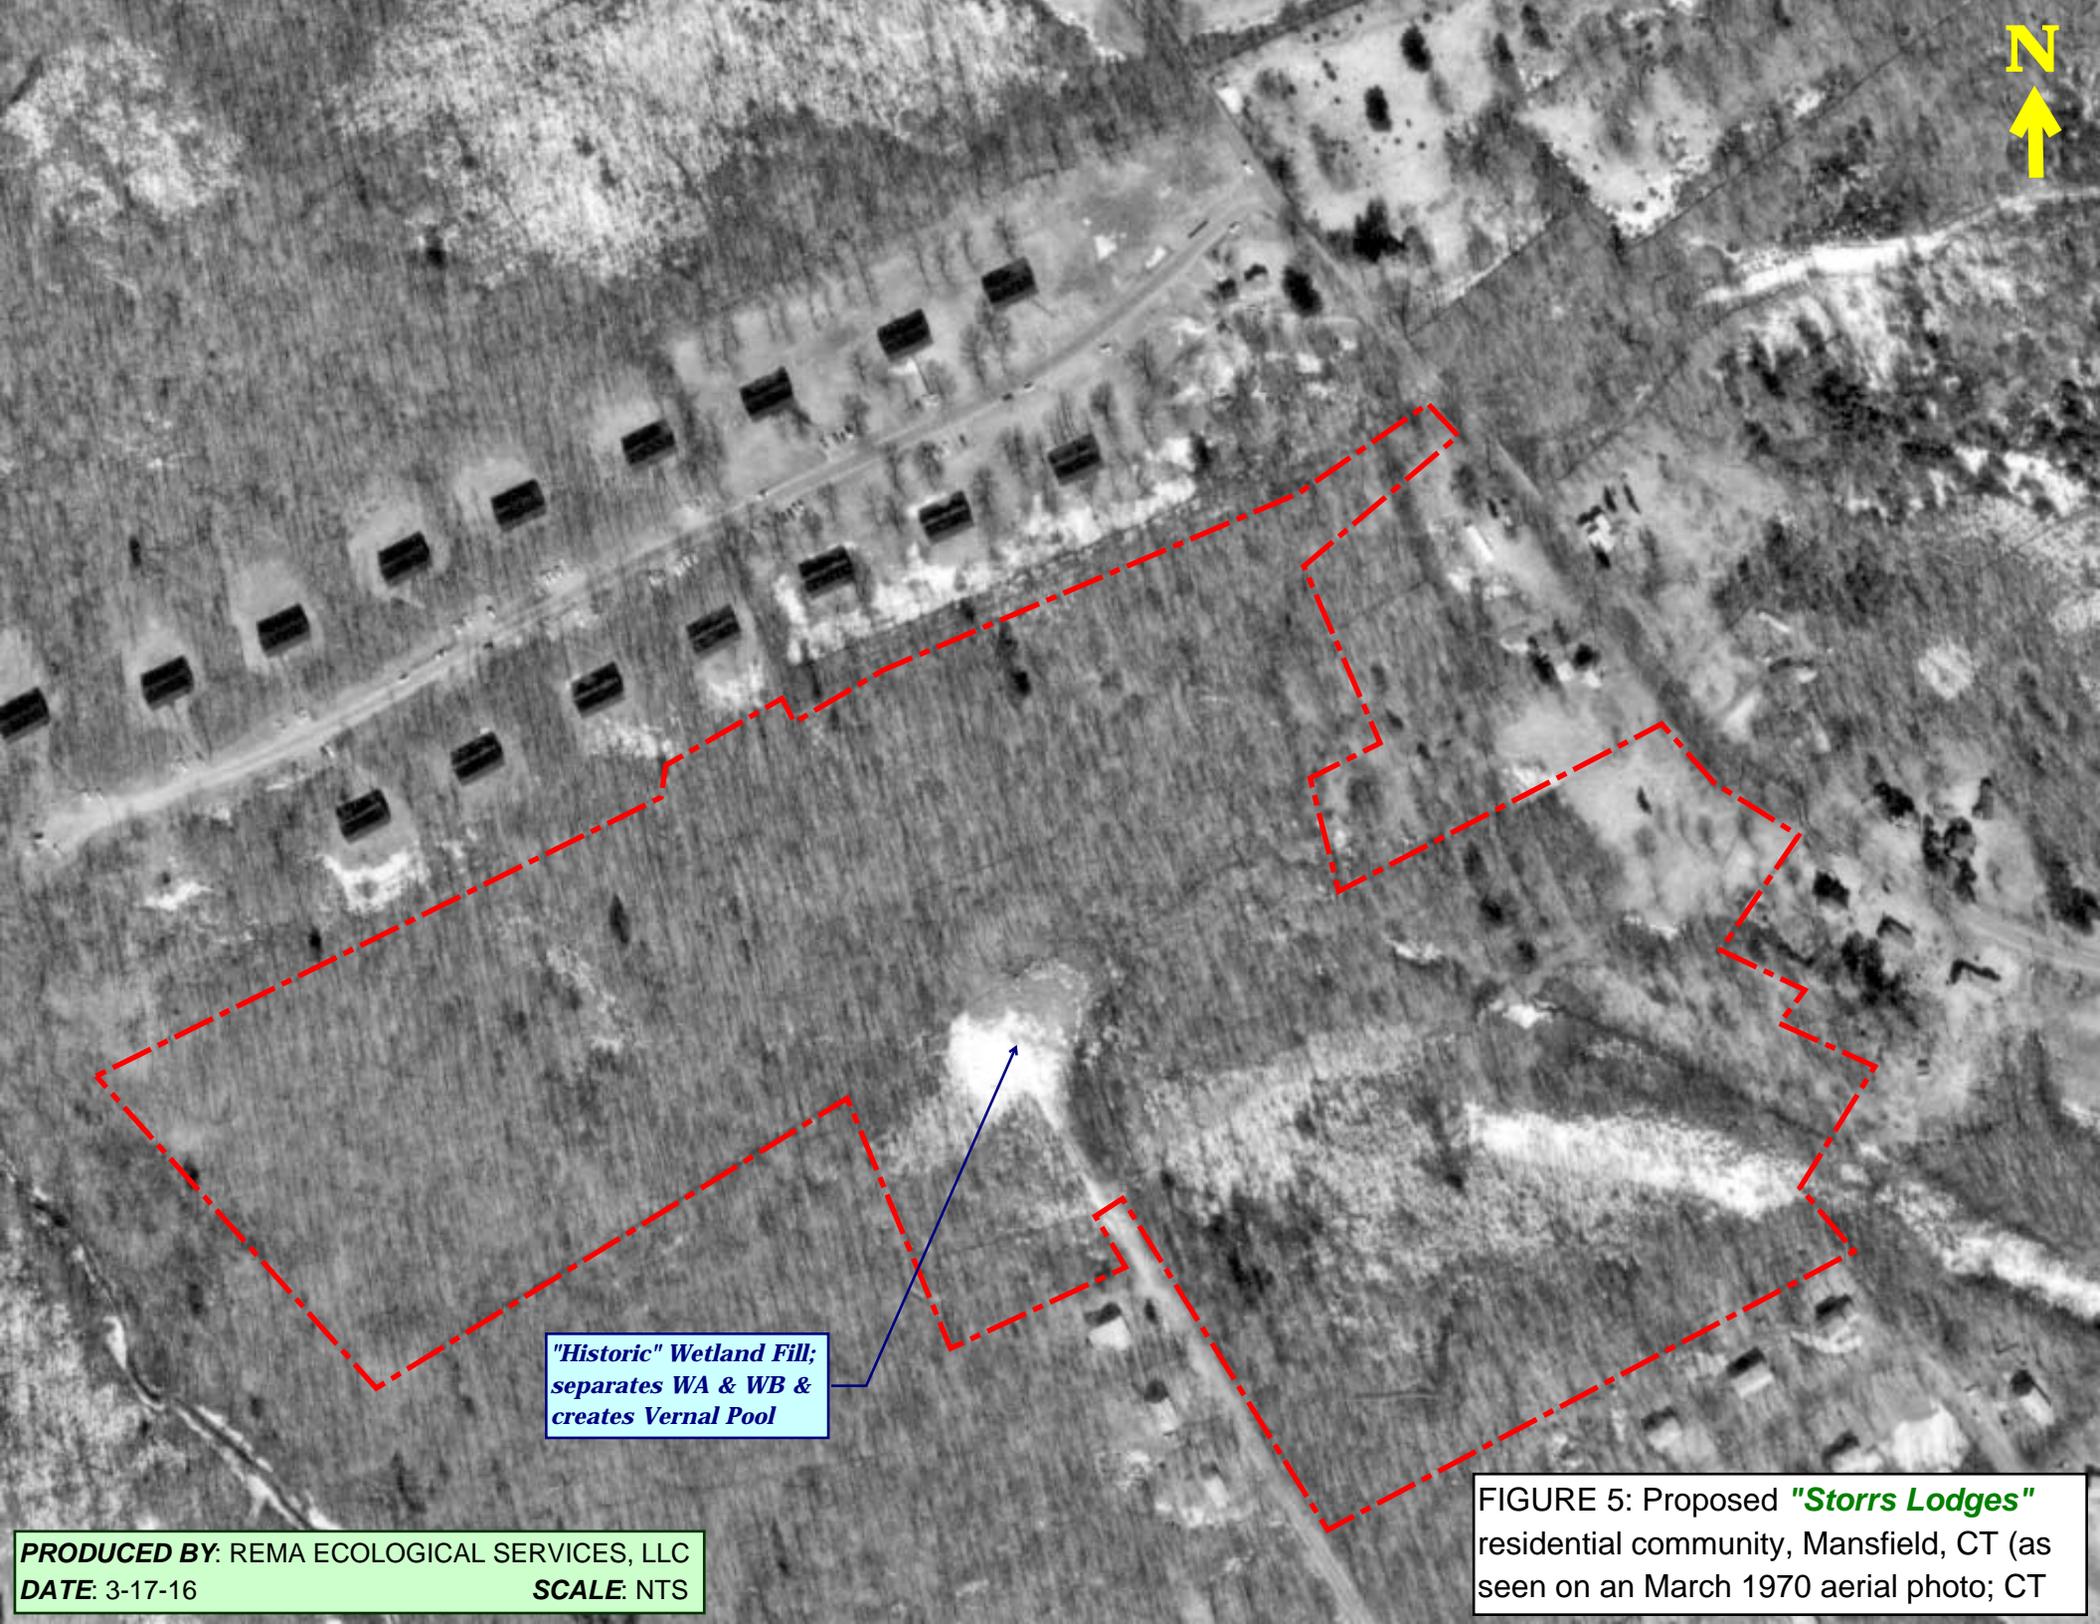
FIGURE 5: Proposed **"Storrs Lodges"** residential community, Mansfield, CT (as seen on an March 1970 aerial photo; CT

*"Historic" Wetland Fill;  
separates WA & WB &  
creates Vernal Pool*

- ◆ The property is currently entirely forested. A 1970 CTDEEP aerial photo (Figure 5, attached) shows only one unvegetated fill area at the terminus of Northwood Road. Although the entire site is seen to be wooded in archived aerial photographs dating back to 1934, with the noted above exception, it is likely that selective logging has taken place in the 20<sup>th</sup> century. Even so, portions of two of the eastern wetlands, WC2 and WC3, have a “woodland” cover type (20% to 60% cover), because a very poorly drained hydrologic regime has limited tree growth.

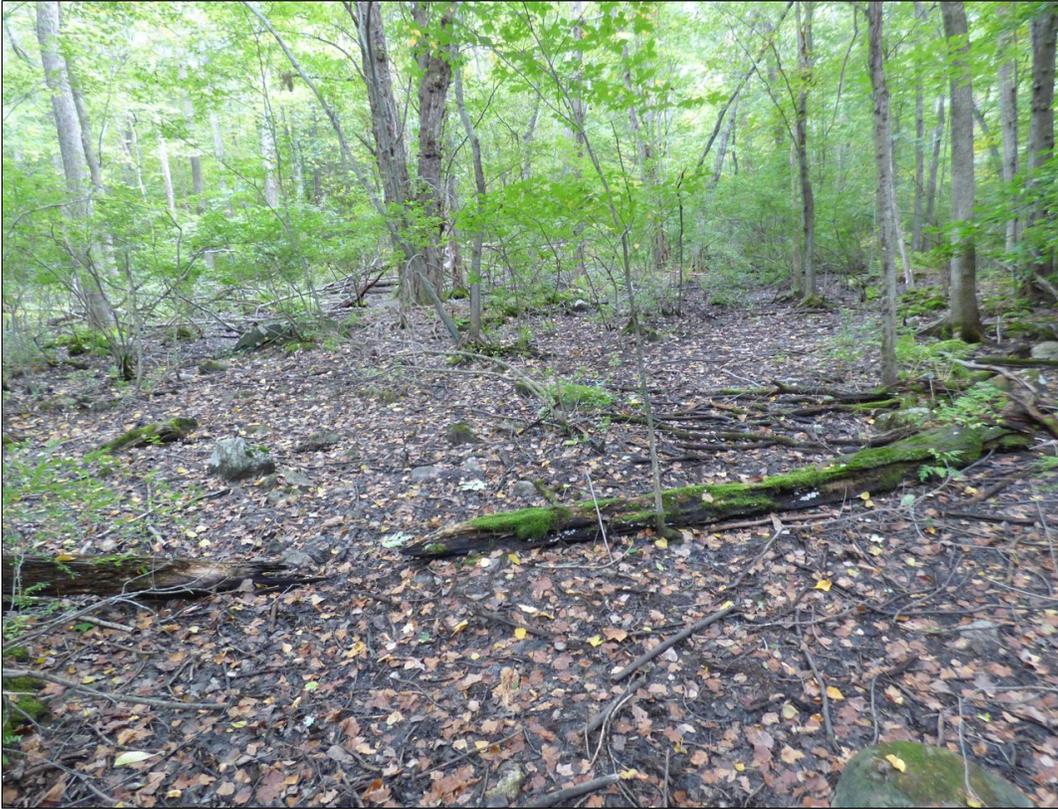
*Photo 1: Wetland A (with embedded vernal pool habitat); early Fall 2015; facing westerly*

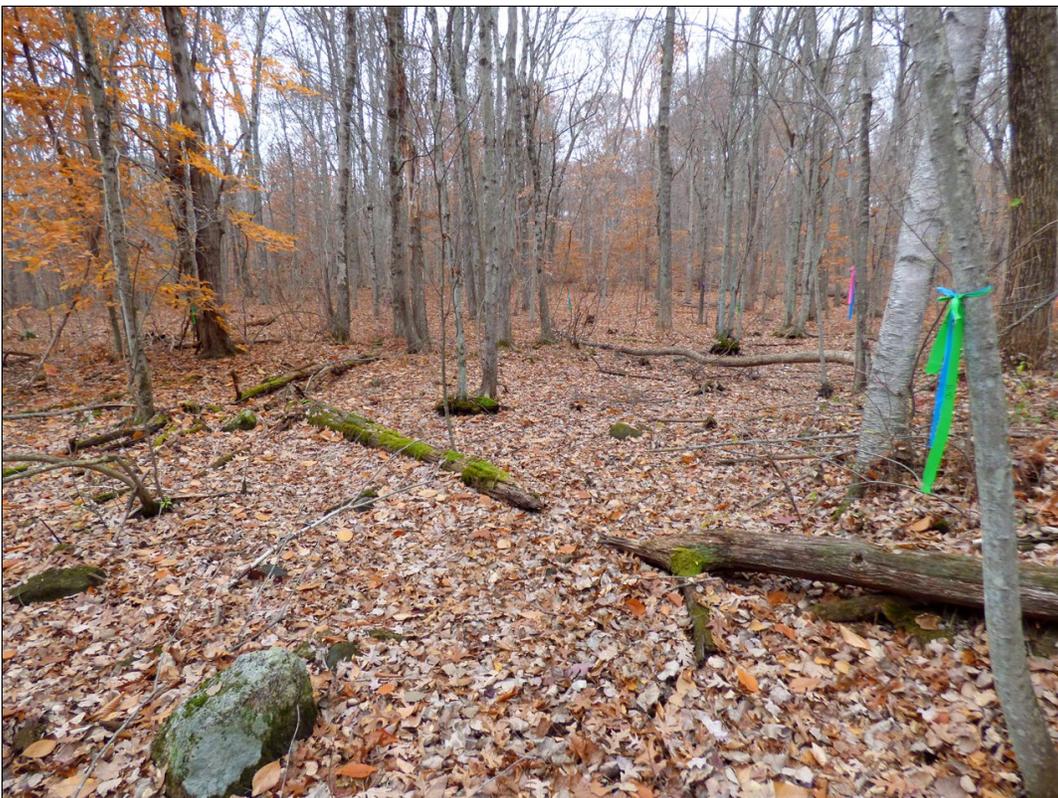
*Photo 4: Wetland A; no inundation in mid-Fall 2015; blue/green flagging denotes edge of vernal pool habitat; pink/blue is the wetland boundary; facing northerly*

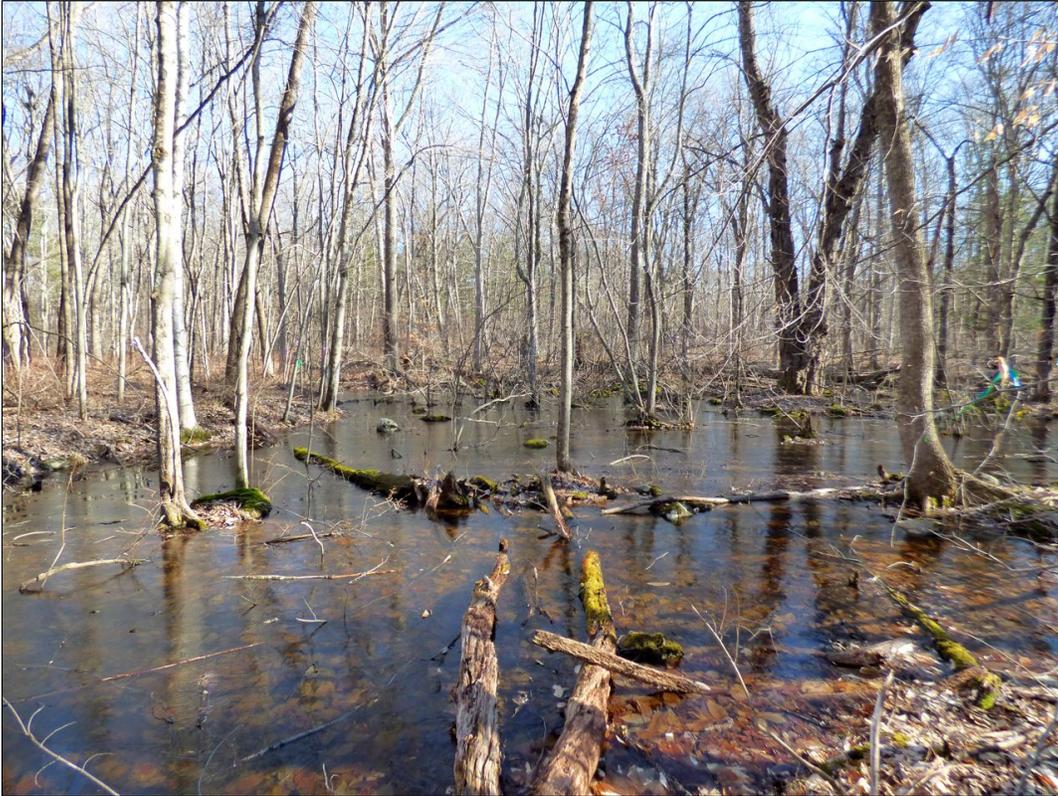
*Photo 7:* Wetland A; east-central section; February 2016; seasonally flooded pool near capacity; facing southerly

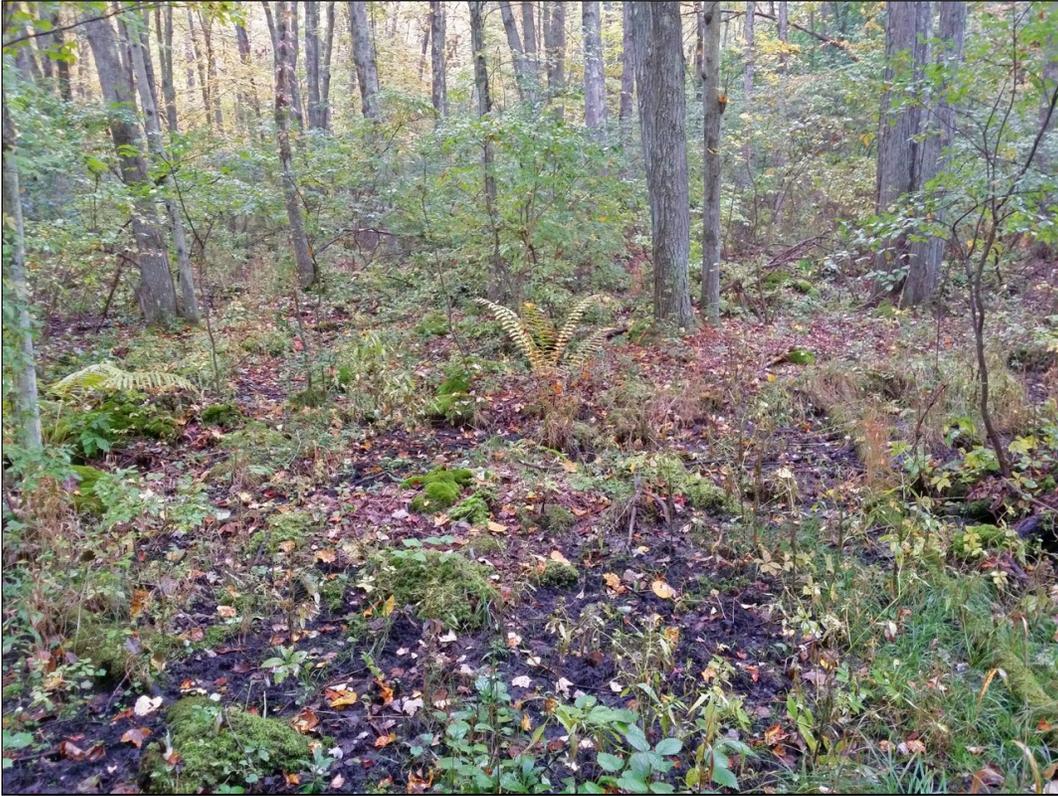
*Photo 11:* Wetland C1; seasonally saturated to seasonally flooded wooded swamp; central section; September 2015; floristic diversity is moderately high; facing easterly

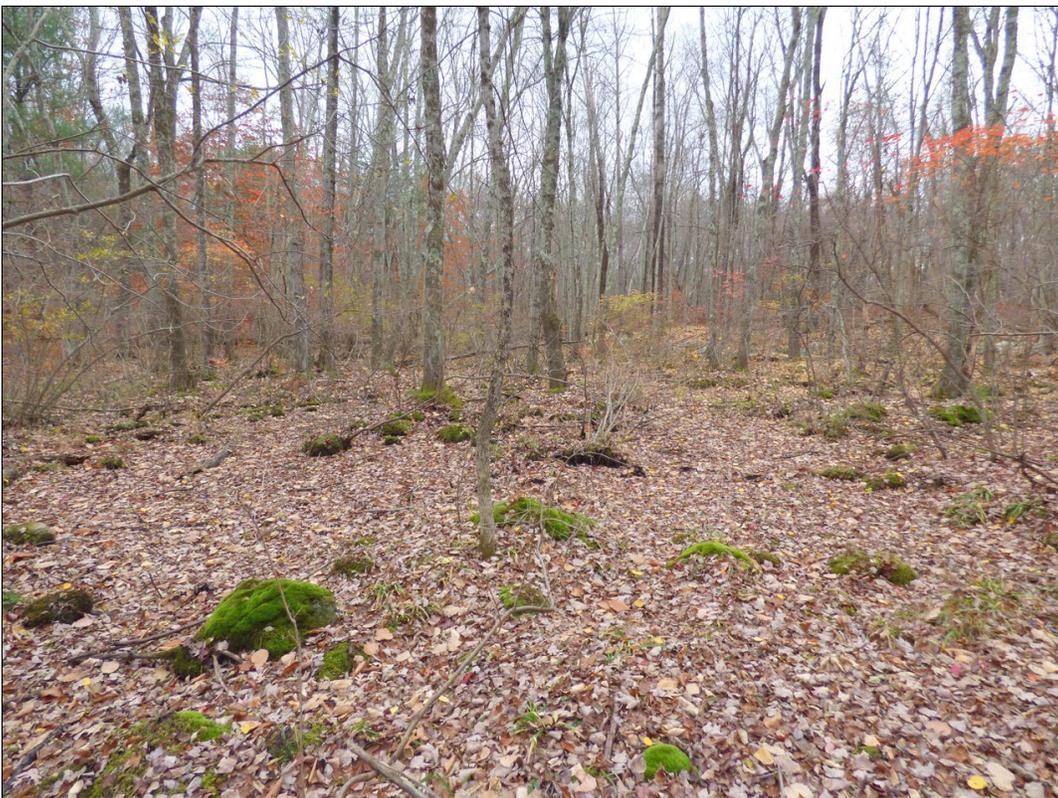
*Photo 12:* Wetland C1; west-central section; October 2015; section filled in the late 1960s at far edge of wetland (background); facing southwesterly

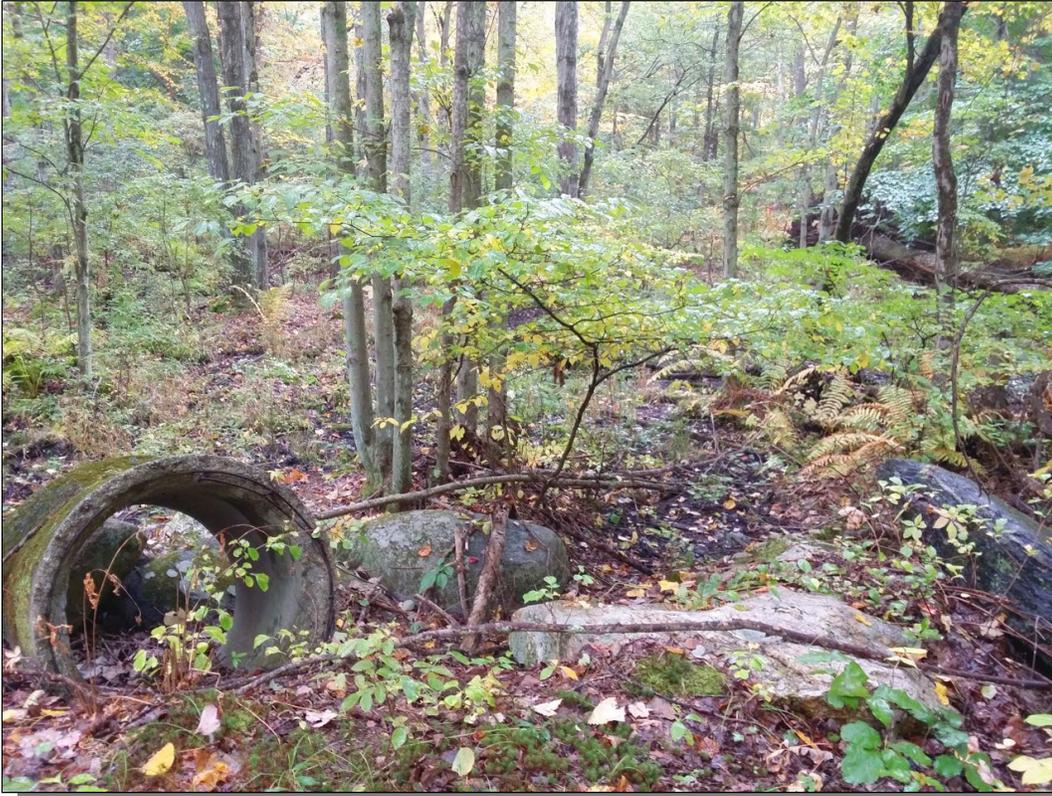
*Photo 15:* Wetland C1; view of westernmost section from on top of old fill (area of proposed wetland restoration); September 2015; facing southwesterly

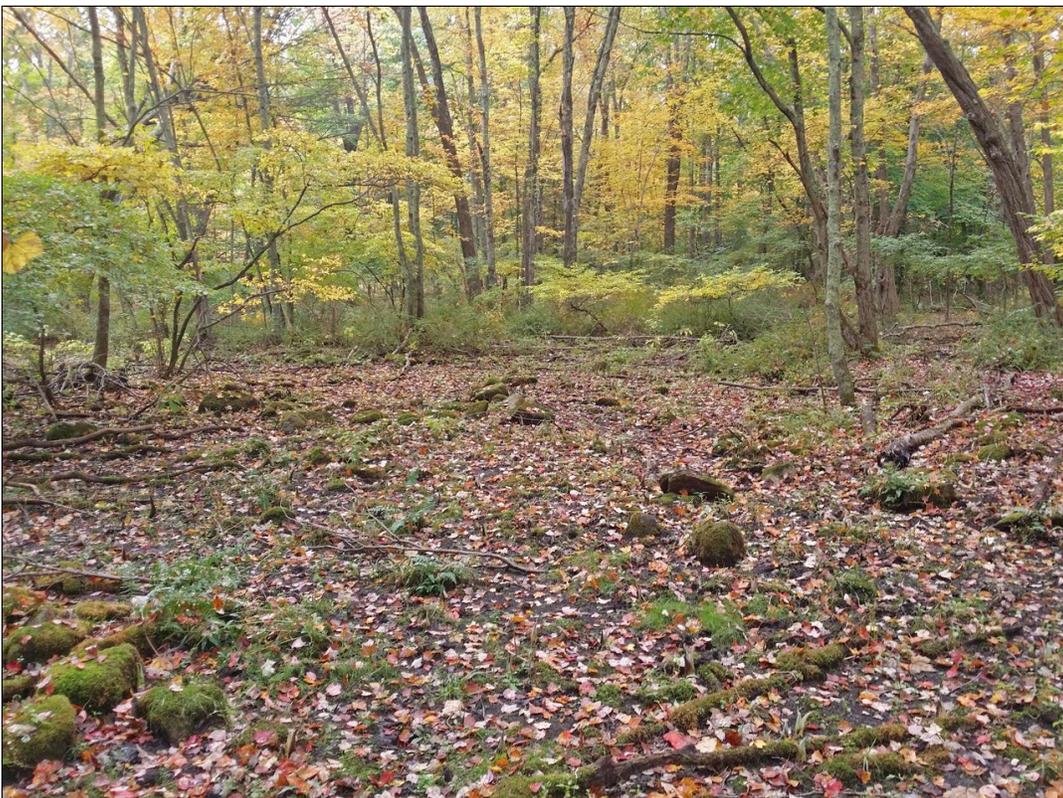
*Photo 20:* Wetland C2; a significant proportion of wetland is very poorly drained, seasonally flooded, and devoid of shrubs and trees; facing southerly

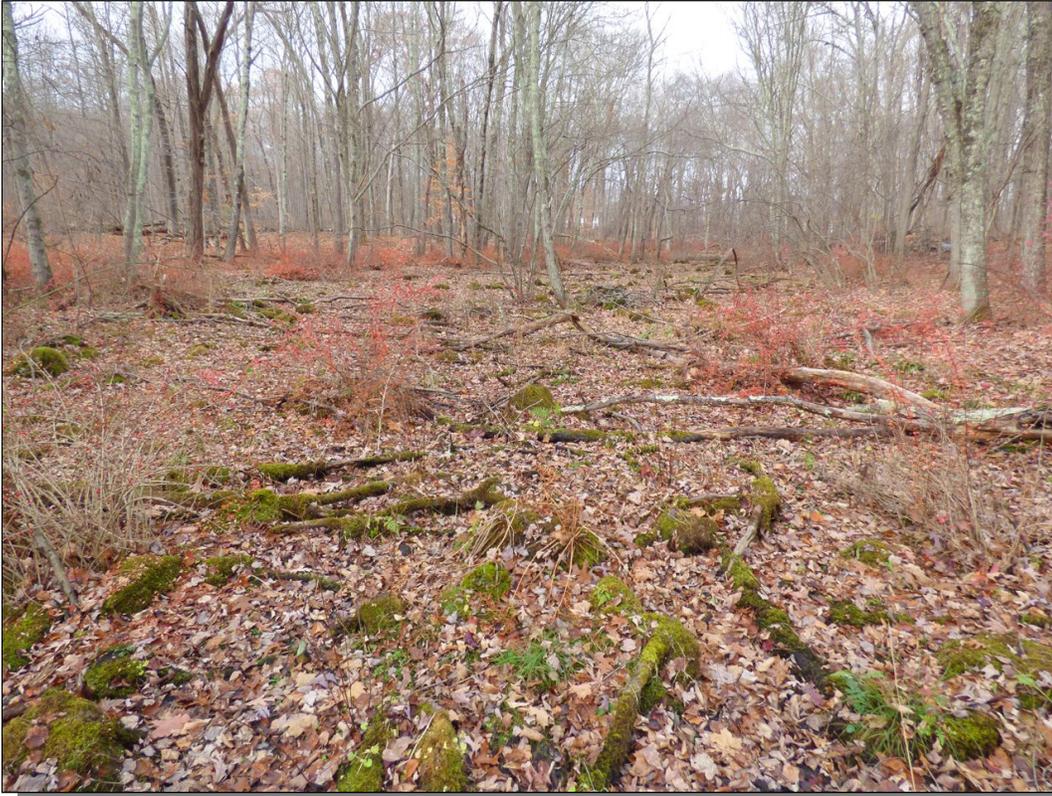
*Photo 21:* Wetland C3; central section; October 2015; note invasive Japanese barberry (common throughout); facing northerly

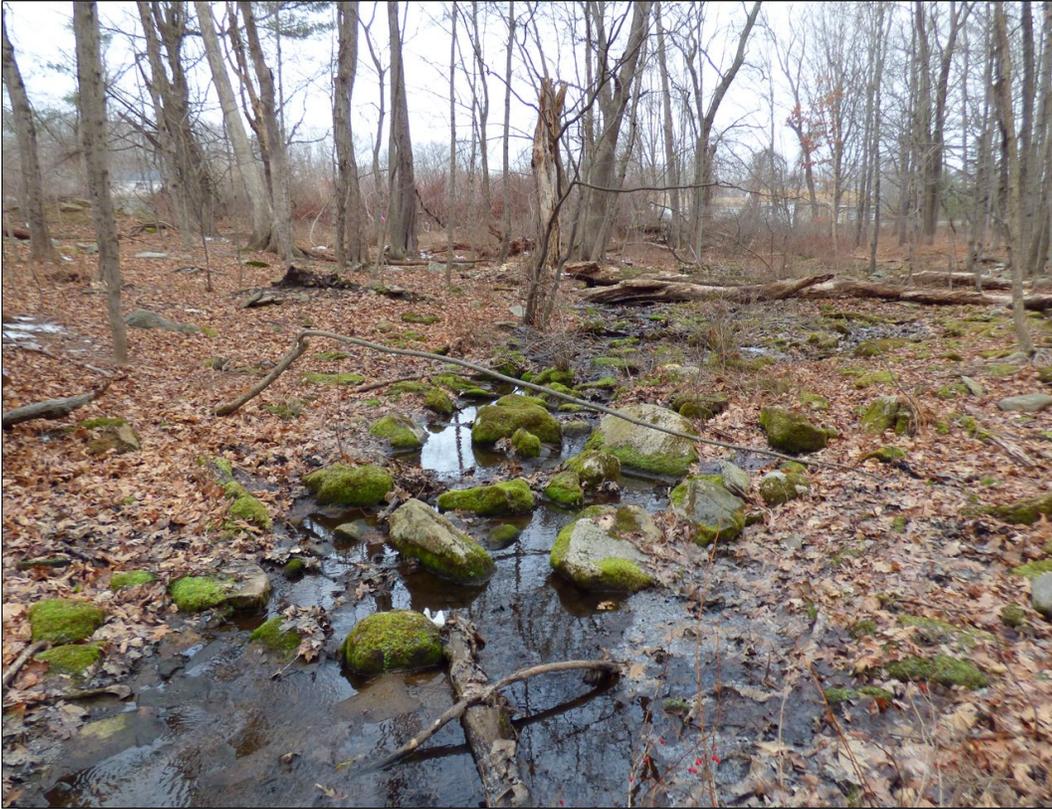
*Photo 23: Wetland C3; uppermost section; December 2015; sandy deposits originate at discharge from Hunting Lodge Road; facing northerly*

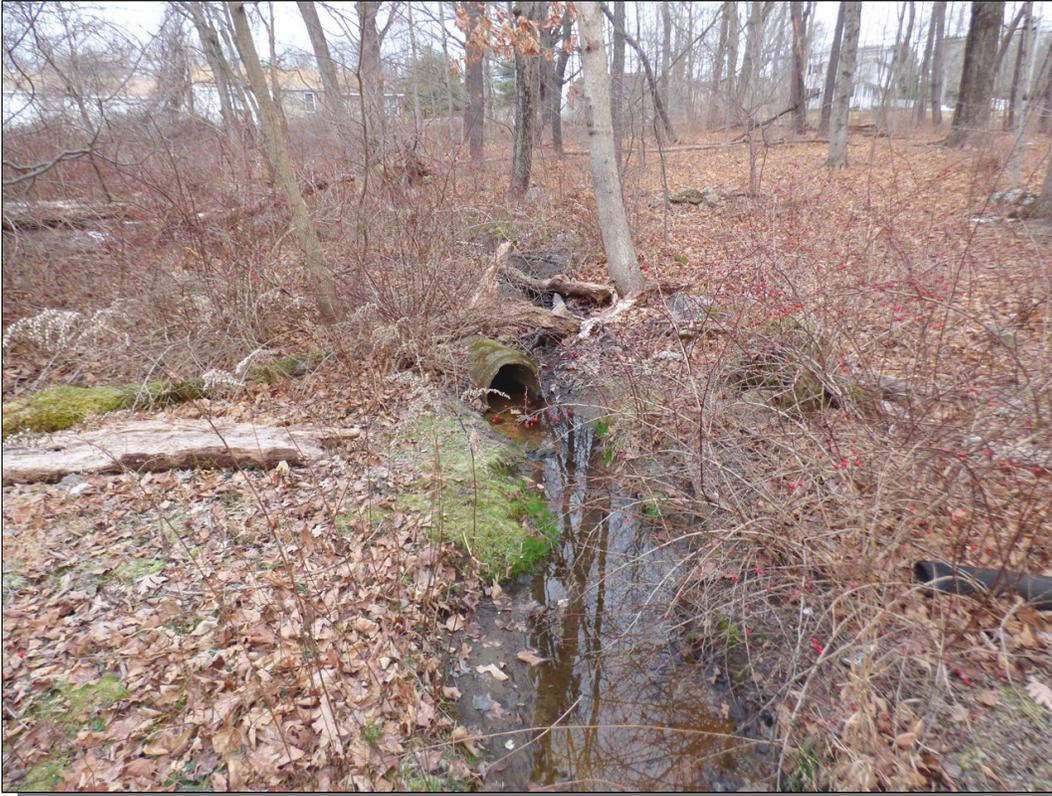
*Photo 29: One of two off-site, piped discharges to Wetland C3; facing northerly*

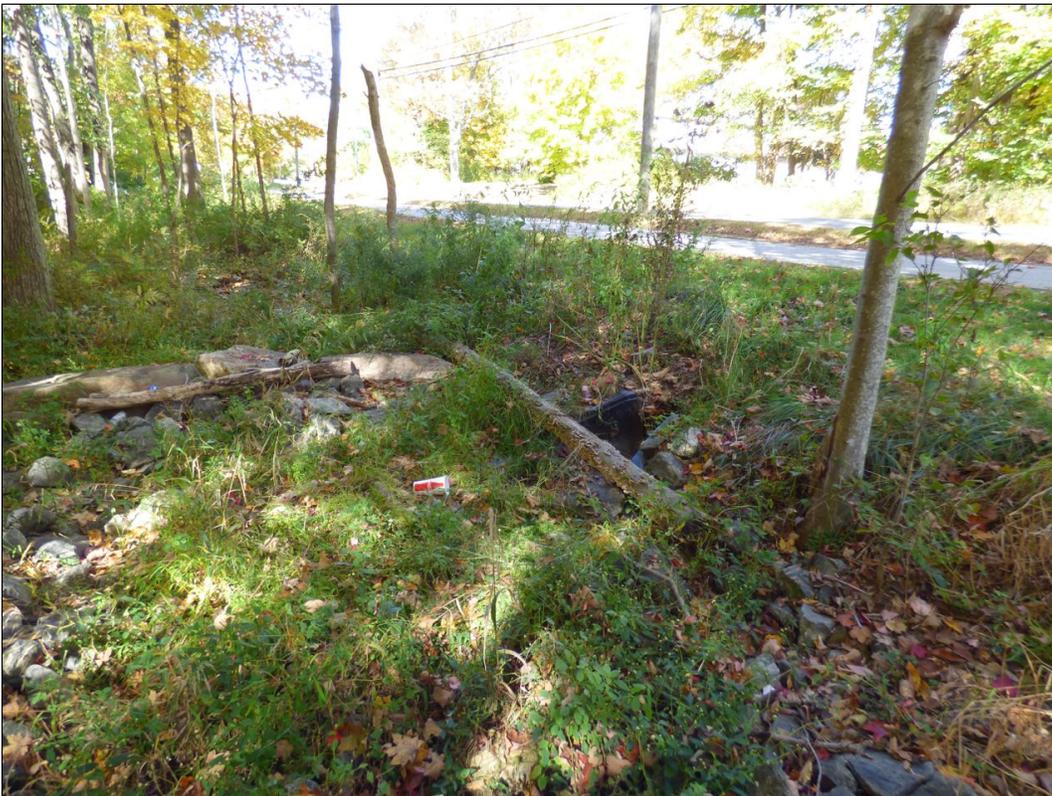
*Photo 30: Stormwater discharge to Wetland C3 from Hunting Lodge Road; located at the far northeastern corner of the site; facing northerly*

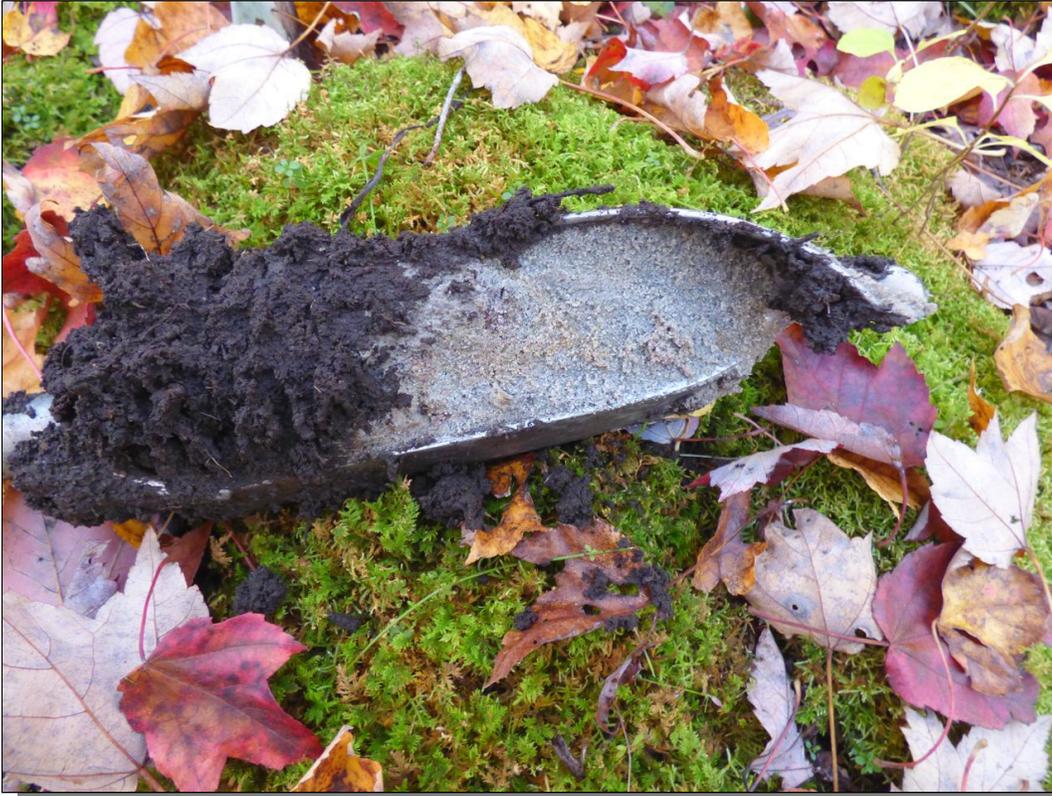
*Photo 31:* Soils in the central sections of Wetlands C3 and C4 are very poorly drained, as seen in this soil core with mucky topsoil and nearly glazed sandy subsoil

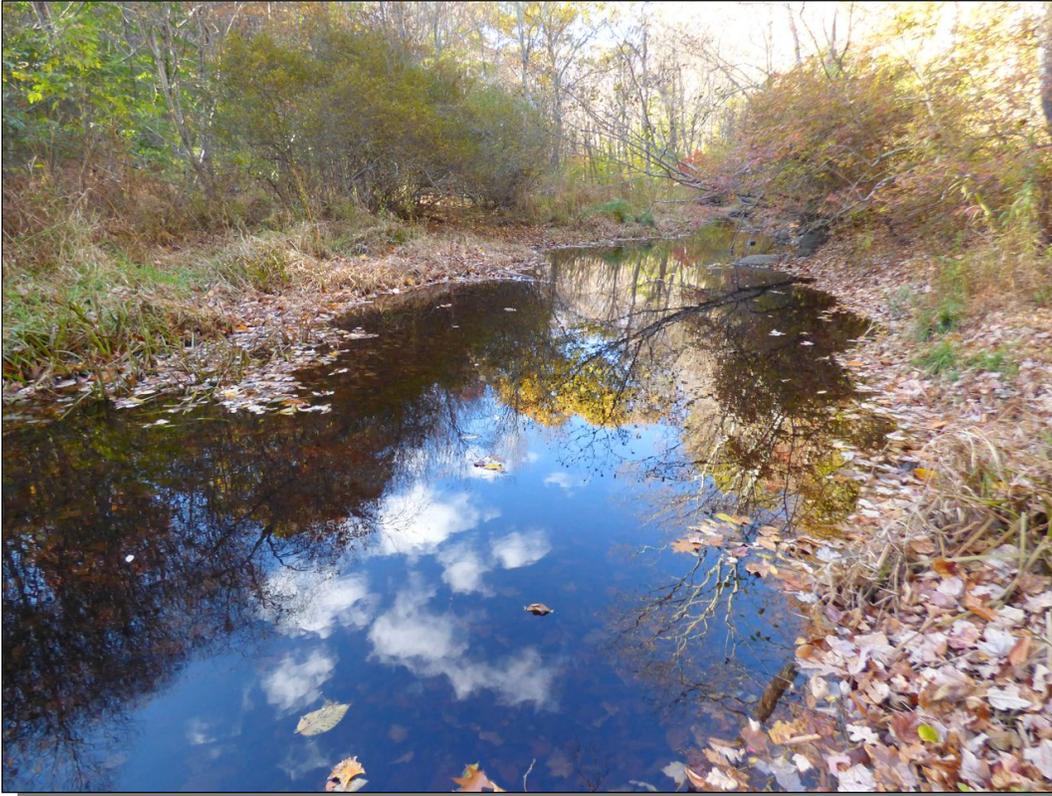
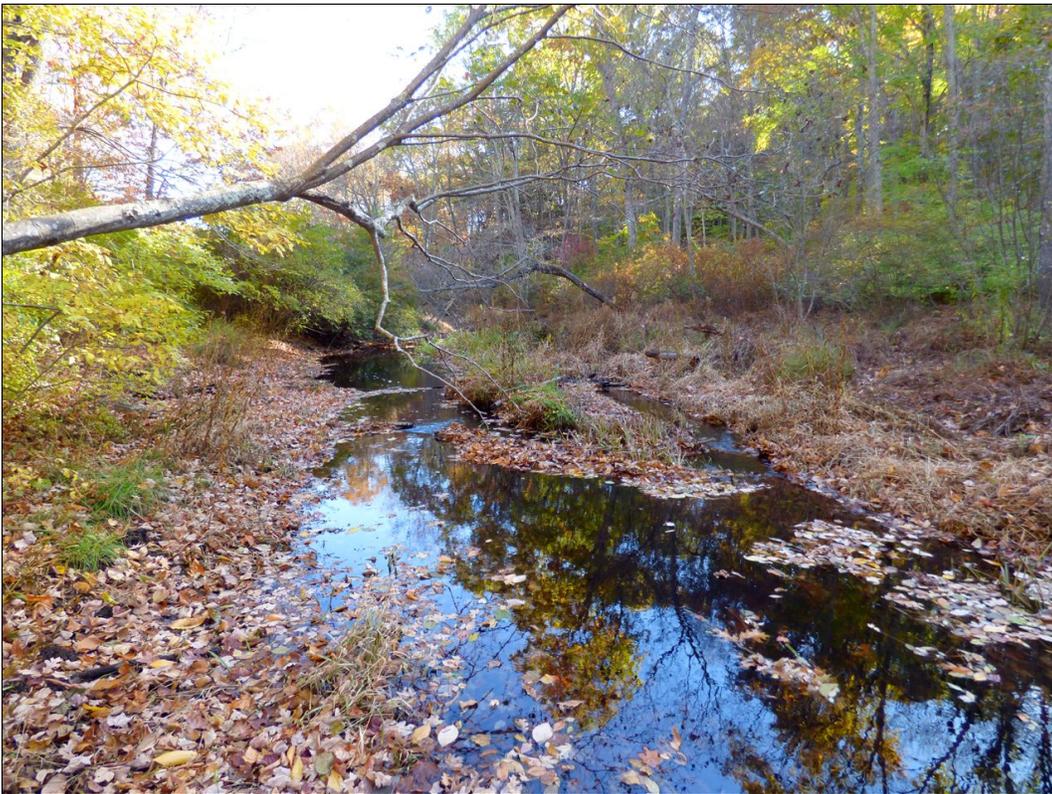
*Photo 39:* Cedar Swamp Brook just westerly of subject site; facing northwesterly (upstream)

*Photo 40:* Cedar Swam Brook flows within a steep sided “ravine”; facing southeasterly (downstream)

southerly, shown in Photos 39 to 41. Both Cedar Swamp Brook and Eagleville Brook are tributaries of Willimantic River. The watershed divide is an old farm road built on fill, the extension of the northern terminus of Northwood Road, bisecting a seasonally flooded red maple swamp.

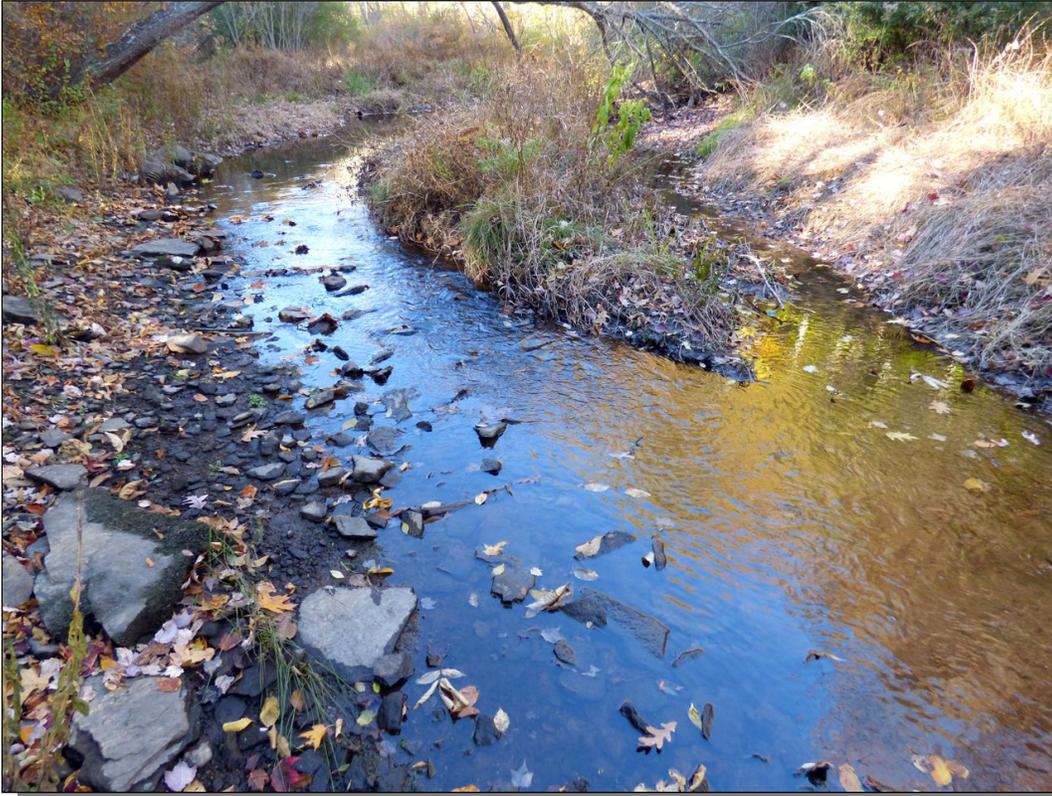
*Photo 41: Cedar Swamp Brook; qualitative macro-benthos survey at this riffle, revealed the stream to be moderately impaired; facing northwesterly (upstream)*

- ◆ The 2009 ERT reported moderately impaired water quality downgradient of the site. Water quality testing has not been completed by REMA, but field observations indicate that the diversity and productivity of aquatic life is limited, by seasonal low flow and non-point source pollution. One stream salamander was observed in WC3 and some hydroptychid net spinner caddisflies, but no stone flies, mayflies or hellgrammites. However, plants indicative of clean water do occur on the stream

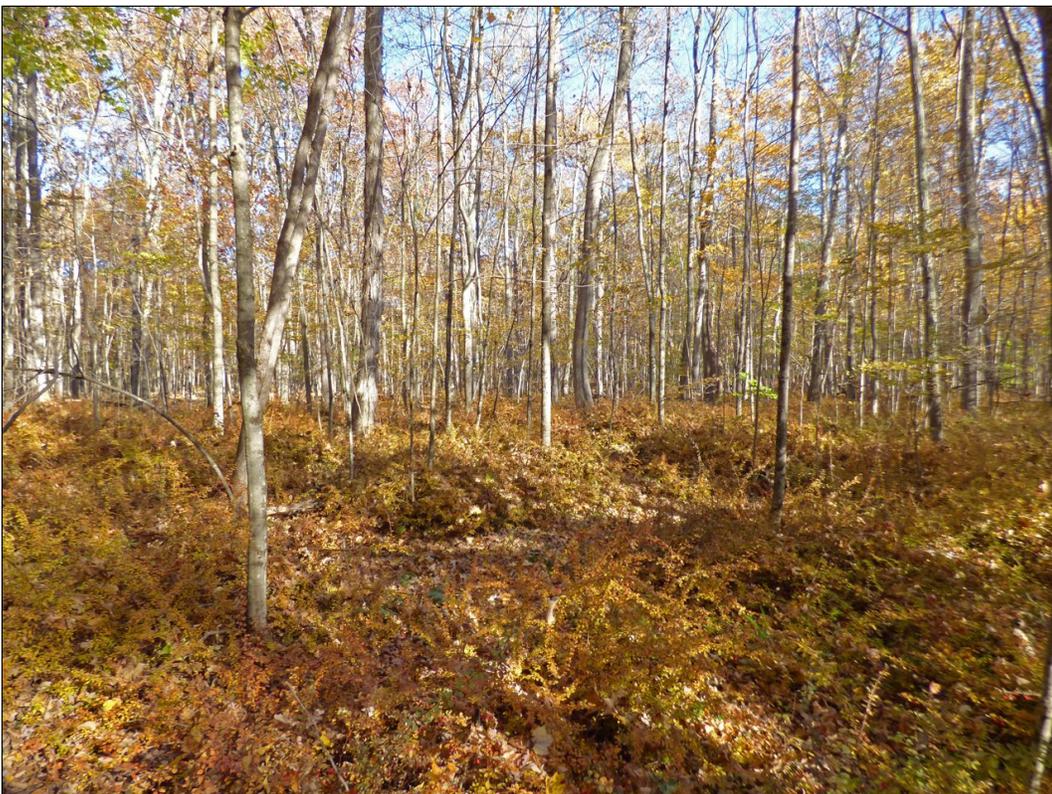
*Photo 44:* Off-site wetland, with heavy Japanese barberry infestation, downgradient of the western section of the site that drains to Cedar Swamp Brook; facing easterly

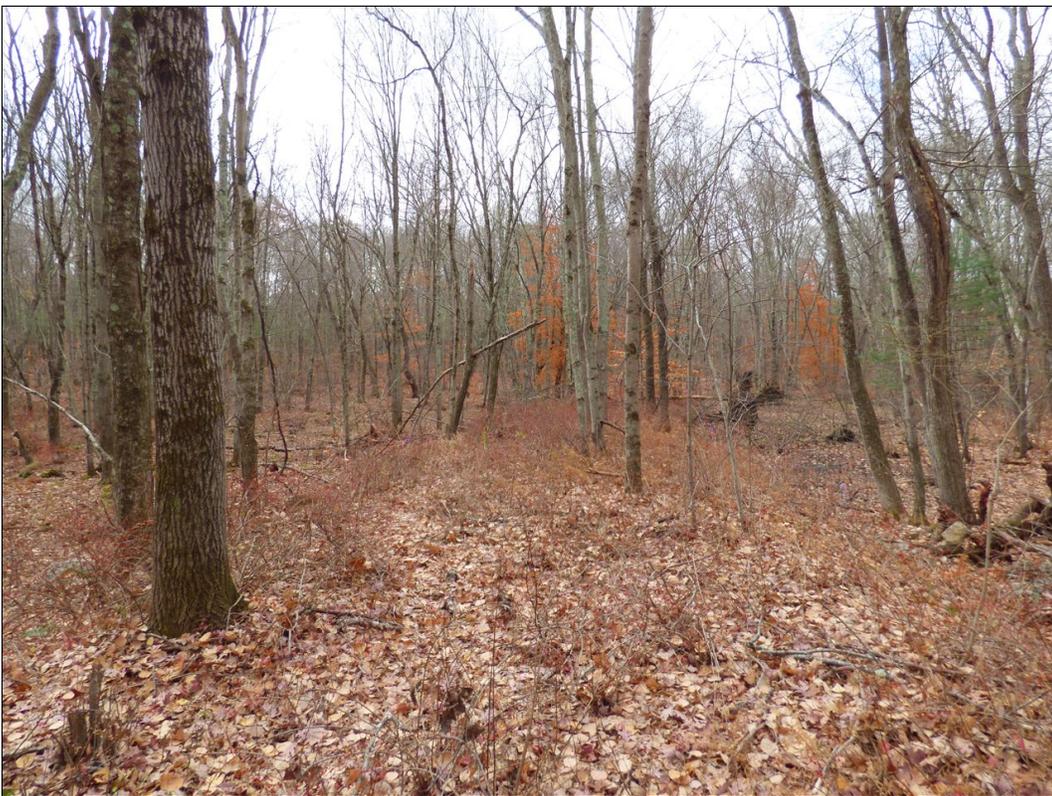
*Photo 46:* Old farm road crossing will be the location of the main roadway into the site from Hunting Lodge Road; WC3 to right, and WC4 to left of photo; facing southwesterly

- ◆ A total of 4,402 square feet (0.10 acres) of *direct* wetland impacts are proposed, in order to provide access to the developable portions of the site from Hunting Lodge Road. The proposed location is that of an old woods road, which would represent a roughly 4,675 square foot reduction of wetland impacts for a roadway crossing at this location, without this pre-existing wetland impact. Overall, this wetland impact is of *low intensity* and does not unduly alter or compromise the functions and values provided by Wetlands C3 and C4. We should note that the existing "breach" of the old road crossing, which allows passage of the intermittent watercourse, will be

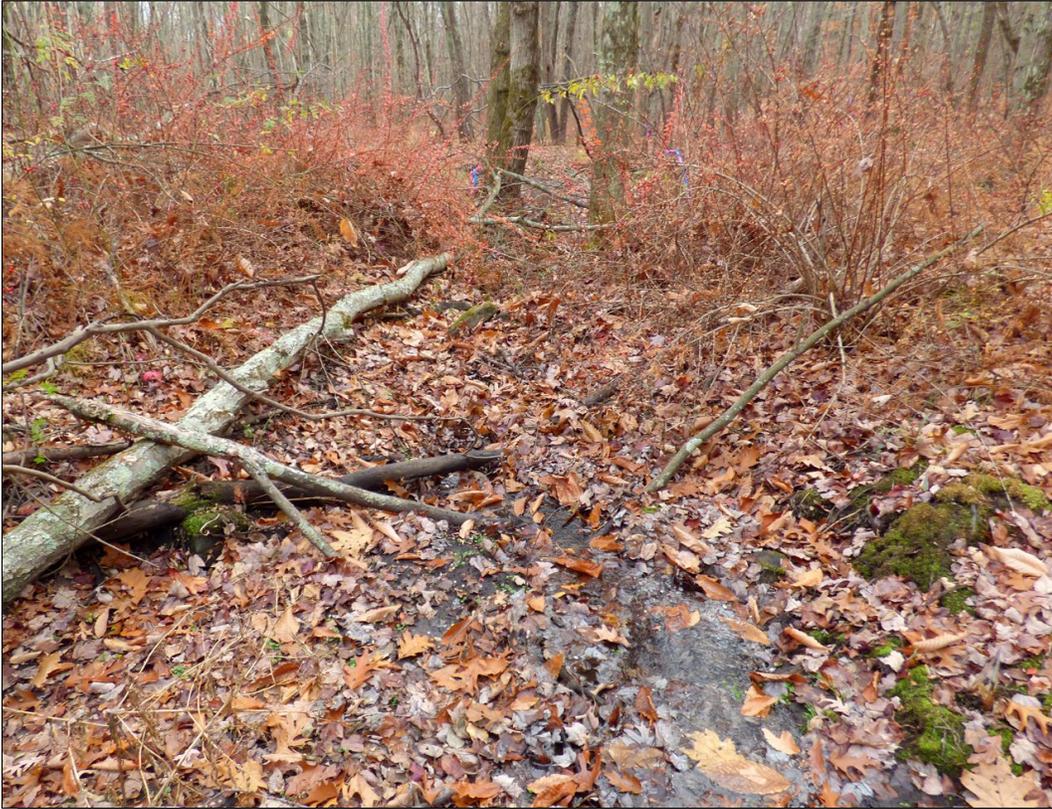
*Photo 47:* Breach in old farm roadbed will be maintained in order not to alter the hydrology of Wetland C3, upstream; facing northwesterly

maintained by using a precast bridge with a 30-foot wide span and a 4-foot vertical clearance. This will not only allow for passage of wildlife, but also ensure that the hydrology of Wetland C3, upgradient of the crossing, will not be altered.
