**Re: WETLANDS ASSESSMENT & IMPACT ANALYSIS: SUMMARY OF FINDINGS**

***Storrs Lodges, Connecticut***

Hunting Lodge Road, Mansfield, CT

*REMA Job No.: 15-1860-MNS18*

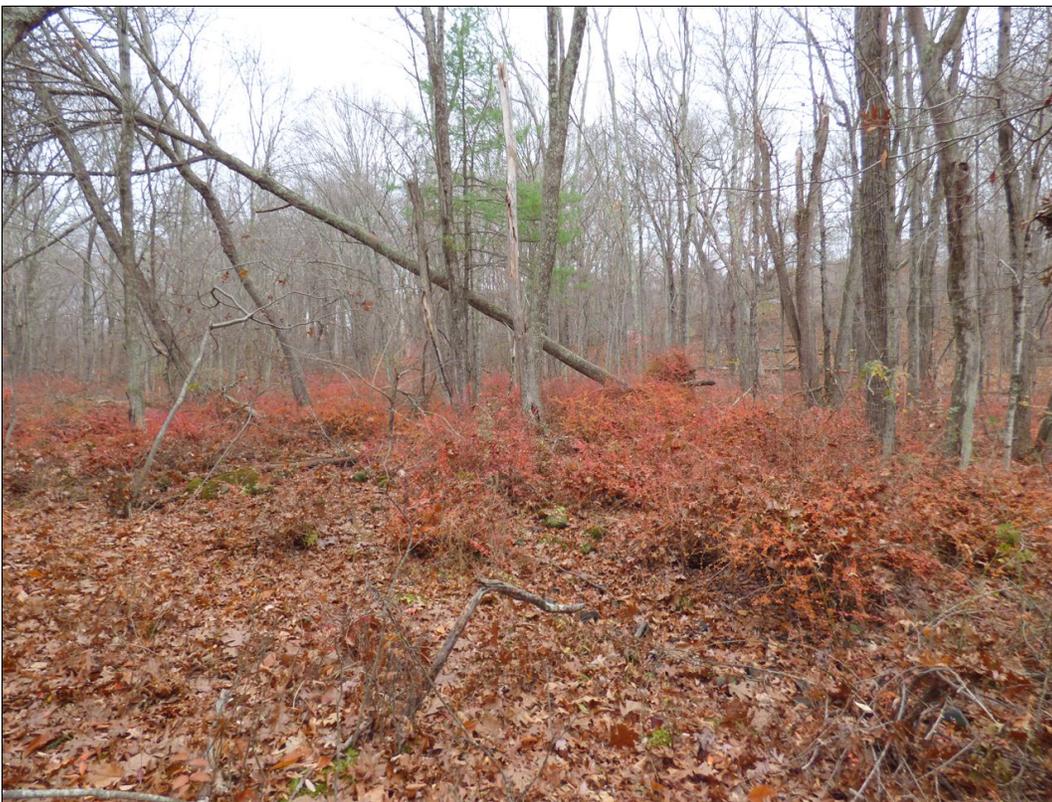
*Photo 48:* Old wetland fill area, adjacent to Wetland C1, will be removed and wetland conditions restored and planted; facing northerly

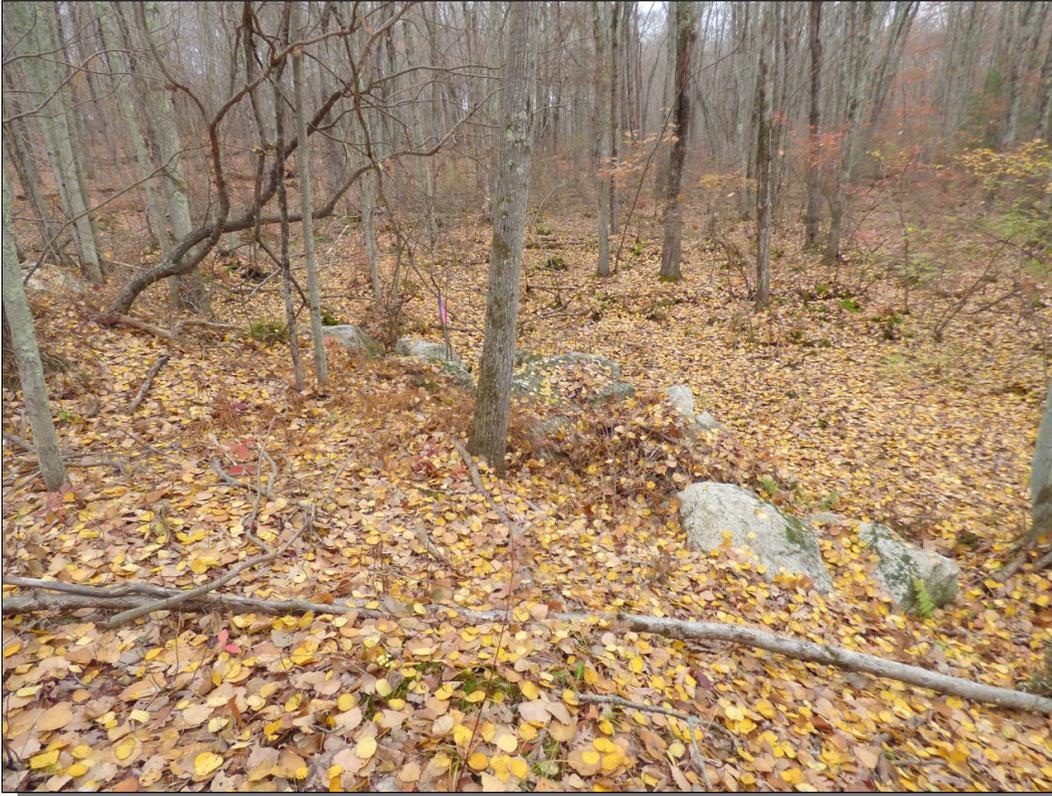
*Photo 49:* Large boulders were placed at edge of old fill and Wetland C1; facing northerly

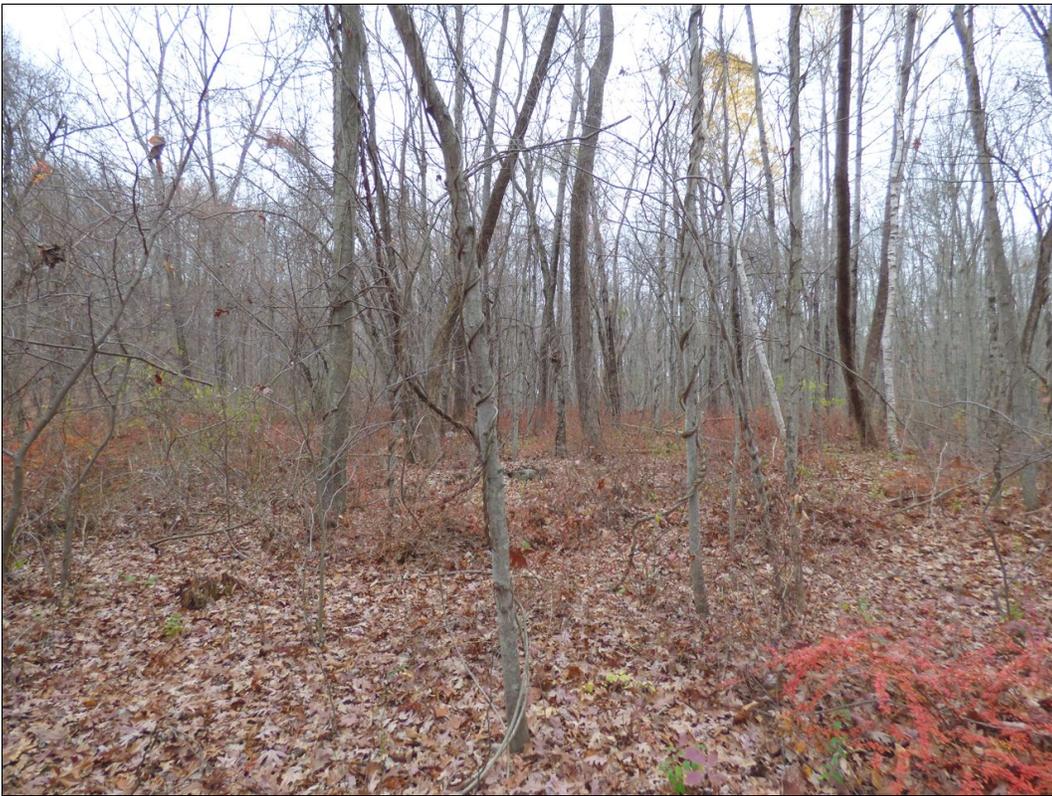
*Photo 50:* Old wetland fill area, adjacent to Wetland C1, is replete with invasives; trees include “pioneer” species such as aspens; facing northerly
