Submission Date	Jan 28, 2026 12:03 PM
Project Name	State Project 0077-0249 Replacement of Bridge No. 04730 Gurleyville Road over Fenton River
Address of Subject Property	Gurleyville Road over Fenton River [41.814590, -72.225303]
Tax Assessor Parcel Identification Number(s)	N/A - Bridge on town road
Tax Assessor Parcel Identification Number(s)	N/A - Bridge on town road
Tax Assessor Parcel Identification Number(s)	N/A - Bridge on town road
Project Description	<p>This project proposes full replacement of Bridge No. 04730. The existing bridge, built in 1970, is 43' long with a roadway width of 23'-7". The proposed structure will be 53'-9" long, and will have a roadway width of 30' to accommodate two (2) 10' travel lanes and two (2) 5' shoulders. The bridge is within a FEMA Zone A. Both State-only and State/Federal wetlands abut the project area. Riprap atop granular fill is proposed on the adjacent embankments for stabilization. Riprap atop granular fill with washed-in natural streambed material is proposed along the channel banks within the structure.</p> <p>This project includes proposed full-depth pavement reconstruction of 650' of the roadway surrounding the project site. A pull-of

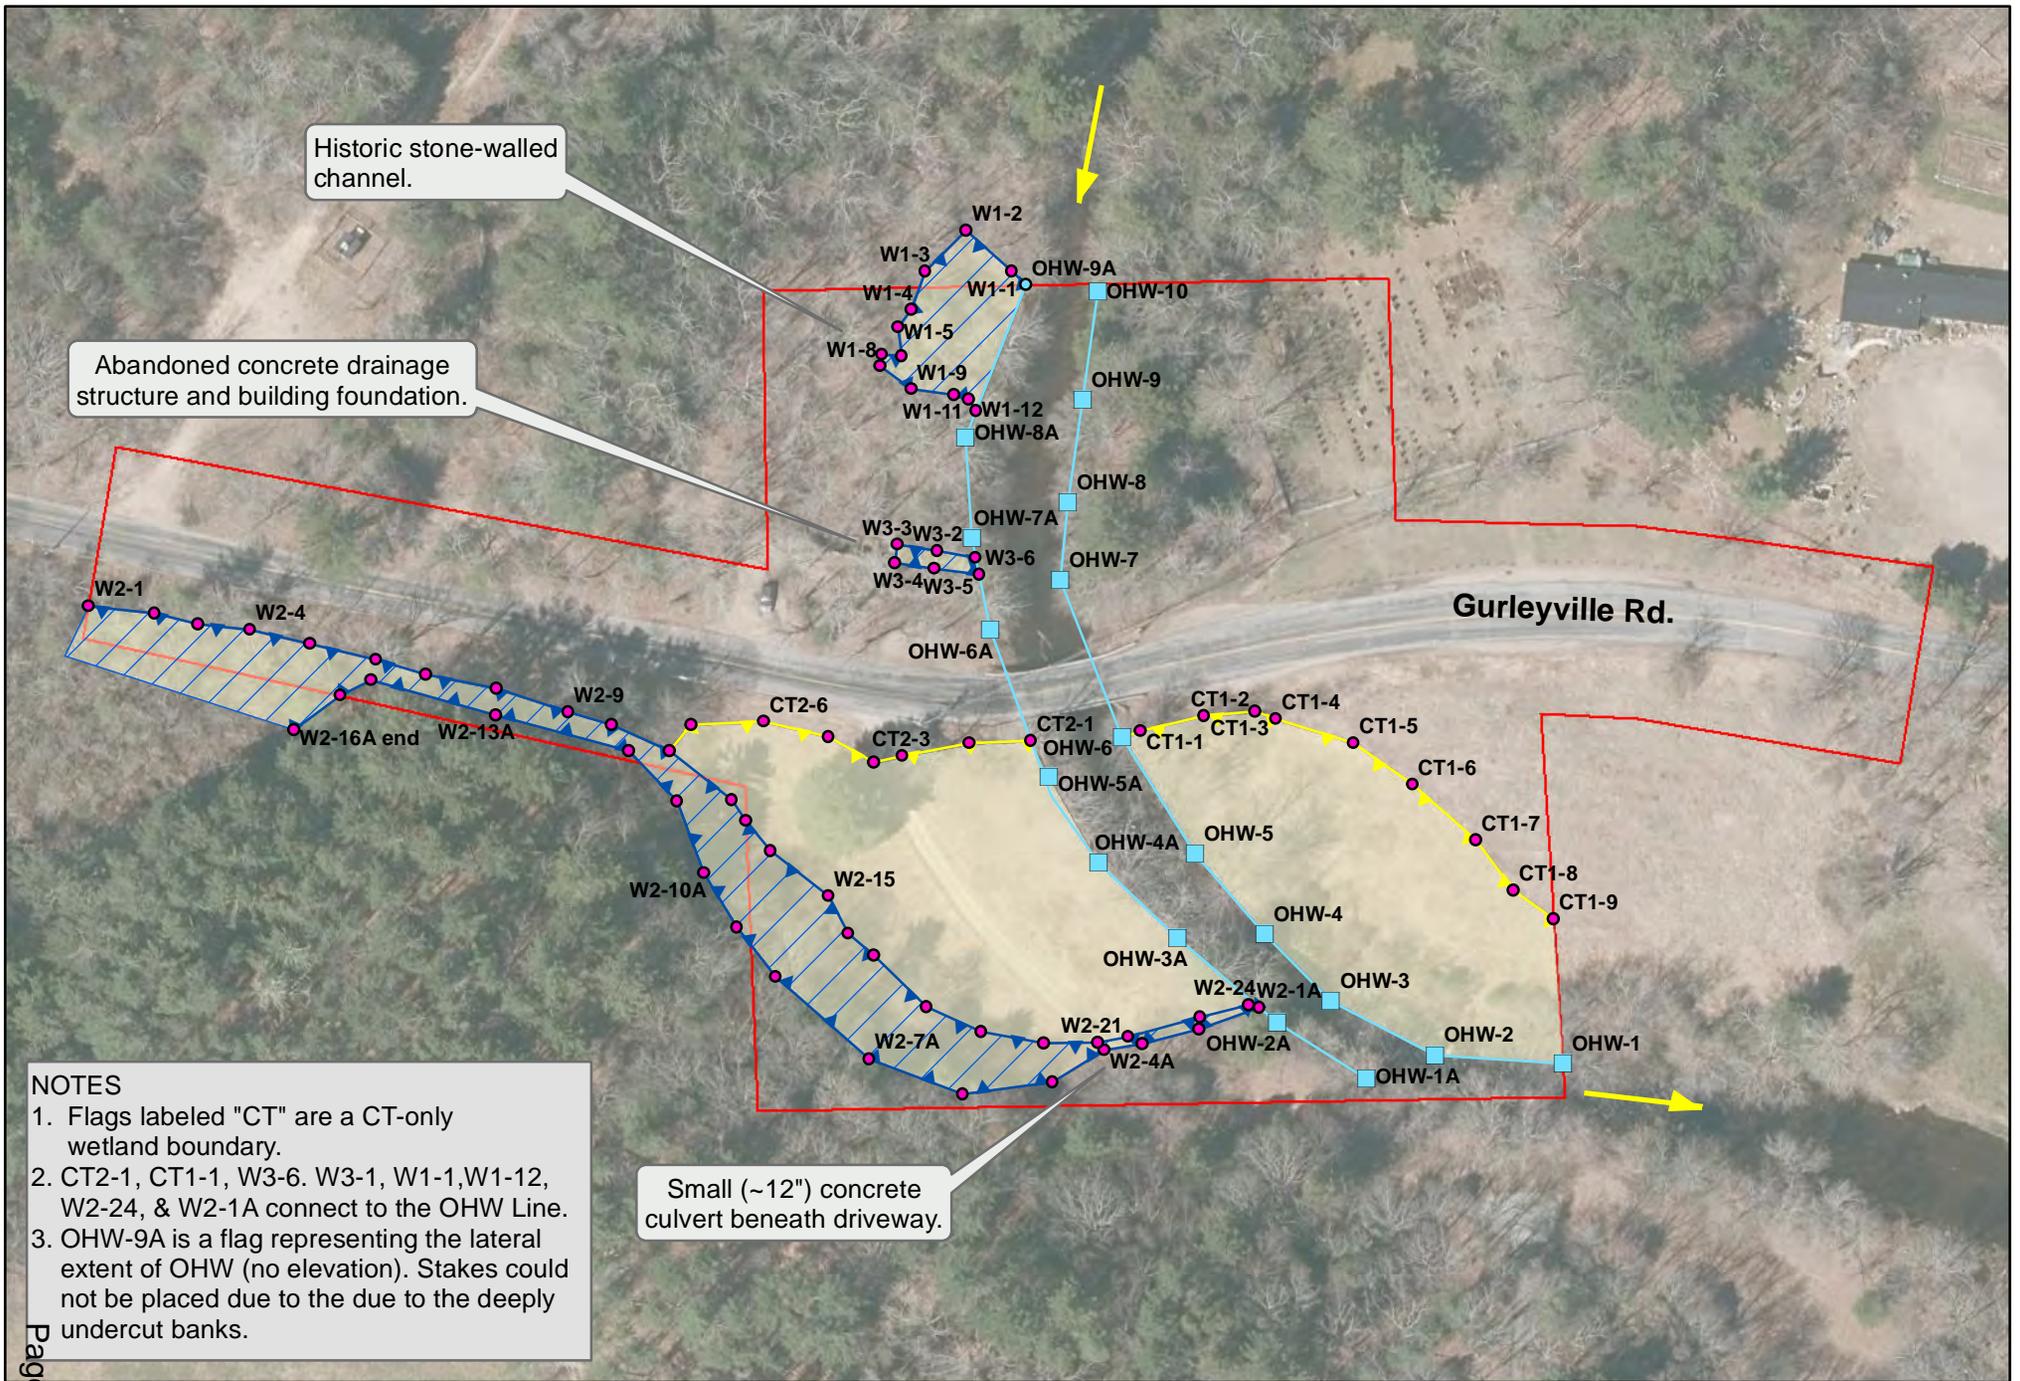
# Wetland Sketch Map

Historic stone-walled channel.

Abandoned concrete drainage structure and building foundation.

This palustrine, emergent wetland exists as a low-lying floodplain along the western bank of the Fenton River approximately 130 feet north of the Bridge. The State and federal wetland boundaries are coincident and appear to be hydrologically sustained by a locally-high water table and through overflow from the Fenton River during high-water conditions. Flagged wetland resources begin (flag W1-1) and end (W1-12) at the OHW limit within the Fenton River as shown in the Wetland Sketch Map in Attachment A.

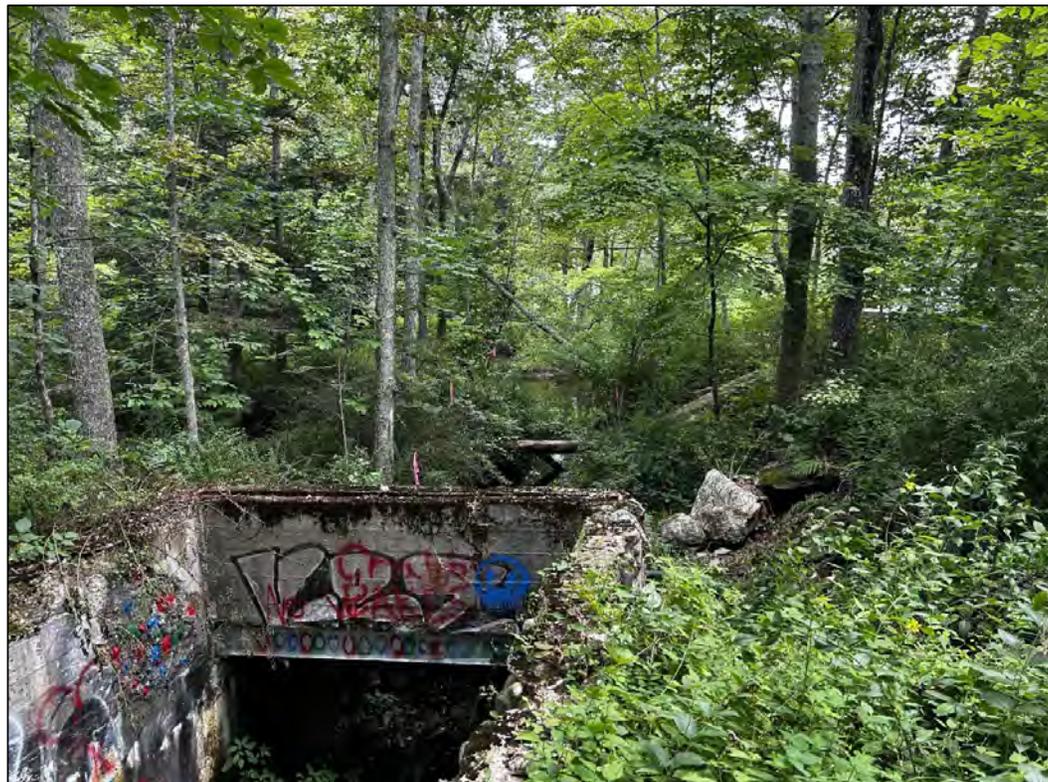
Photo 12. Abandoned concrete structure abutting wetland W3. Photo facing east toward the Fenton River (photo center).

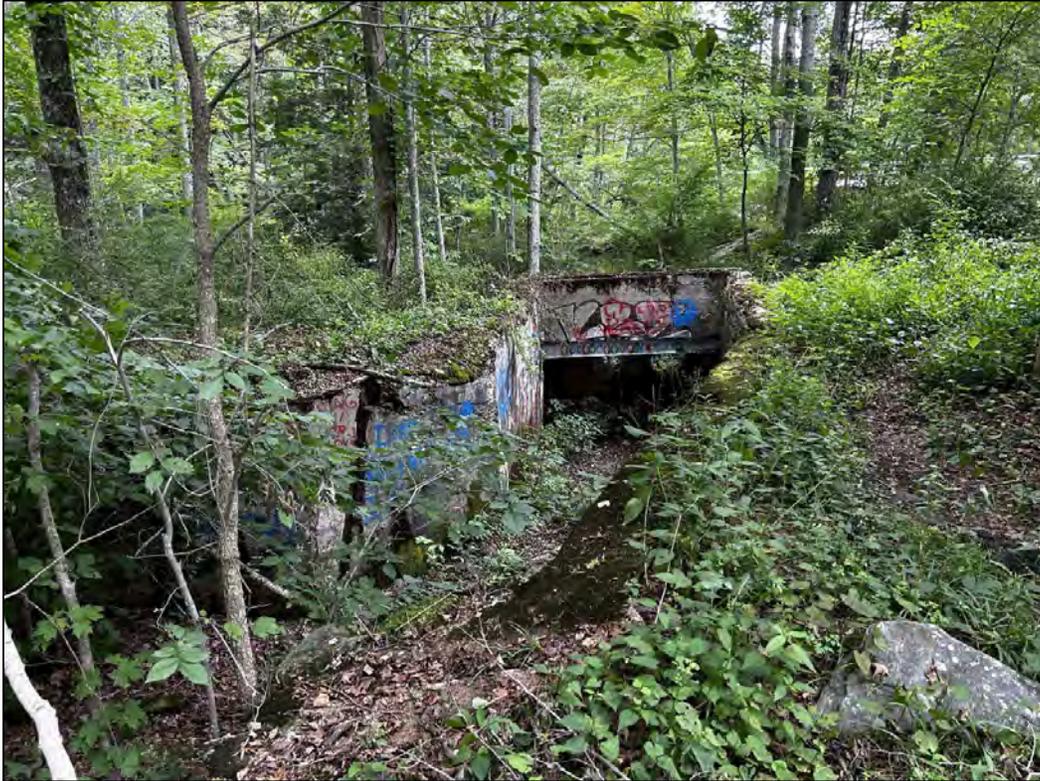
Photo 15: Abandoned concrete structure and walled "channel" upgradient of wetland W3. Photo facing east.

Soils observed include a thick layer of decompsed plant material and fine, sandy loam. The flagged swale exists between two, historic stone walls and connects directly to the River. Although the walls and channel are man-made it has remained unaltered for an extensive period of time and has become naturalized with accumulated material.

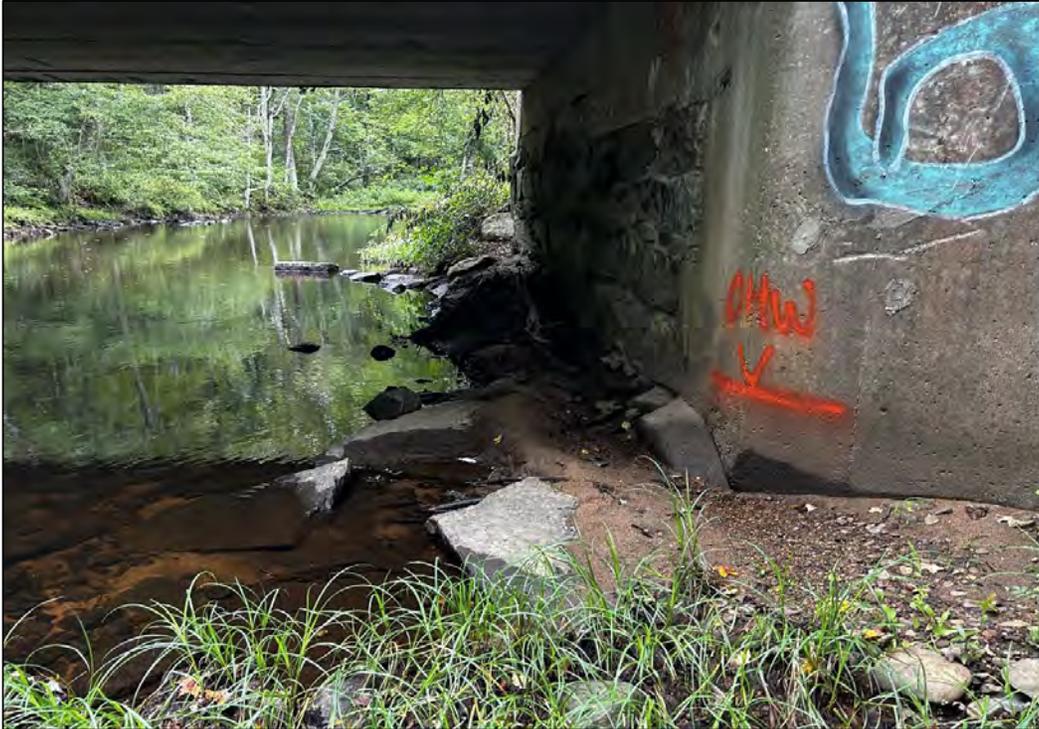
Photo 3. OHW indicated on the eastern abutment of Bridge 04730. Photo facing north.

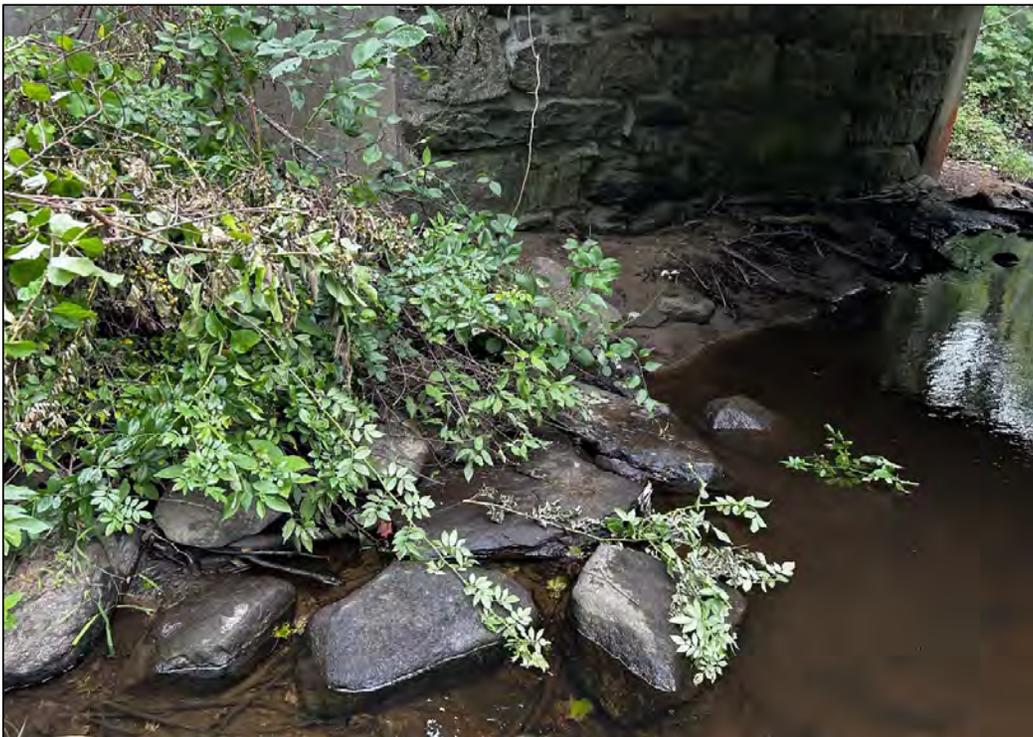
Photo 4. Eastern abutment of Bridge 04730 showing accumulated sediment along the northern side preventing OHW painting.

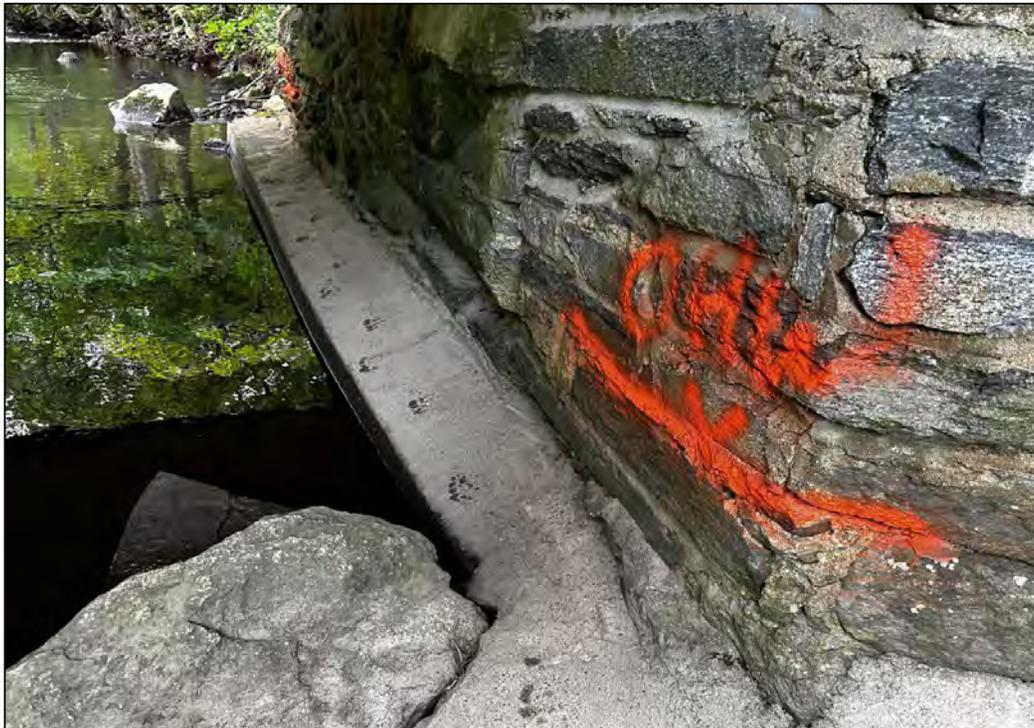
Photo 6. OHW painted on the western abutment of Bridge 04730. Photo facing south.

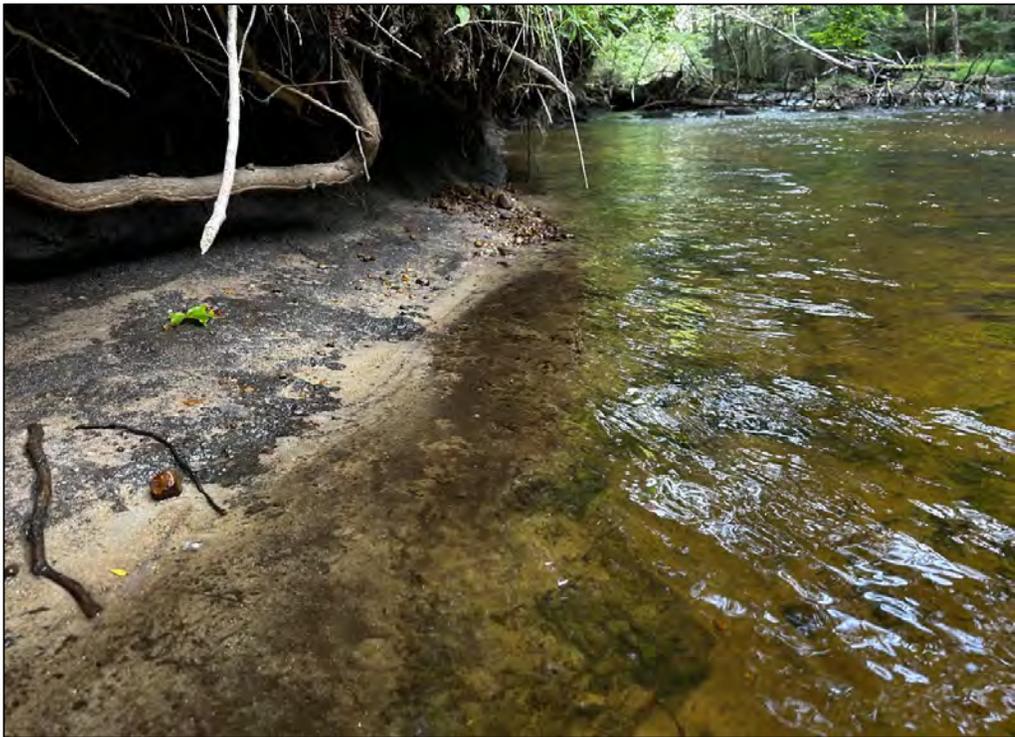
Photo 10. Deeply undercut banks evident along portions of the Fenton River.

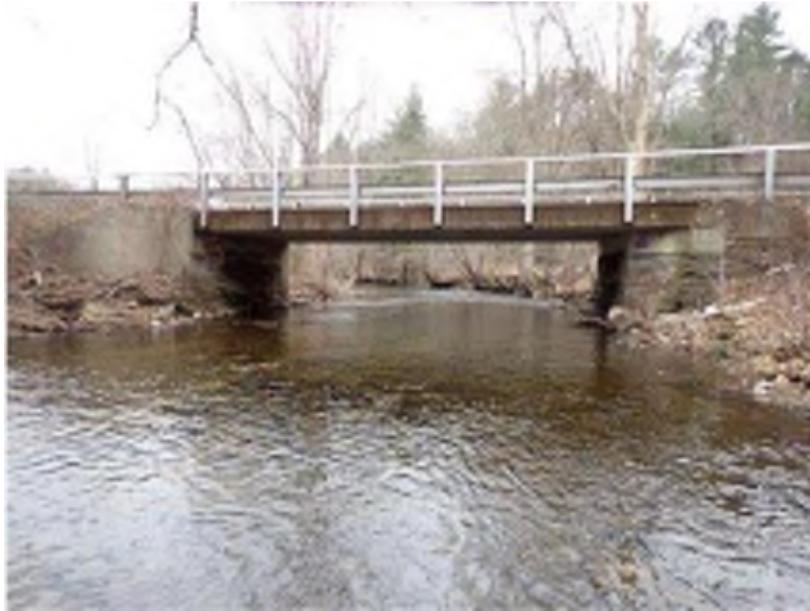
Inlet Elevation (North)

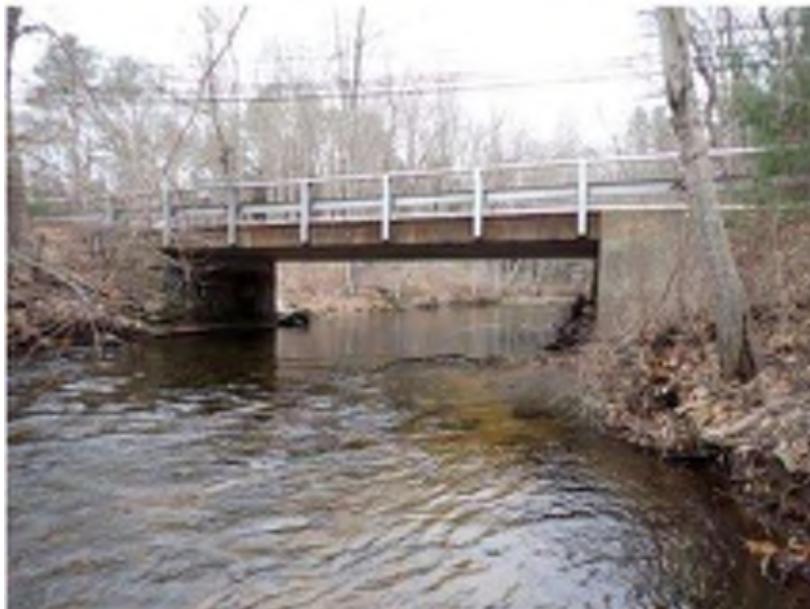
Outlet Elevation (South)

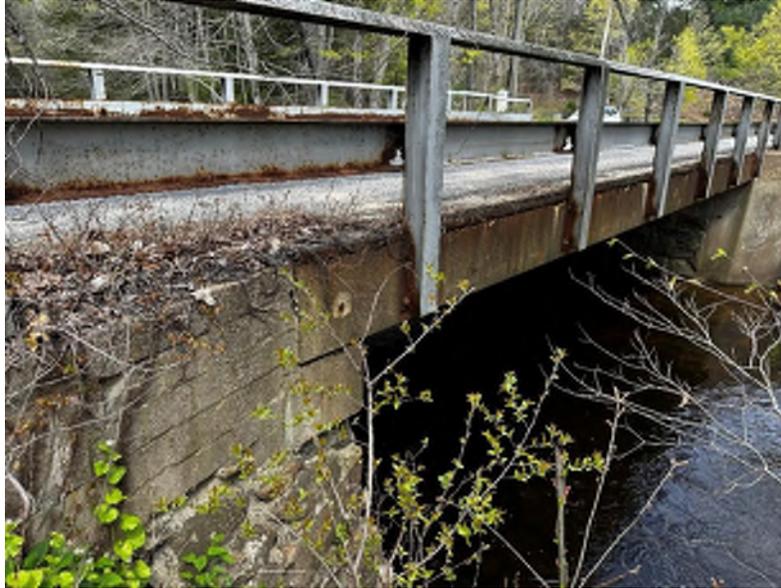
Severe Rusting observed in Bridge Railing

- The rail system on the bridge requires replacement to meet current MASH/NCHRP 350 safety standards. This cannot be achieved without full replacement because the strands of the existing prestressed concrete beams would be damaged.

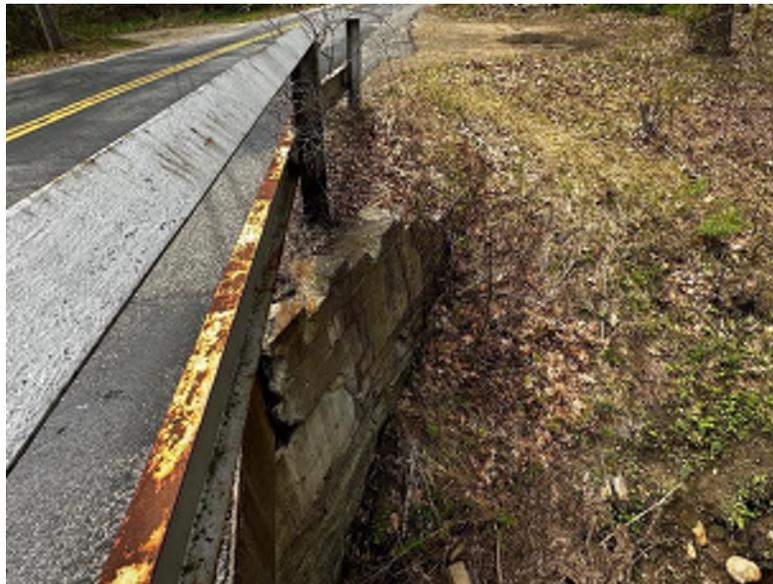
Stone masonry wingwall

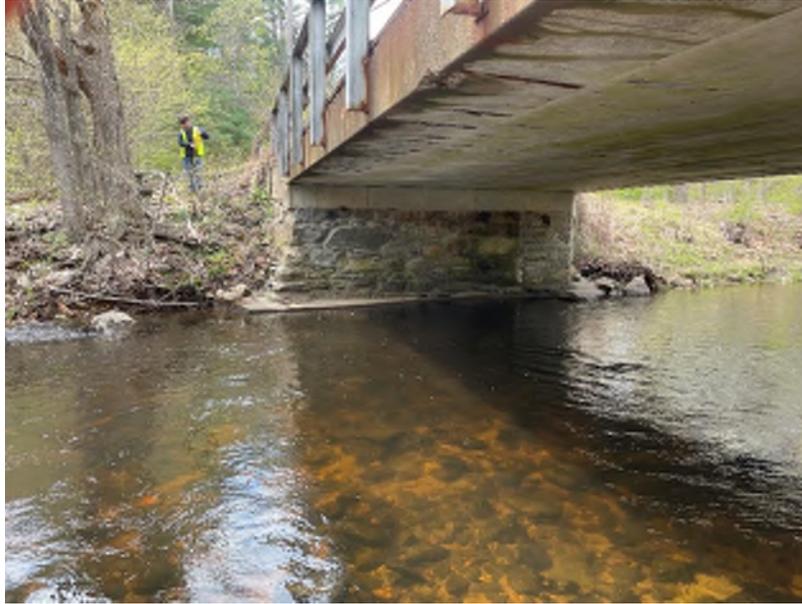
Underside of Prestressed Concrete Deck Units – Note Shallow Spalls with Exposed rebar

- The superstructure of the bridge is nearing the end of its service life and requires replacement.

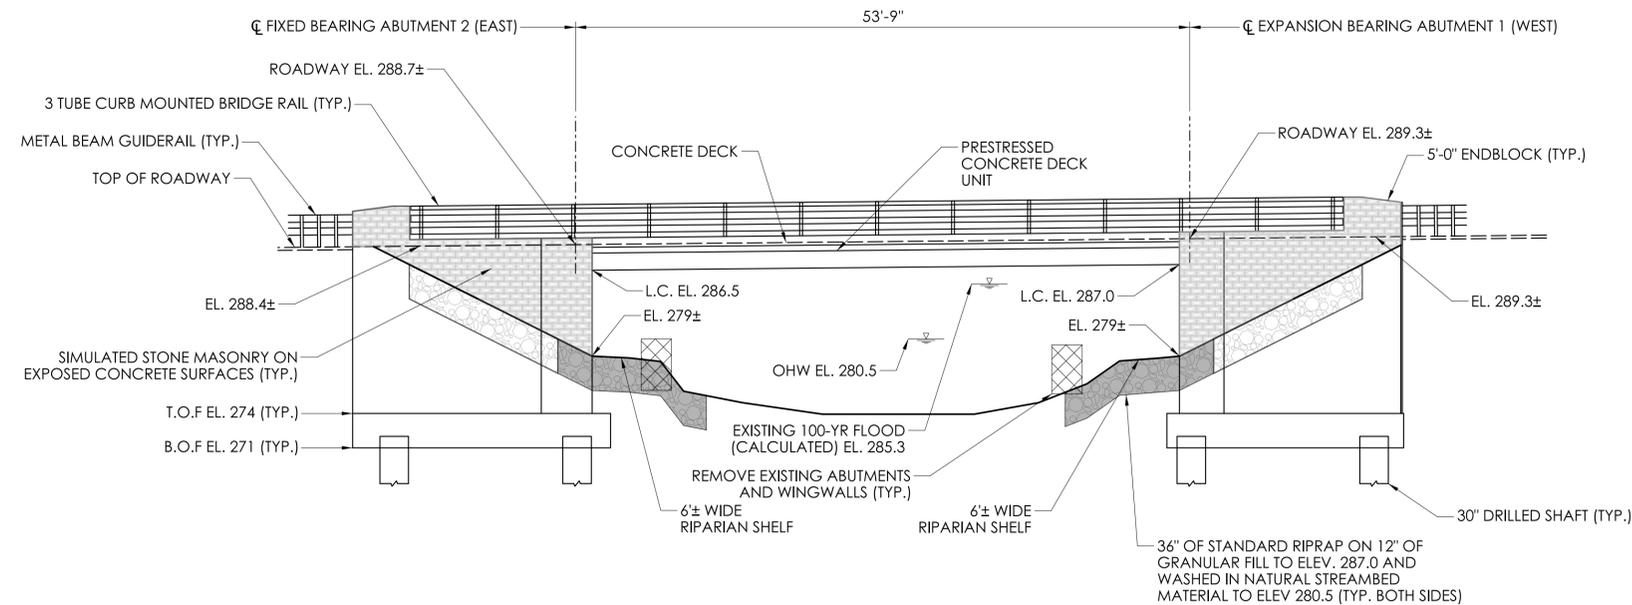
**NORTH (UPSTREAM) ELEVATION**  
SCALE: 1/8"=1'-0"  
PMT-05

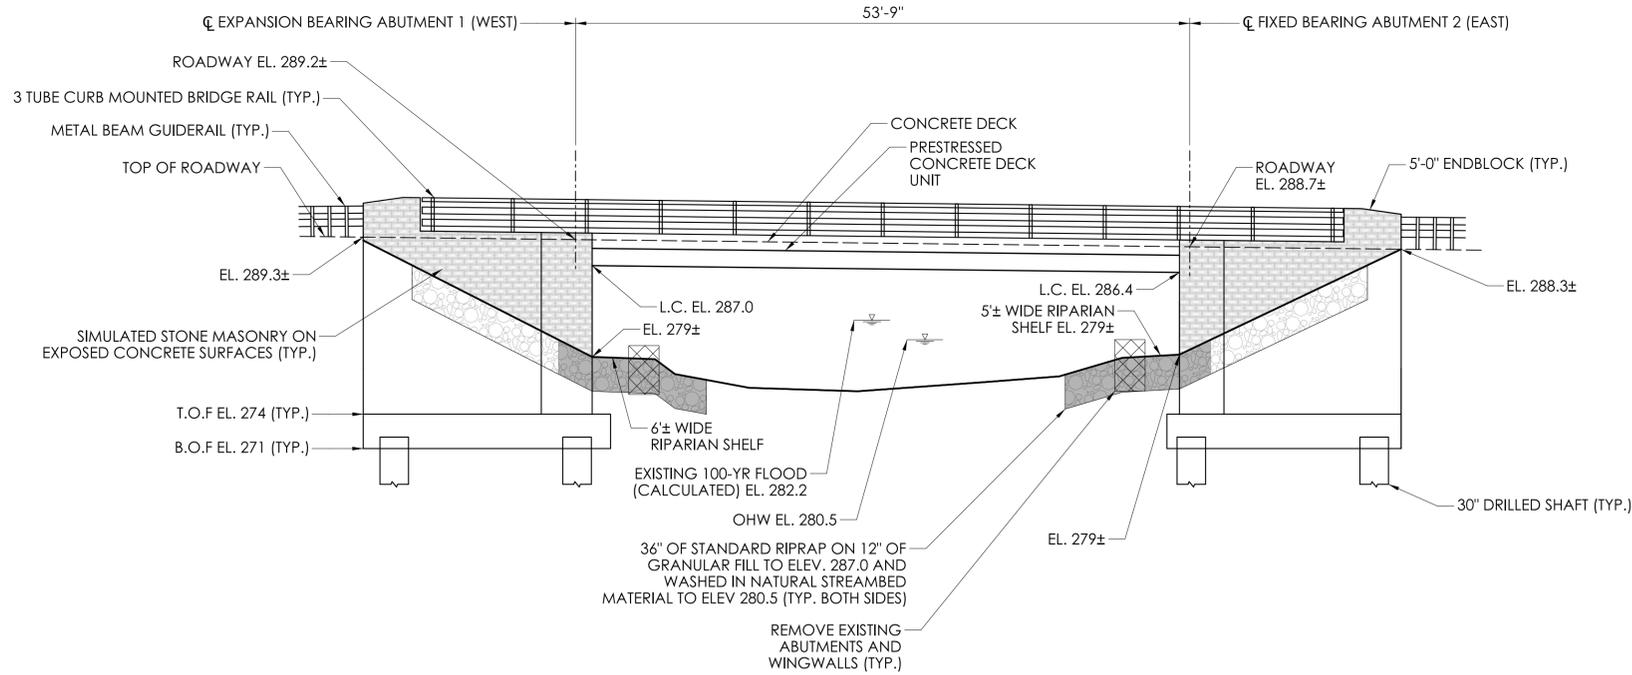
**SOUTH (DOWNSTREAM) ELEVATION**  
SCALE: 1/8"=1'-0"  
PMT-05

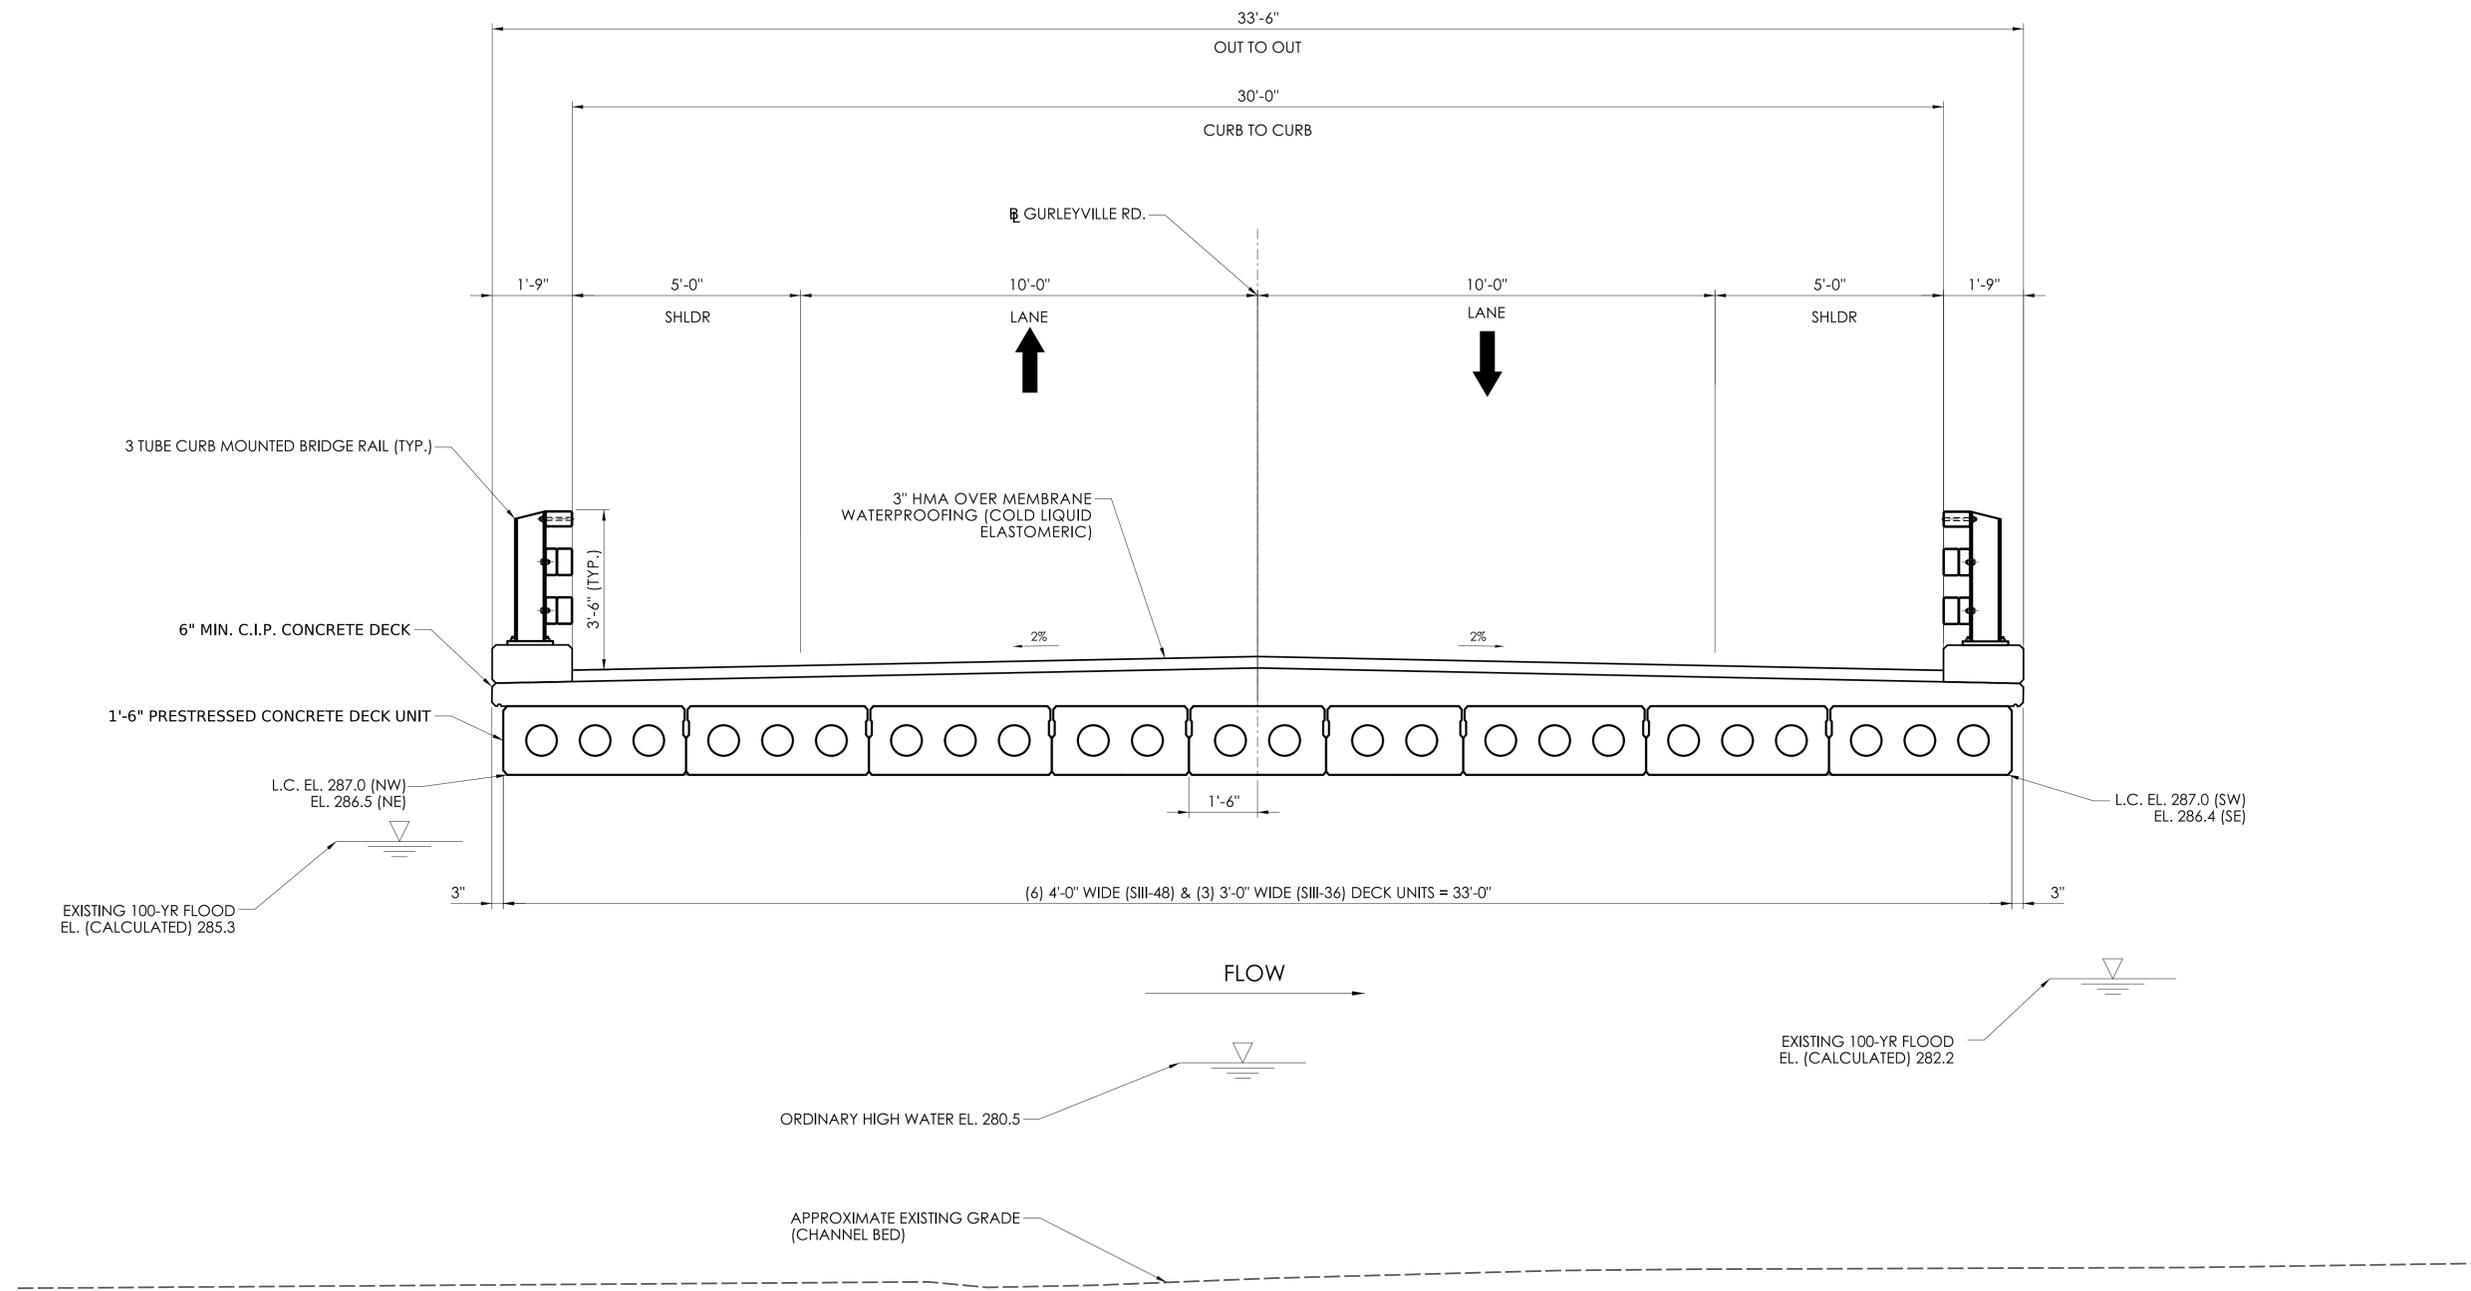
**PROPOSED BRIDGE SECTION (LOOKING EAST)**  
 SCALE: 1/2"=1'-0"

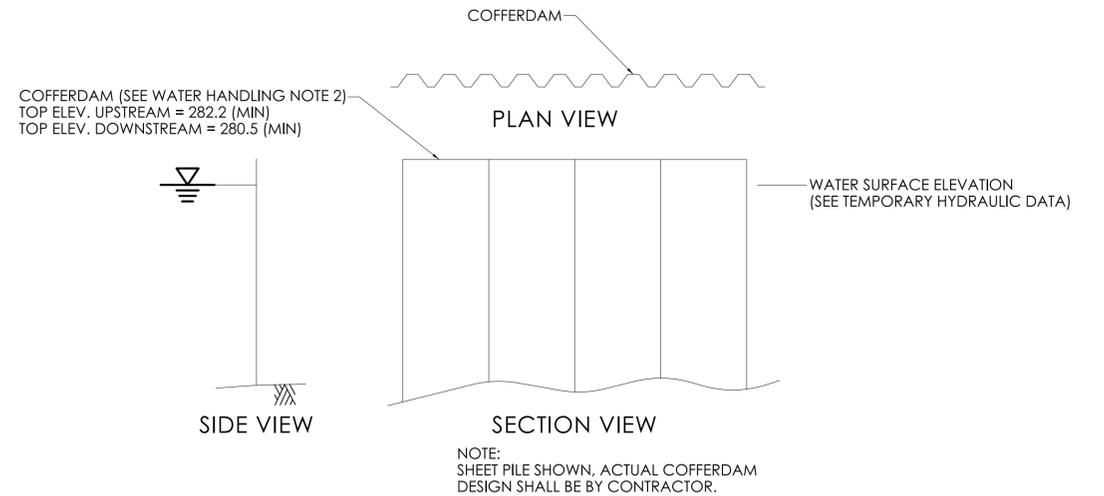
**COFFERDAM DETAIL**  
NOT TO SCALE

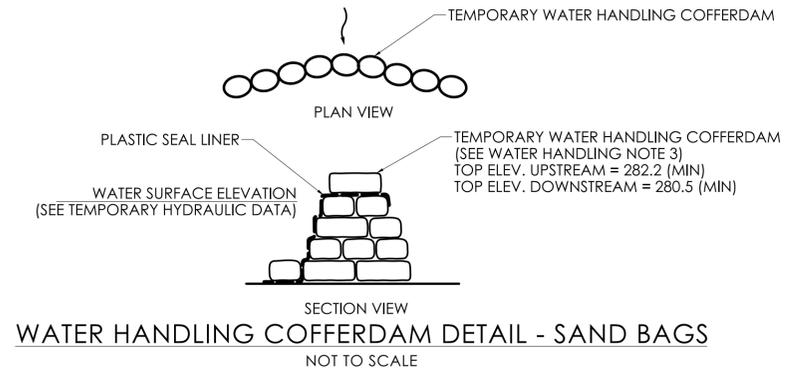
**WATER HANDLING COFFERDAM DETAIL - SAND BAGS**  
NOT TO SCALE

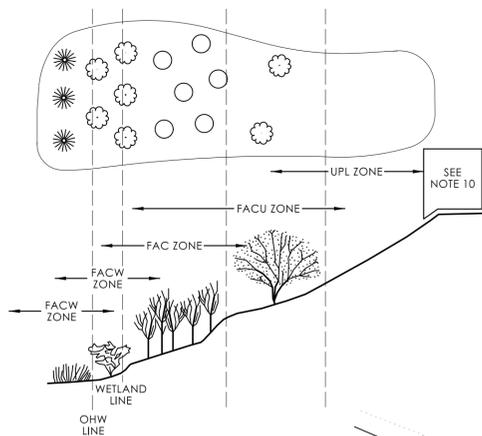
**SCHEMATIC PLANTING**
