# FOUR SCHOOLS RENOVATION PROJECT MANSFIELD, CT

January 9, 2008

### EXISTING CONDITIONS ANALYSIS

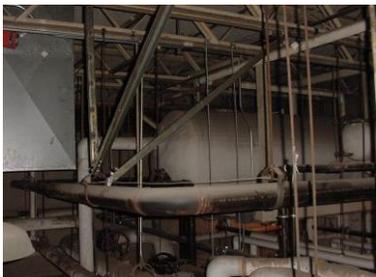
## HOT WATER TANK:

There is an 86 gallon domestic water heater and a 300 gallon hot water storage tank in the boiler room. The large tank is 30+ years. It is recommended to replace the domestic hot water system with a central dual fuel fired system.

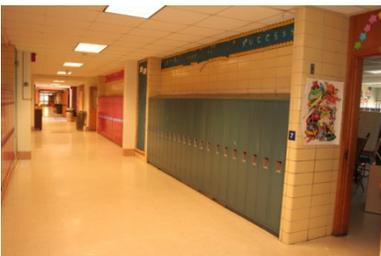
**Interior Walls** - Corridor walls are a combination of brick veneer and glazed CMU (mainly in the original building) and painted CMU in the new additions. Classrooms and other smaller teaching spaces are generally painted CMU construction. Some gypsum board partitions were noted in the Office and Nurse's areas.

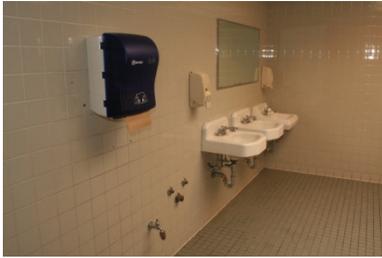
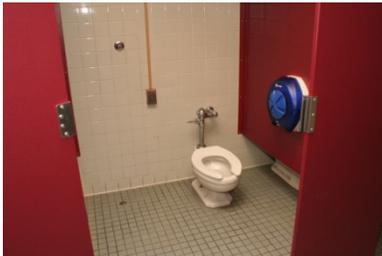
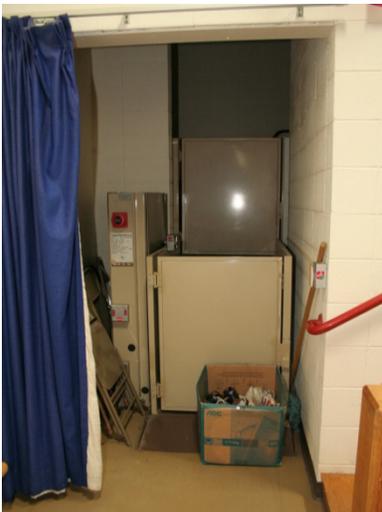
**Exterior Entries** - It was noted that all of the exterior entries appeared to provide level platforms and full accessibility to the paved walkway surrounding the school.

**Toilet Facilities** - Some of the Boys and Girls Toilet Rooms have been modified to provide accessible fixtures based on previous codes. These facilities do not comply with current standards for turning radii, clearances, accessibility or types of fixtures.

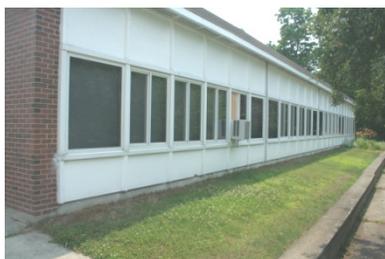
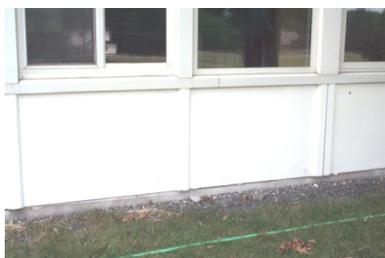
**Exterior Walls** - The exterior walls of the 1951 original building consist of a wood-framed curtain wall type system with non-insulated transite panels over ½” plywood and replacement aluminum windows. Where visual access was available, it did not appear that there was insulation of any significant thickness backing the transite panels over ½” plywood. Some of the end walls at the classrooms wings and the higher walls surrounding the Gymnasium / Cafeteria were constructed using concrete masonry units as a backup and brick veneer on the exterior surface. Based on the building’s original age, it does not appear likely that there is insulation between the two wythes of masonry.

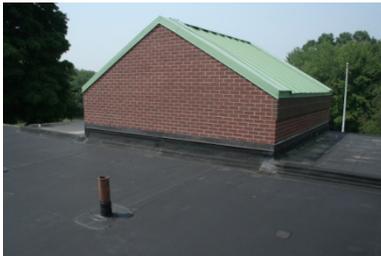
**Roof** - The entire building received a new roof when the 1990 additions were constructed. The roof is a single-ply EPDM (rubber) fully adhered .060" membrane manufactured by Firestone. The membrane has markings indicating it was manufactured in "10-89". Internal roof drains were located throughout the non-pitched roof areas. The roof pitches to exterior gutters connected to downspouts and an underground storm drainage system. Drawings indicate the presence of 2½" of rigid insulation beneath the EPDM membrane and on some portions of the roof, tapered insulation adds to this thickness. Some ponding was noted by standing water and evidence of residue left where previous moisture had evaporated. A standing seam metal roof occurs over the new entranceway to the school.

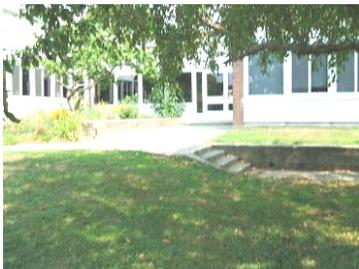
**ACCESSIBILITY:**

There are three handicapped parking spaces on the site. Two of the spaces serve the school, and the third space serves the separate building to the rear (east) of the school. All three spaces appear to generally conform to present regulations in regards to slope of pavement, ramp design, etc. Pavement markings, signage, etc. would need to be adjusted to meet present regulations. Along the south side of the front of the school, there are concrete sidewalks with stairs within the walks to adjust for elevation. These stairs, including a single step into the building in this area, do not meet accessibility guidelines. This area should be reconfigured to provide handicapped access. There is an entrance on the south end of the building with only stairs for access. This entrance should be reconfigured for handicapped accessibility with a ramp.

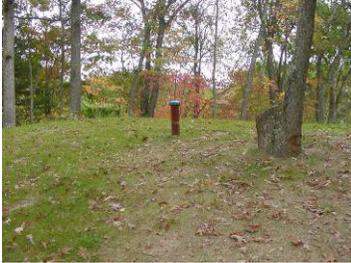
**NEW WELLS:**

**Domestic Water** - Domestic and water for the hydronic systems is provided by two new wells drilled in 2005 to replace the existing wells. Two new 5000 gallon in ground water storage tanks were also installed. The water system is of adequate size, in good condition, raises no energy efficiency issues and is suitable for continued existing use.

Water pressure and volume are maintained through two variable speed water pumps on each well and pressure tanks. All water distribution is through copper piping. The pumps and piping are of adequate size, in good condition, raises no energy efficiency issues and is suitable for continued existing use.

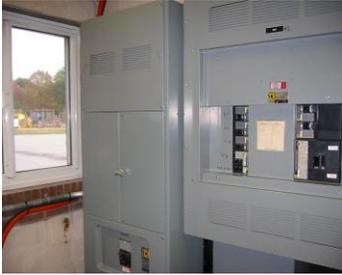
### ELECTRICAL SERVICE:

The school's main electrical service is a single phase 1,000 amps service with a 1,200 amp MDP#1 and smaller 400 amp MDP#2 panel. The MDP #2 panel is one year old and is used to power to the new well pumps. The single-phase service is inadequate and impedes expansions. The cramped electrical room does not meet current code requirements. The branch circuit panels are very old and mostly full, with many original ones dating back to 1952 or to 1965 in the South Wing. Classrooms and other spaces are in need of additional 120v outlets.

It is recommended to replace the entire electrical service with 3-phase power into a code compliant room on the main level. Add new panelboards throughout the school. Older single-phase branch circuit panels in good condition can be re-fed from a new 3 phase MDP, with all new panels at 3-phase for new loads.

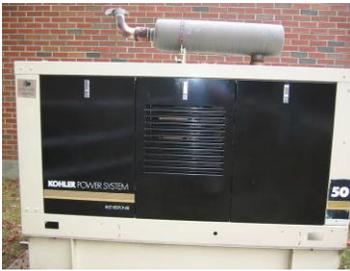
### GENERATOR:

The existing 50-kW generator and manual transfer switch are old and do not provide power to all emergency systems during a power failure. Identify power panels, equipment and services that require emergency power and collect them for switching to emergency power when normal power fails. It is recommended to replace the generator, ATS and add emergency panel boards for emergency circuits.

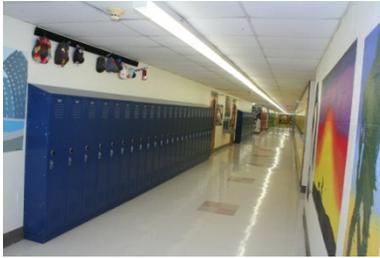
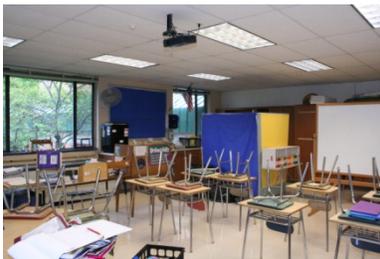
### INTERIOR FINISHES & FIXTURES:

**Interior Walls** - Corridor walls are a combination of painted CMU with some brick veneer accents. Student paintings are prominently featured on the light, neutral colored painted surfaces in many locations. Metal lockers line corridor walls in many locations and appear to be in fairly good condition.

**Floors** - Corridor floors are almost exclusively VCT with resilient base with the exception of the corridor directly in front (east) of the Auditorium, which has carpet. Carpet is also located in the Music and Choral Rooms. Toilet Rooms and Custodial Spaces have ceramic tile with no base. The new Library/Media Center, Computer Rooms and associated spaces have carpet on the floors with resilient base. The Kitchen and adjacent spaces with food service operations have 4" square quarry tile floors with no base. The Gymnasium has a wood floor.

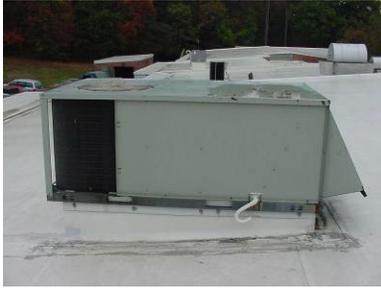
### MUSIC ROOM ROOF TOP UNIT:

**Instrument Music Room** - The instrumental music room is heated, ventilated and air conditioned by two Trane packaged roof top units with electric heat, 6 ton DX cooling units and supply fans with exhaust back through the unit. Supply air ducted into the music room returns through exhaust grills in the auditorium. The unit installed in 1992 needs replacement. It is recommended to replace the music room packaged roof top unit with a packaged roof top unit using hot glycol heating with DX cooling and supply air fan.
