# FOUR SCHOOLS RENOVATION PROJECT MANSFIELD, CT

January 9, 2008

### EXISTING CONDITIONS ANALYSIS

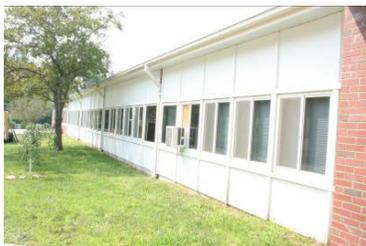
**Exterior Walls** - The exterior walls of the 1955 original building consist of a wood-framed curtain wall type system with non-insulated transite panels over 1/2" plywood and replacement aluminum windows. Where visual access was available, it did not appear that there was insulation of any significant thickness backing the transite panels over 1/2" plywood. Some of the end walls at the classrooms wings and the higher walls surrounding the Gymnasium / Cafeteria were constructed using concrete masonry units as a backup and brick veneer on the exterior surface. Based on the building's original age, it does not appear likely that there is insulation between the two wythes of masonry.

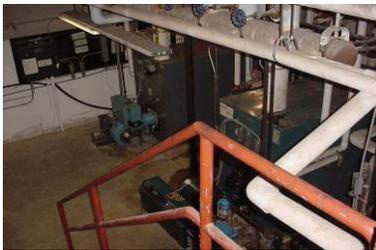
### BOILERS:

Both boiler burners are dual fuel and approximately 5 to 10 years old. One is manufactured by Webster and the other by Power Flame. Both boiler burners appear to be adequate for present and current needs. The combustion air is provided through a gravity damper located in the boiler room wall. The capacity and condition appear to be adequate for current needs. The boiler has multiple breeching with 12 inch connections and barometric draft. It is of adequate size, in good condition, raises no energy efficiency issues and is suitable for continued existing use

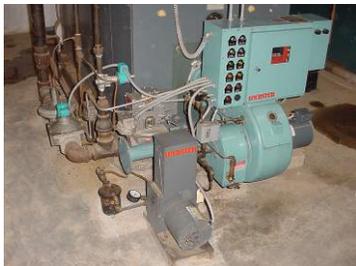
### BOILER BURNER:

There are three expansion tanks installed above the two boilers and they appear over 30 years old. It is recommended to replace the expansion tanks and piping with a new blow down tank system. The chimney is masonry with stainless steel lining. It is of adequate size, in good condition, raises no energy efficiency issues and is suitable for continued existing use. The original control valves are pneumatic and changed to electronic as maintained. It is recommended to replace all pneumatic equipment with digitally controlled Johnson controls. The heating distribution piping is copper with fiberglass insulation outside the crawl spaces. It varies in age from original to 5 years old. While some is of adequate size, in good condition, raise no energy efficiency issues and is suitable for continued existing use, older pipe based on age and condition should be replaced.

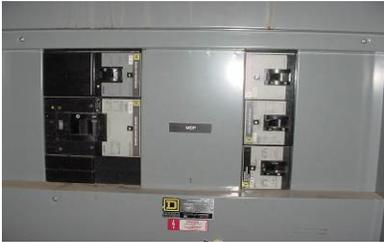
### MAIN ELECTRICAL SERVICE:

The school's main electrical service is a 3 phase 800-amp service with an 800 amp MDP and smaller branch circuit panels. The electrical equipment is in a crawl space adjacent to the boiler room and well tank room. It is not compliant with current egress code requirements. Circuit breakers in the MDP are newer than the panel. Some newer panels serve branch circuit loads, but most panels, including the MDP and main service switch are original. (1950's). All panels are full or almost full. Classrooms are in need of more 120v outlets. It is recommended to replace the entire electrical service into a full height room with code compliant egress. Locate the new room on the main level near the existing electrical equipment. Add more circuit breaker panel boards and branch circuits throughout the school.

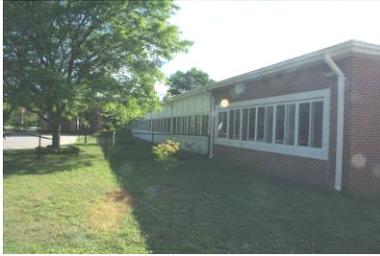
The exterior walls of the 1990 additions were constructed using concrete masonry unit (CMU) backup and brick exterior. Wall sections from the construction documents used to build these additions indicate 2" of rigid polystyrene insulation between the two wythes of masonry.

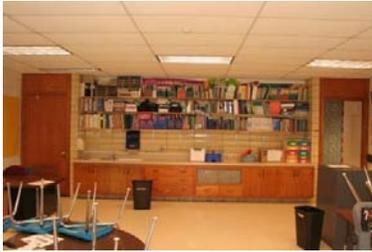
**Classroom Casework** - Throughout the building, the casework is stained wood with plastic laminate countertops and backsplashes. Some painted shelves were noted in the original building with stained wood base cabinets and plastic laminate countertops. It was noted in many locations that wear and deterioration were showing on both vertical surfaces of the cabinetry and the plastic laminate countertops and edgings.

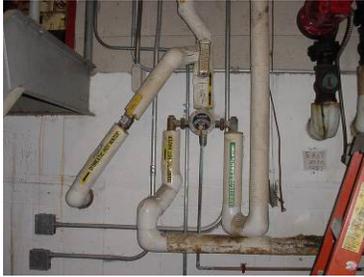
### HOT WATER PIPING:

**Terminal Heating Units:** The classrooms are served by built in place convector units located along the perimeter of the building. These units are piped together in a manifold loop system that is not easily retrofitted or modified. Control of space temperature is via thermal motor/ Danfoss control valves.

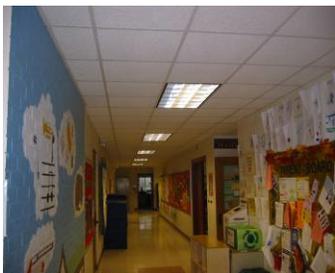
### INTERIOR LIGHTING:

The prevalent lighting in the school is recessed parabolic fluorescent light fixtures with T8 lamps and electronic ballasts. This lighting was installed in the 1989 code update project and is in good condition. Most of the old ballasts were replaced recently.

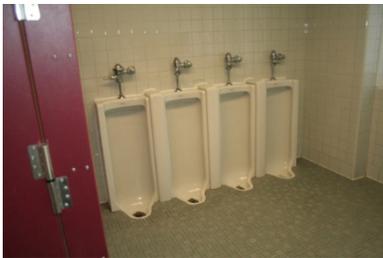
**Toilet Facilities** - Some of the Boys and Girls Toilet Rooms have been modified to provide accessible fixtures based on previous codes. These facilities do not comply with current standards for turning radii, clearances, accessibility or types of fixtures.

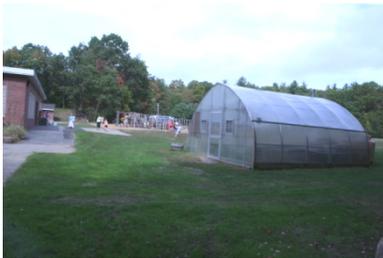
**FREE- STANDING GREENHOUSE:**

**Existing Structure** - A free-standing greenhouse structure is located a further distance away from the existing building than at the other two elementary schools south and east of the main building. There is no paved walkway and the structure is used mainly during warm weather since it lacks an appropriate heating system. Positive comments were heard about the activities and programs, which are beneficial to the educational environment. Incorporating this space into a more permanent component of a school building project was noted as being desirable.

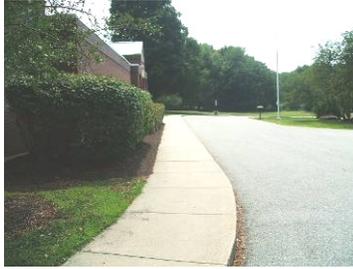
**PEDESTRIAN CIRCULATION:**

The buses drop off students in front of the school via a separate loop area. The sidewalk on the drop off loop is limited in width, and would need to be widened to meet current standards. Generally, the handicapped spaces appear to meet code. Access from the front parking areas requires crossing the bus maneuvering areas. Parking in the rear of the school requires walking along the drive aisle in some locations for a distance without sidewalks, etc.

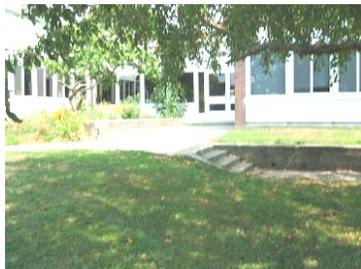
**ACCESSIBILITY:**

There are three handicapped parking spaces on the site. Two of the spaces serve the school, and the third space serves the separate building to the rear (east) of the school. All three spaces appear to generally conform to present regulations in regards to slope of pavement, ramp design, etc. Pavement markings, signage, etc. would need to be adjusted to meet present regulations. Along the south side of the front of the school, there are concrete sidewalks with stairs within the walks to adjust for elevation. These stairs, including a single step into the building in this area, do not meet accessibility guidelines. This area should be reconfigured to provide handicapped access. There is an entrance on the south end of the building with only stairs for access. This entrance should be reconfigured for handicapped accessibility with a ramp.

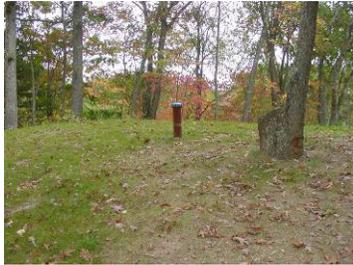
**NEW WELLS:**

**Domestic Water** - Domestic and water for the hydronic systems is provided by two new wells drilled in 2005 to replace the existing wells. Two new 5000 gallon in ground water storage tanks were also installed. The water system is of adequate size, in good condition, raises no energy efficiency issues and is suitable for continued existing use.

Water pressure and volume are maintained through two variable speed water pumps on each well and pressure tanks. All water distribution is through copper piping. The pumps and piping are of adequate size, in good condition, raises no energy efficiency issues and is suitable for continued existing use.

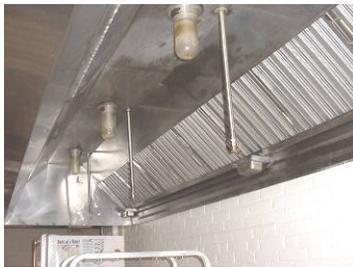
**KITCHEN HOOD:**

A hood with an exhaust fan ducted to the roof is mounted over the gas range. There is a second exhaust fan and a makeup air fan for the kitchen. The equipment is 19 years old. Based on its age and condition it is recommended to replace the hood, ducts and fans.

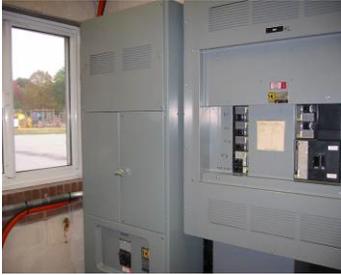
### ELECTRICAL SERVICE:

The school's main electrical service is a single phase 1,000 amps service with a 1,200 amp MDP#1 and smaller 400 amp MDP#2 panel. The MDP #2 panel is one year old and is used to power to the new well pumps. The single-phase service is inadequate and impedes expansions. The cramped electrical room does not meet current code requirements. The cramped electrical room does not meet current code requirements. The branch circuit panels are very old and mostly full, with many original ones dating back to 1952 or to 1965 in the South Wing. Classrooms and other spaces are in need of additional 120v outlets.

It is recommended to replace the entire electrical service with 3-phase power into a code compliant room on the main level. Add new panelboards throughout the school. Older single-phase branch circuit panels in good condition can be re-fed from a new 3 phase MDP, with all new panels at 3-phase for new loads.

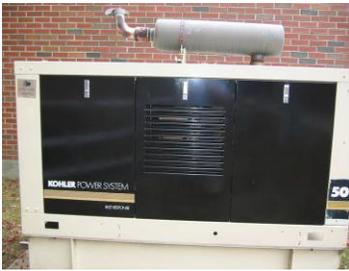
### GENERATOR:

The existing 50-kW generator and manual transfer switch are old and do not provide power to all emergency systems during a power failure. Identify power panels, equipment and services that require emergency power and collect them for switching to emergency power when normal power fails. It is recommended to replace the generator, ATS and add emergency panel boards for emergency circuits.

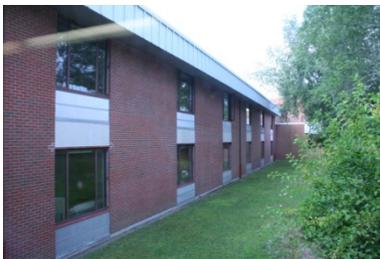
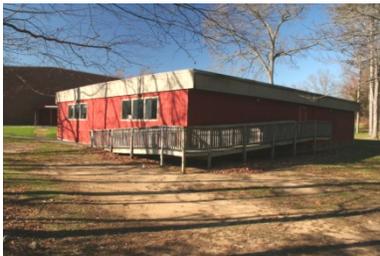
#### BUILDING STRUCTURE:

Original building and the newer Library/Media Center Addition were constructed using concrete footings, continuous concrete foundation walls, a structural steel frame with steel beams, girders and trusses to support the floors and roof construction. Most of the interior classrooms, corridors and similar demising walls were constructed using CMU with some locations having brick veneer exposed in accent panels and columns. Both the original construction and the addition have concrete slab on-grade floors. Visual observations around the exterior walls did not reveal a significant deterioration, cracking or similar evidence of problems with the building's structural system. However, interior CMU walls were noted in several locations as having horizontal and vertical cracks on exterior walls. Most likely, this is a result of differential settlement and/or shrinkage and can be repaired by cleaning out the mortar joints and applying a resilient sealant.

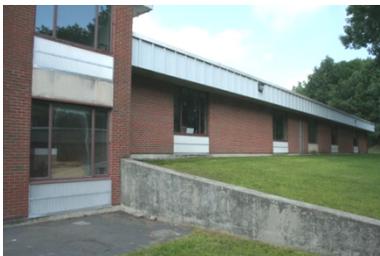
#### EXTERIOR ENVELOPE:

**Exterior Walls** - The exterior walls of the 1969 original building were constructed using exterior brick veneer, air space, and 2" rigid insulation with a backup wythe of CMU on the interior. Spandrel panels at the base of windows and between first and second level windows was constructed using brownstone panels. In the Library/Media Center Addition, the exterior walls were constructed almost completely with exterior face brick, air space 1" rigid insulation and backup CMU for the interior wythe.

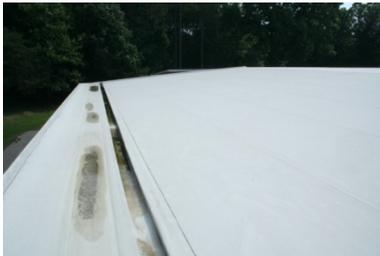
**Doors** - Exterior doors were mainly hollow metal in hollow metal frames with non-insulated wire glass in adjacent vision panels.

**Roof** - The roof of the original building consists of a white reinforced Stevens Hi-Tuff EP PVC membrane over rigid insulation. There are built-in gutters with drains at regular intervals but no slope in the gutter trough between the drains. This creates pockets of standing water where leaves and debris collect. In some locations, standing water was noted on both the high and lower side of the gutter trough.

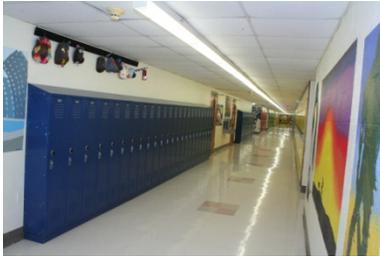
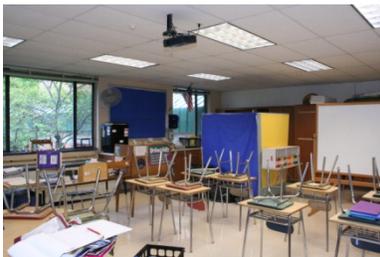
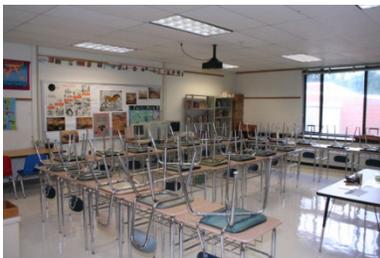
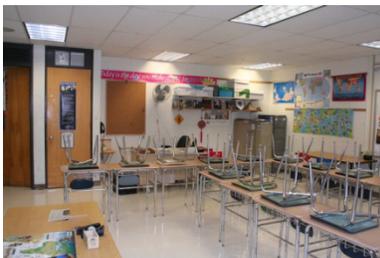
### INTERIOR FINISHES & FIXTURES:

**Interior Walls** - Corridor walls are a combination of painted CMU with some brick veneer accents. Student paintings are prominently featured on the light, neutral colored painted surfaces in many locations. Metal lockers line corridor walls in many locations and appear to be in fairly good condition.

**Floors** - Corridor floors are almost exclusively VCT with resilient base with the exception of the corridor directly in front (east) of the Auditorium, which has carpet. Carpet is also located in the Music and Choral Rooms. Toilet Rooms and Custodial Spaces have ceramic tile with no base. The new Library/Media Center, Computer Rooms and associated spaces have carpet on the floors with resilient base. The Kitchen and adjacent spaces with food service operations have 4" square quarry tile floors with no base. The Gymnasium has a wood floor.

**Ceilings** - Most classrooms, corridors and teaching spaces have 2' x 4' suspended acoustical panel ceilings. Layers of 6" batt fiberglass insulation have been placed over these acoustical ceilings in many classrooms and teaching spaces in an effort to conserve energy. This was noted while attempting to push up ceiling tiles and check for continuity of corridor walls. The new Library/Media Center has 2' x 2' suspended acoustical panels and the Gymnasium has expose steel trusses with the underside of the original Tectum deck exposed below. Ceiling panels in many of the corridors were noted as being uneven with some nicked corners and some evidence of minor vandalism. The ceiling in the Kitchen appears to be a 2' x 2' non-perforated suspended acoustical panel, most likely complying with code requirements to be washable.

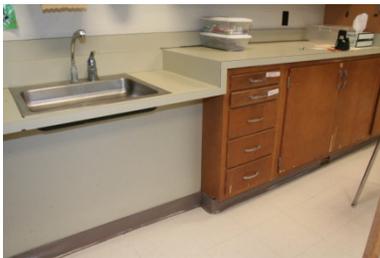
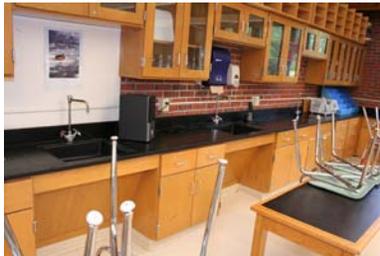
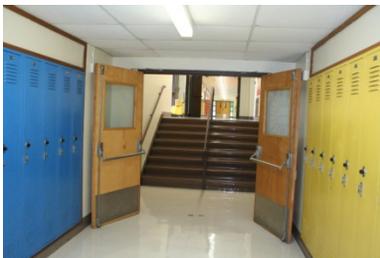
**Classroom Casework** - Throughout the building, most of the casework has been constructed with stained wood base and wall cabinets and plastic laminate countertops and backsplashes. Similar construction was used in the Science Laboratories except for the use of solid, black resinous laboratory countertops and backsplashes. In some locations the wear and deterioration was showing on the vertical surfaces of the wood cabinetry and the plastic laminate countertops and the edgings. Some of the science rooms appear to have newer casework and are in better condition.

**Doors and Frames** - Throughout the entire building doors are solid core wood mounted in hollow metal frames with wire glass vision panels and lites in the doors. Some doors, especially around stairways, show evidence of considerable traffic and wear and tear. Doors between corridors and some stairways were noted as not having positive latching devices and only push/pull plates.

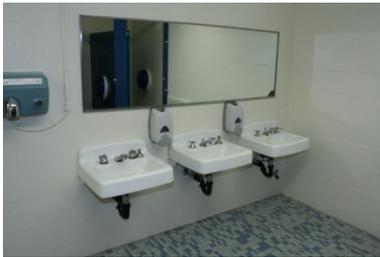
### ADA / ACCESSIBILITY:

**Exterior Entries** - Most of the exterior doors have level platforms and/or ramped sidewalks leading to the adjacent walkways.

**Toilet Facilities** - Some of the Boys and Girls Toilet Rooms have been modified to provide accessible fixtures based on previous codes. These facilities do not comply with current standards or turning radii, clearances, accessibility or types of fixtures.

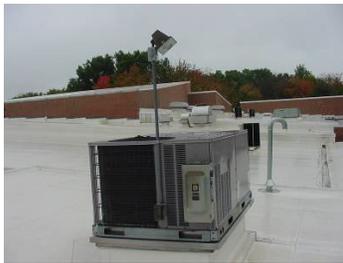
### KITCHEN PACKAGED ROOF TOP HEAT PUMP UNIT:

*Kitchen* - A Carrier packaged roof top heat pump unit with electric supplemental heating, heats, cools and supplies outside air to the kitchen. This equipment is over 30 years old. It is recommended to replace the unit with a packaged roof top unit using hydronic or gas fired heating. A recently installed wall mounted refrigeration unit cools and circulates inside air for supplemental kitchen cooling. A roof top kitchen hood fan exhausts the kitchen. It is recommended to replace the hood exhaust fan, which is over 30-years old. A roof top condensing unit installed in 1994 comprises part of the walk in cooler refrigeration system. It is recommended to replace the walk in cooler refrigeration system based on age and condition.

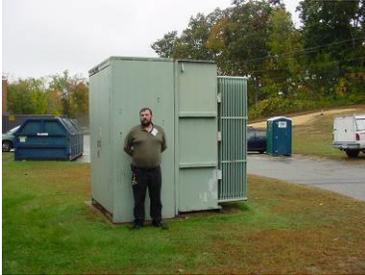
### ELECTRICAL SERVICE:

The original 4,000-amp 480-volt 3-phase system installed in 1969 provides electrical service to the school buildings. The system is old but in good working order. The 3 phase 3,000 amp 480 volt Main Distribution Panel and the newer 1,600-amp 480-volt distribution panels are both full, with no spare capacity to add additional circuits. Branch circuit panels are mostly full. A new service with pad-mounted transformer became necessary with the addition of portable classrooms. Future building additions will require additional electrical service.

Future electrical service is available by re-configuring the existing 4,000 Amp service when electrical heating loads are eliminated. Elimination of electric heat frees enough power to handle many new loads and a future renovation project.

The existing electrical service is adequate after removal of electric heat and the addition of a few distribution panels and circuit breaker panel boards.

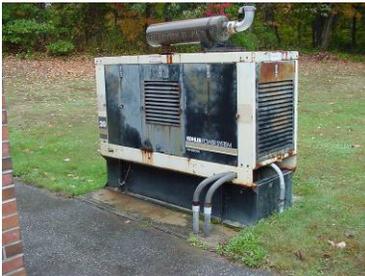
### GENERATOR:

The existing 20 kW generator and manual transfer switch dates back to 1969, and are much too small to be of much use. Implementation of a comprehensive plan that will determine which power panels, equipment and services stay in case of a power outage is required. Additions of new automatic transfer switches (ATS's), a generator and emergency power equipment panel(s) connected to new distribution panel boards will feed existing and future critical loads.

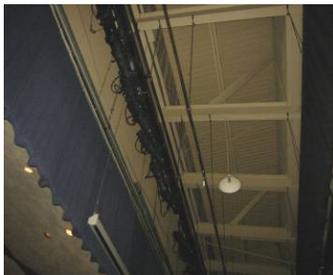
### STAGE LIGHTING:

Relatively new are the stage lights and Strand Stage Lighting Dimmer panel. This equipment is in excellent condition and not addressed for any upcoming renovation project. However, it is recommended to upgrade the stage audio systems.

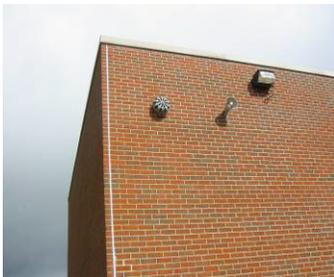
### BUILDING PERIMETER LIGHTS:

Building perimeter light fixtures vary in age with some being new and some being original from 1969. The exterior lights are sodium wallpacks and metal halide wallpacks around the building while incandescent wall wash lights the transite soffits.

The exterior building and grounds shall be evaluated for lighting to meet IES illumination levels. Coordinate walking path and parking lot lighting for proper levels. Add new fixtures as required and replace all 1969 fixtures. Replace transite and roof soffit lights. Currently they are un-maintained due to the asbestos transite around them.
